COLMA CREEK CITIZENS ADVISORY COMMITTEE MEETING

Colma Creek Flood Channel
Maintenance Matrix Monitoring Photos

Survey Date: August 23, 2024

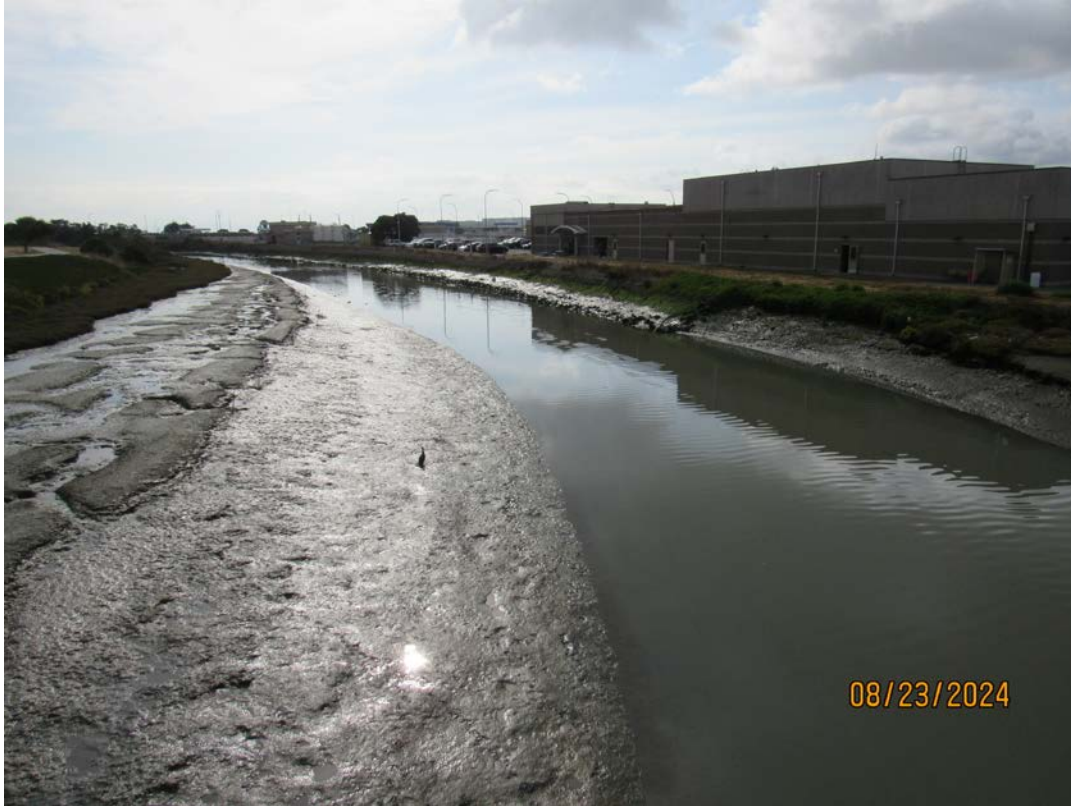
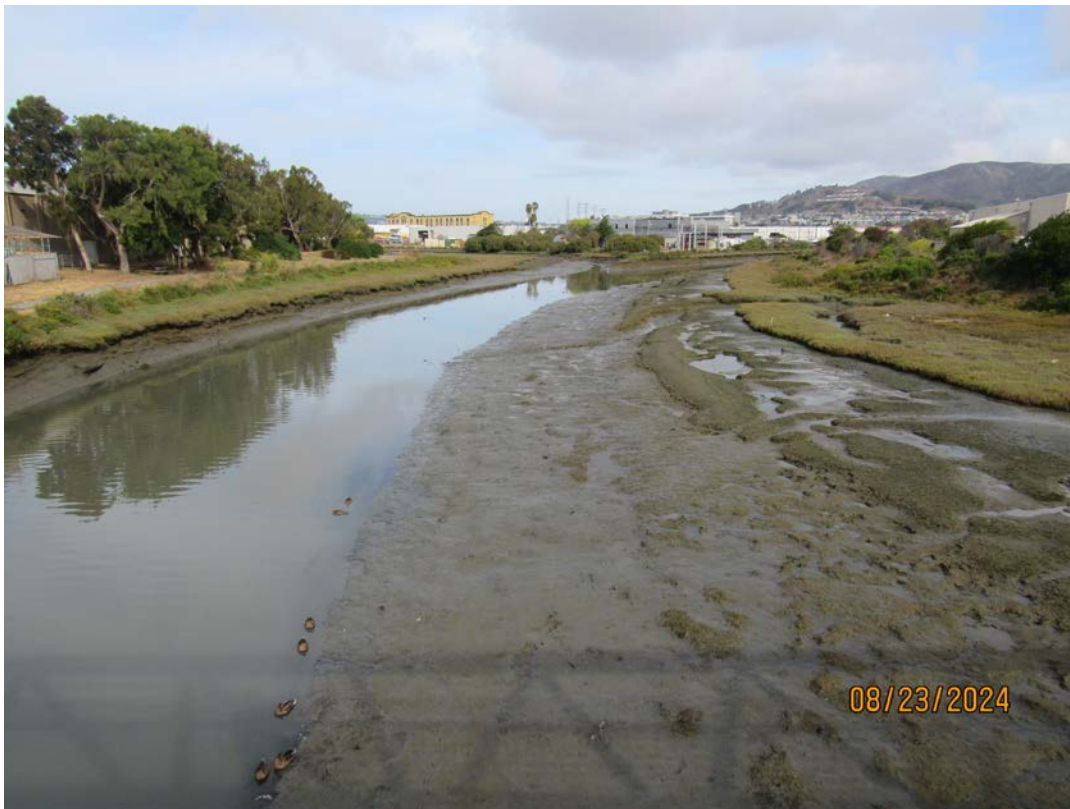
Photos 1 & 2 – Top photo shows Colma Creek looking downstream from the Bay Trail pedestrian bridge. Bottom photo shows Colma Creek looking upstream from the pedestrian bridge.

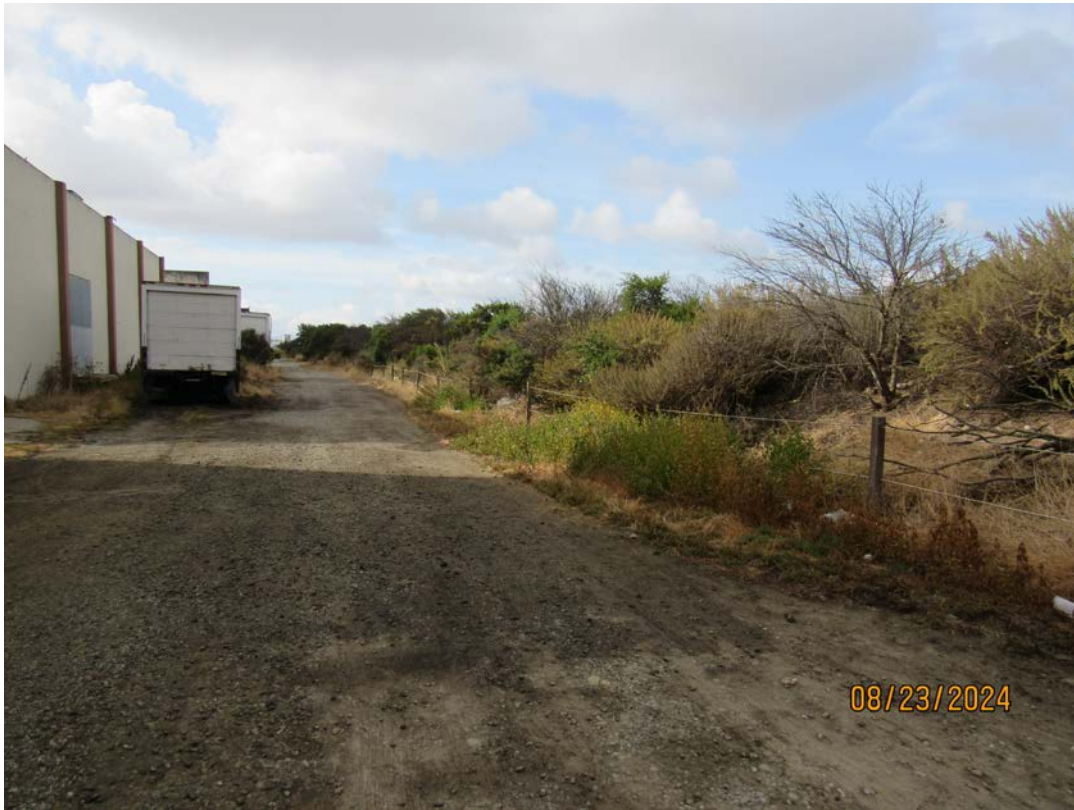
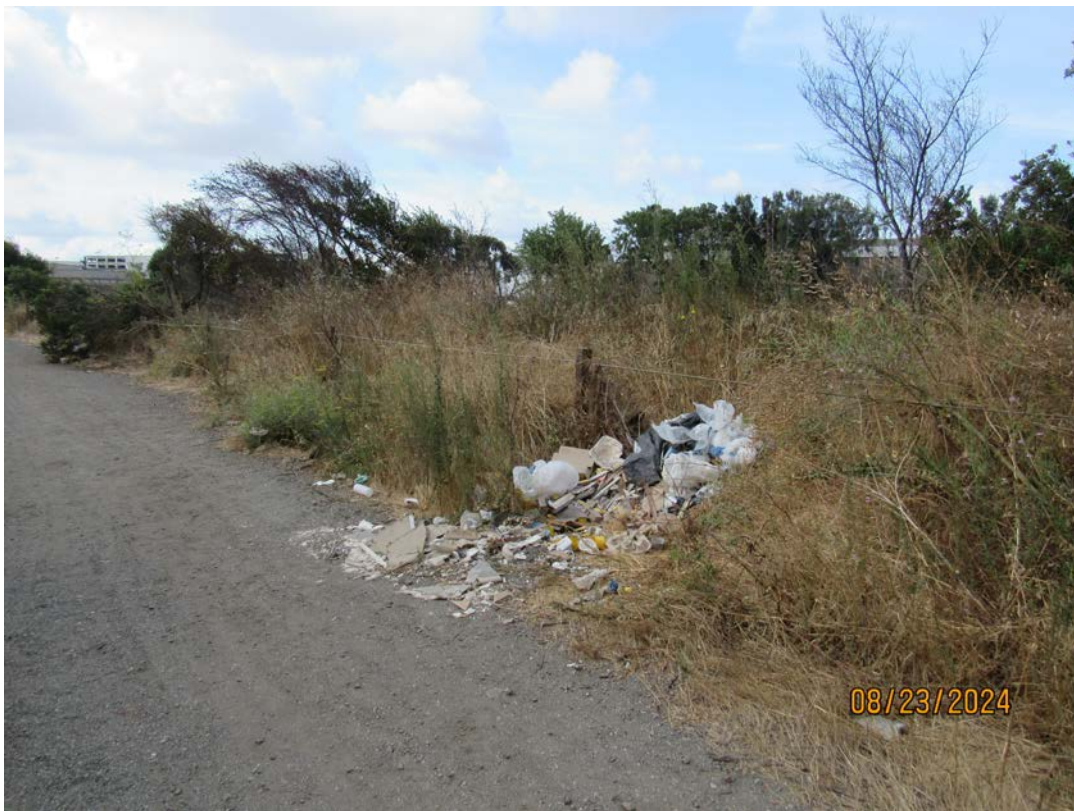
Photos 3 & 4 – Top and bottom photos show access road and mitigation Site 2 between the Bay Trail pedestrian bridge and Utah Avenue remain clear of encampments. However, some trash and illegal dumping was observed. **OneShoreline and County planning on clearing trash/debris in these areas and maintain/replace native vegetation during future cleanup/planting events.**

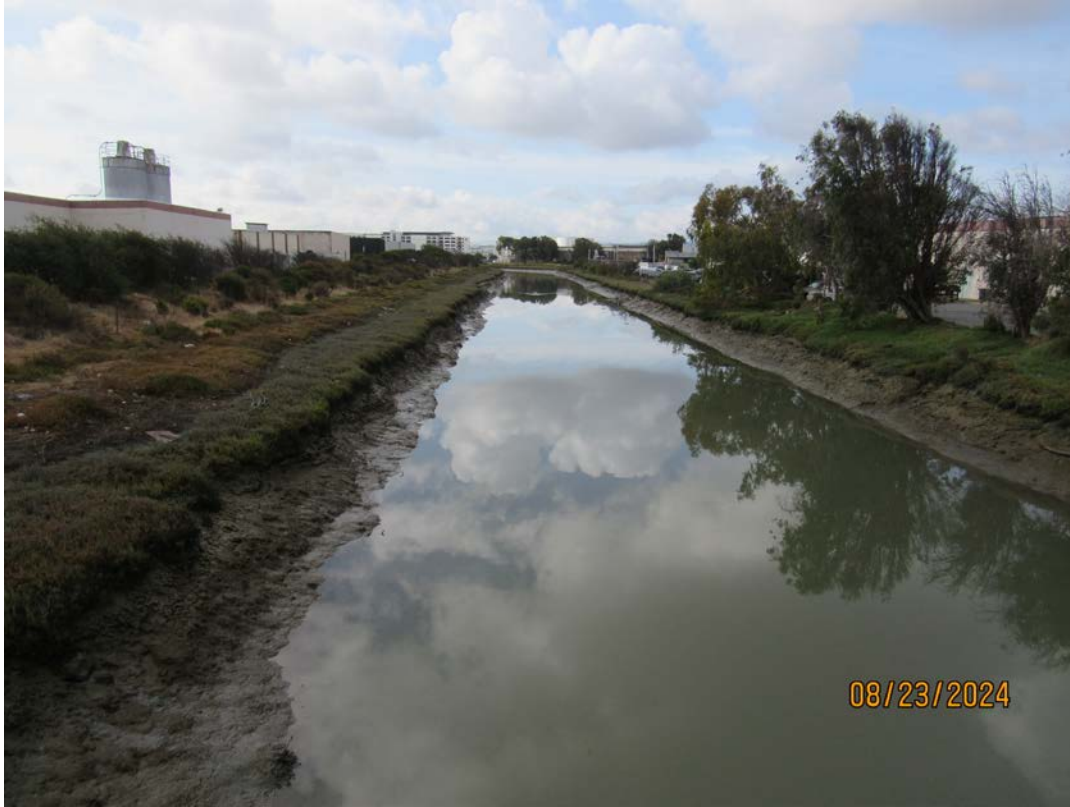
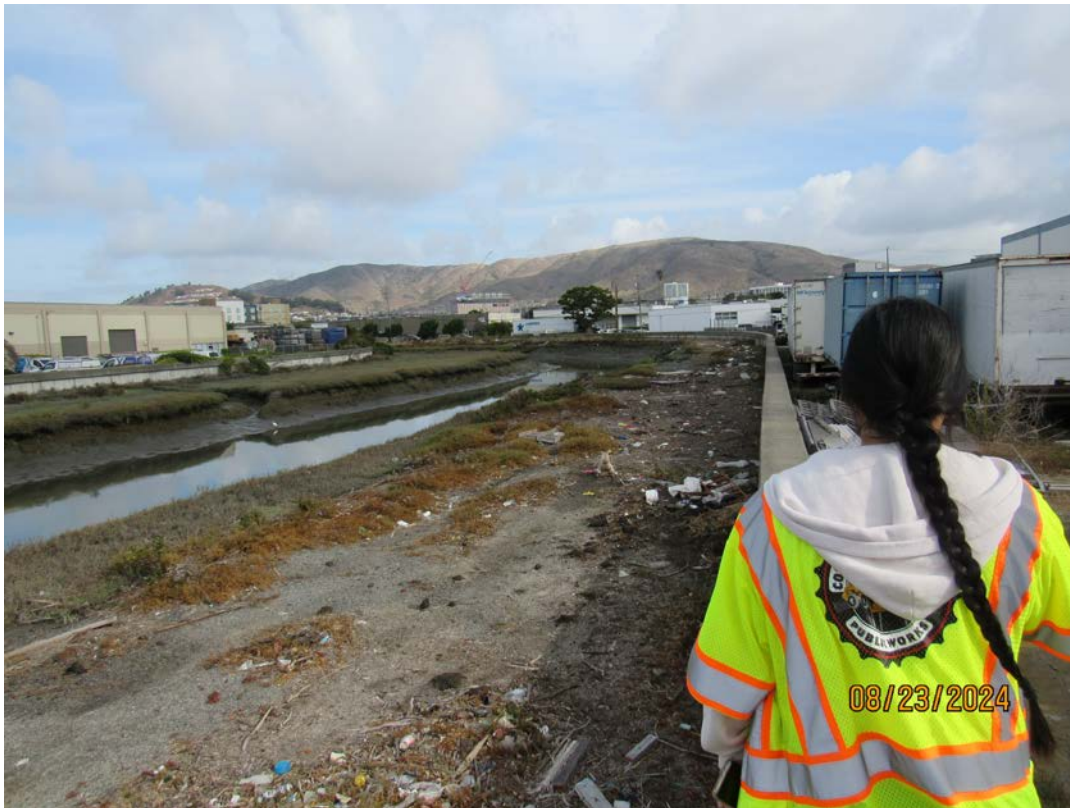
Photos 5 & 6 – Top photo shows Colma Creek looking downstream from the Utah Avenue bridge. Bottom photo shows Colma Creek looking upstream from Utah Avenue. **Trash from various sources including storm drains and illegal dumping continues to be an impairment to the channel in this section.**

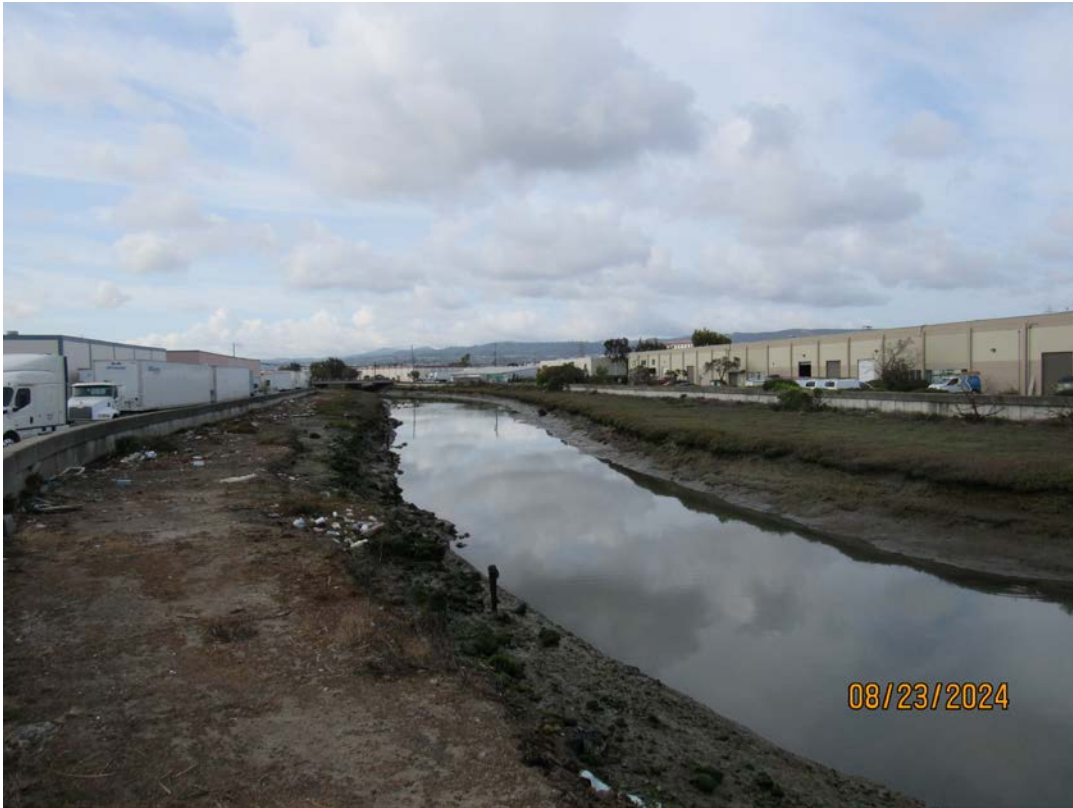
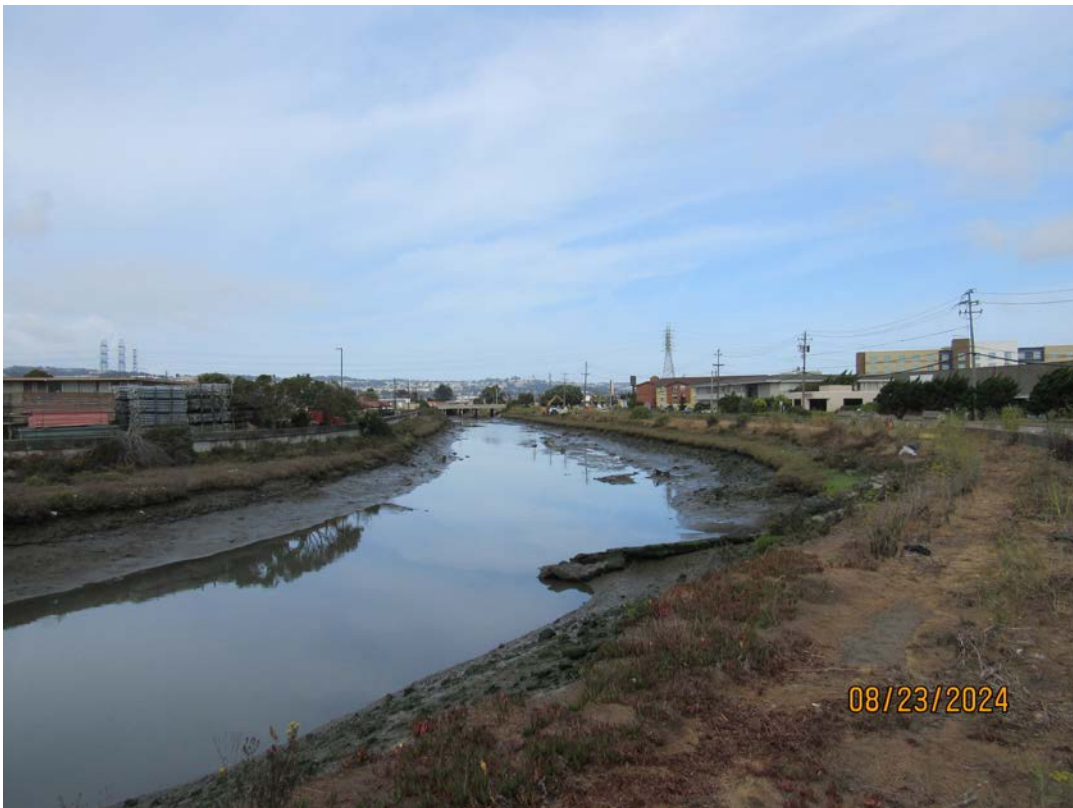
Photos 7 & 8 – Top photo shows Colma Creek looking downstream towards the Utah Avenue bridge. Bottom photo shows Colma Creek looking upstream towards the S. Airport Blvd. bridge.

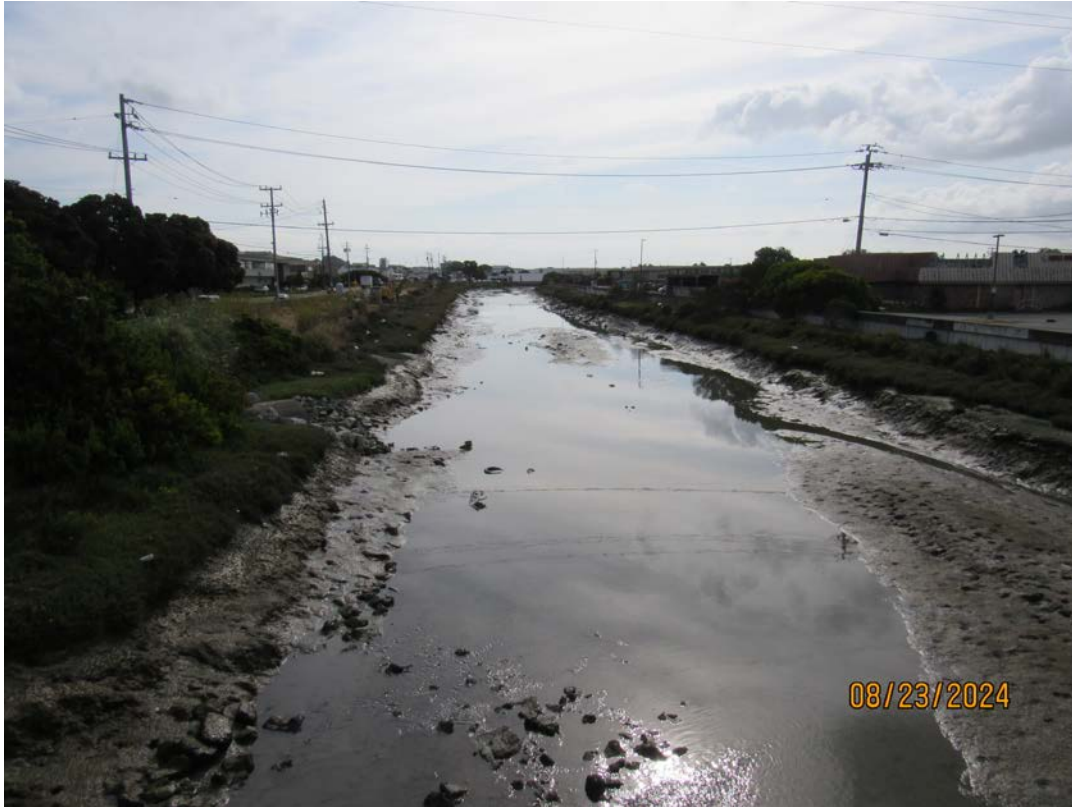
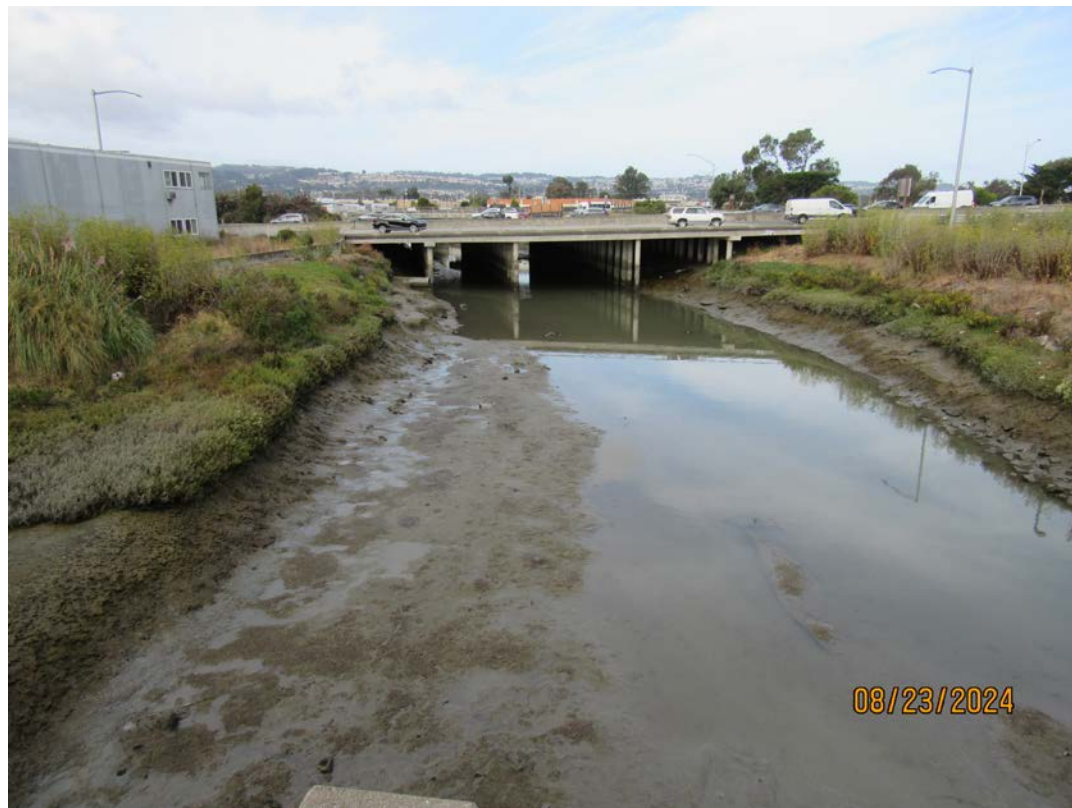
Photos 9 & 10 – Top photo shows Colma Creek looking downstream from the S. Airport Blvd. bridge. Bottom photo shows Colma Creek looking upstream from S. Airport Blvd. facing the Hwy 101 crossing. **Trash and illegal dumping related to homeless encampment activities under the S. Airport Blvd. bridge were visible in this vicinity.**

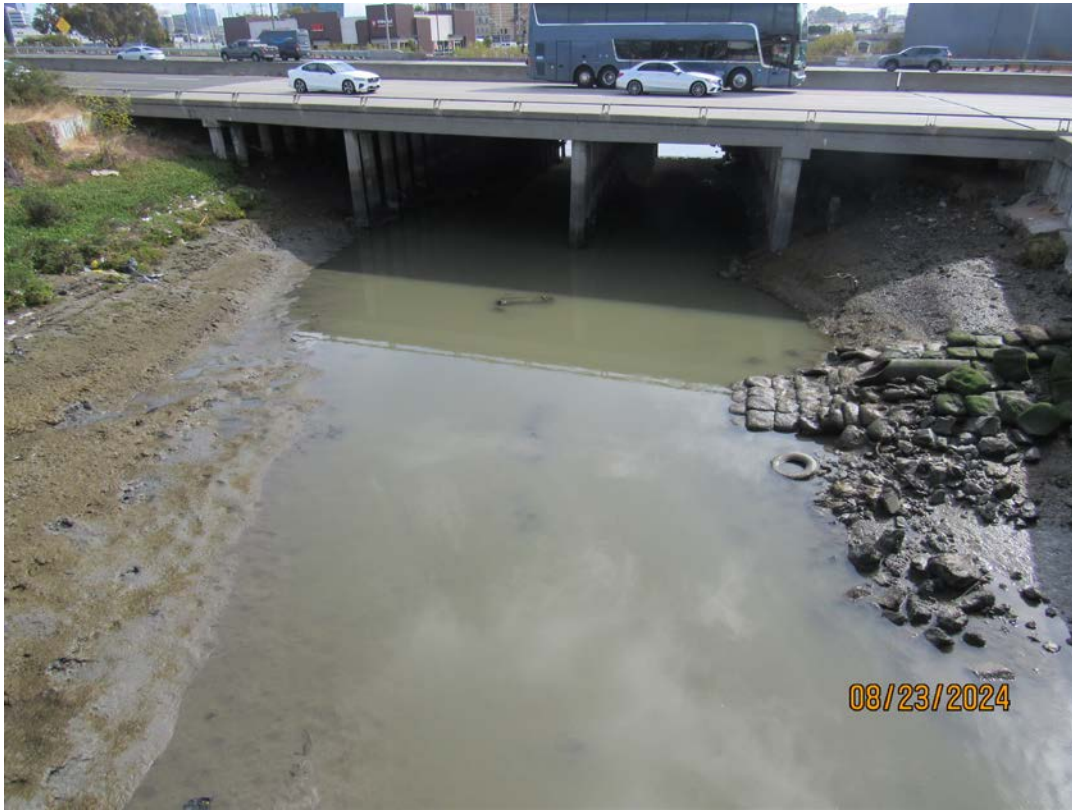
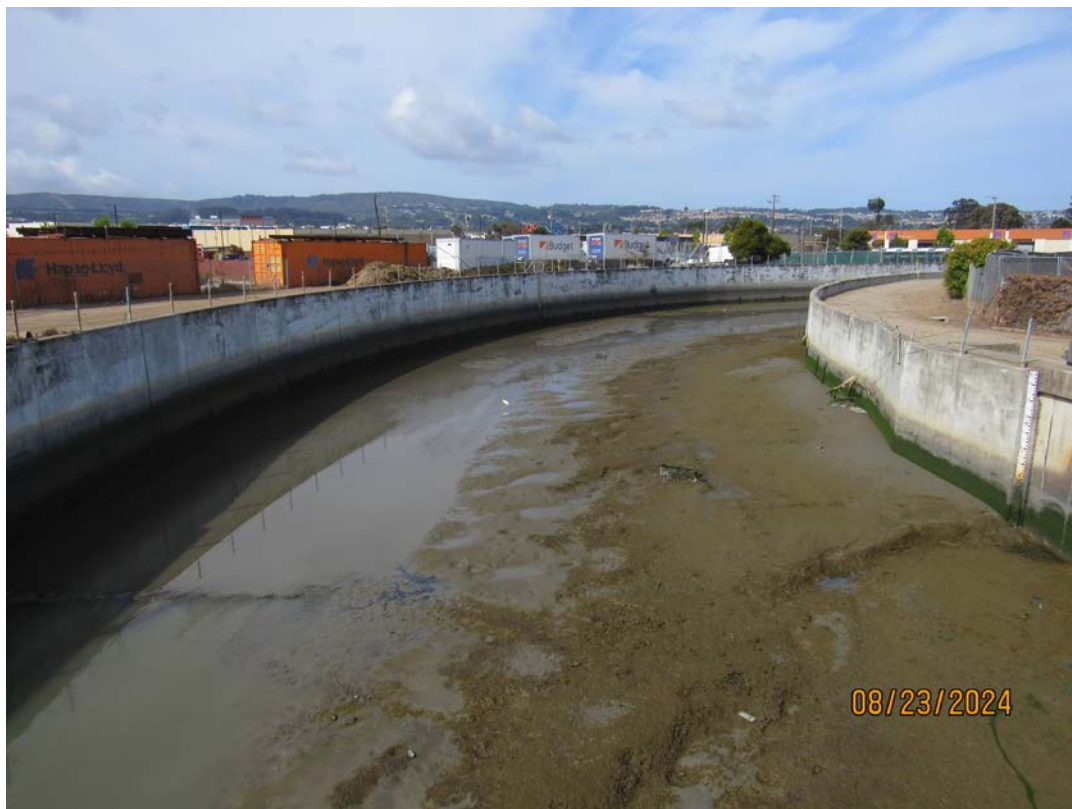
Photos 11 & 12 – Top photo shows Colma Creek looking downstream from the Produce Avenue bridge facing the Hwy 101 crossing. **Trash and illegal dumping related to homeless encampment activities under the Produce Ave bridge were visible.** Bottom photo shows Colma Creek looking upstream from the Produce Avenue bridge. **Access roads in bottom photo were cleared of vegetation and debris by the County on behalf of OneShoreline as part of this year's maintenance work**

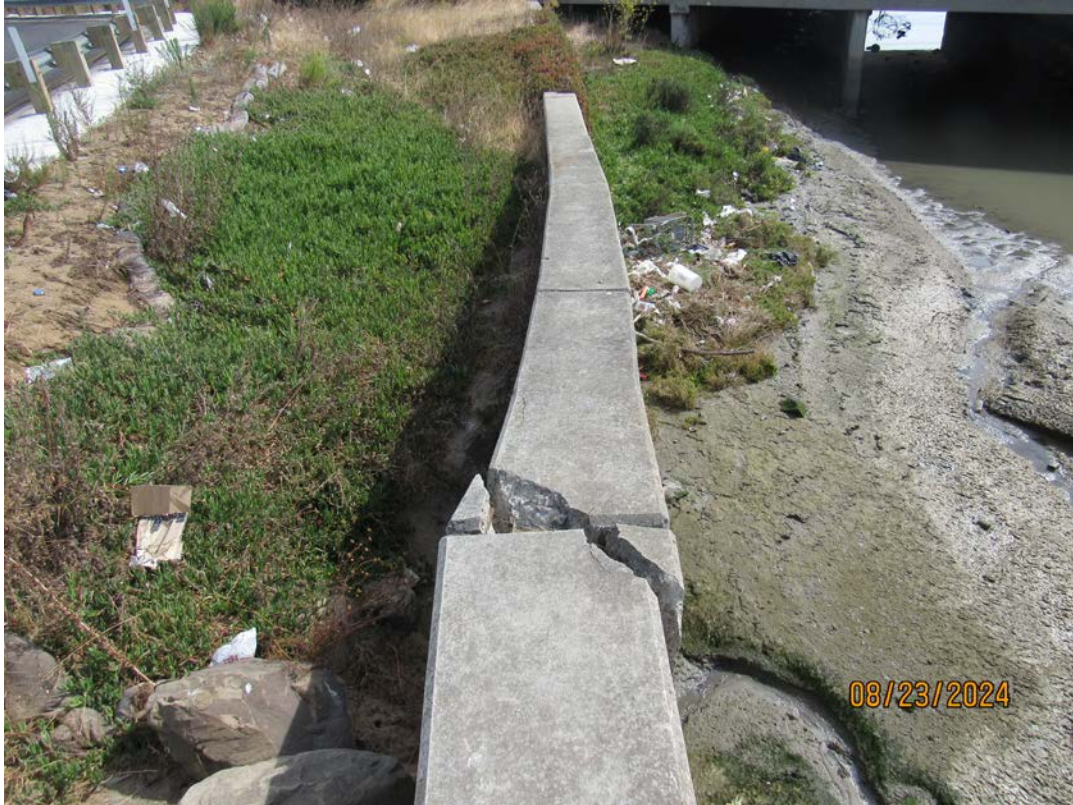
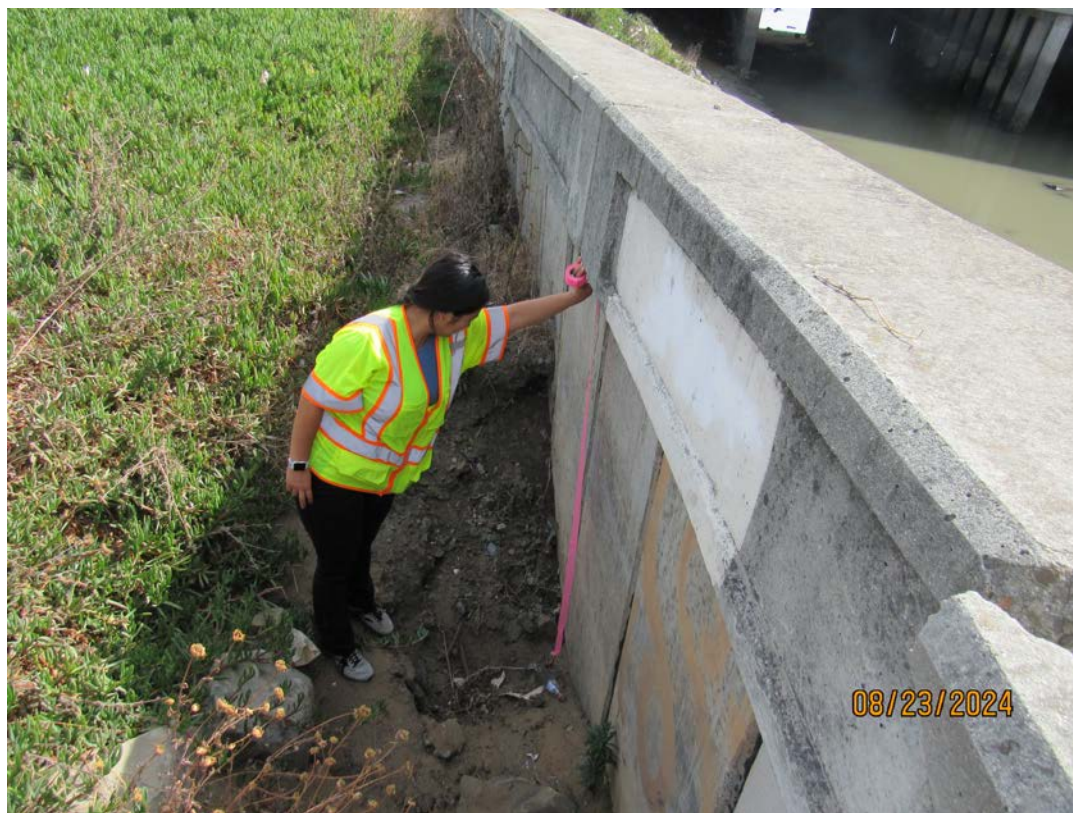
Photos 13 & 14 – Top photo shows damage on channel wall and partially blocked culvert outfall downstream from the Produce Avenue bridge facing the Hwy 101 crossing. Bottom photo shows void outside the channel wall. **County recommends continuing to monitor the area and contacting Caltrans to clear the drain inlet.**

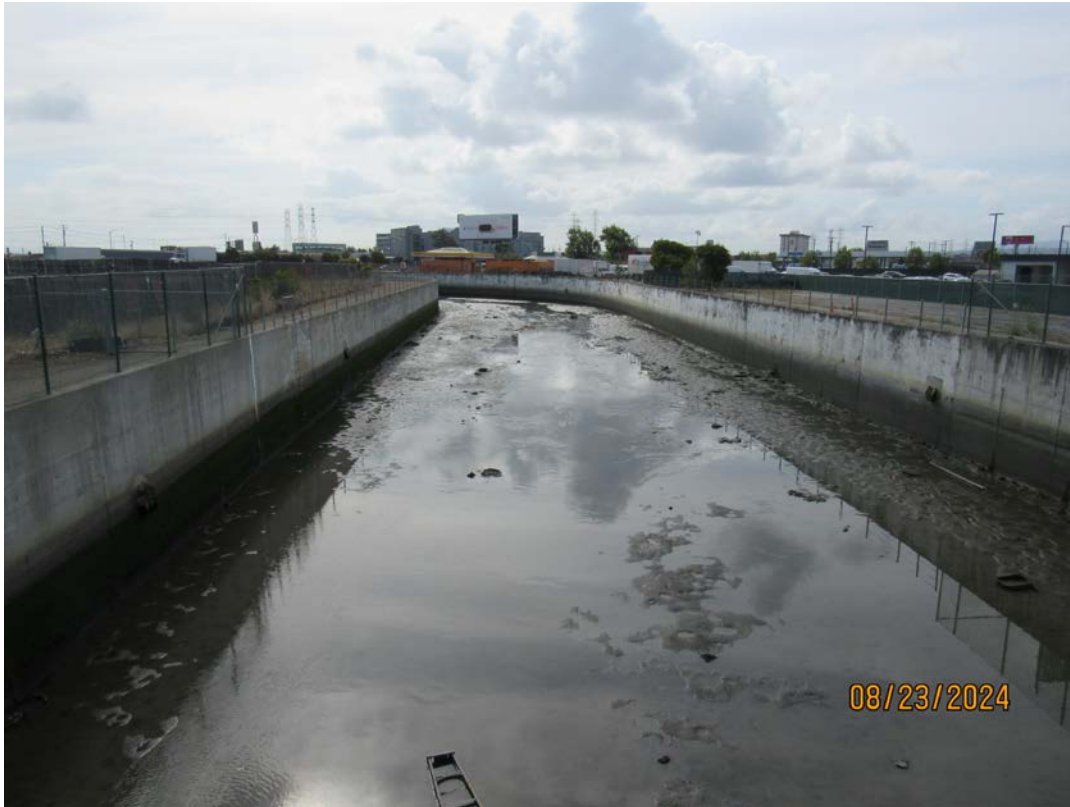
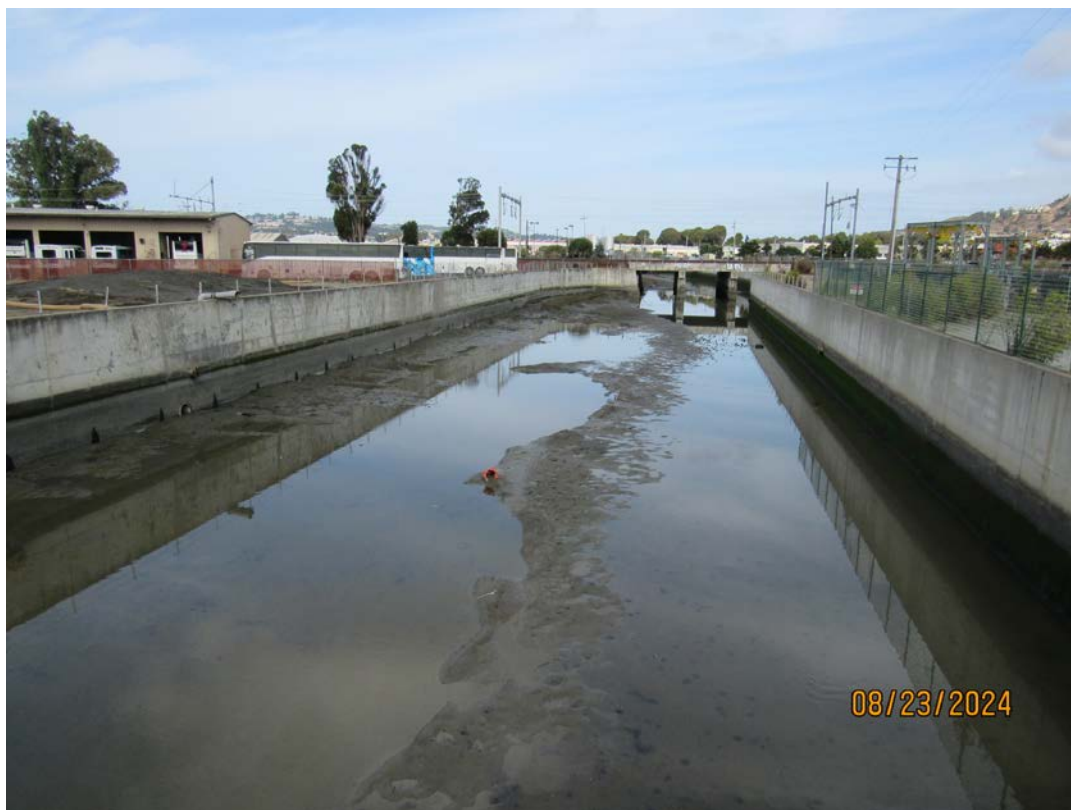
Photos 15 & 16 – Top photo shows Colma Creek looking downstream from the San Mateo Avenue bridge. Access roads in top photo were cleared of vegetation and debris as part of this year's maintenance work. Bottom photo shows Colma Creek looking upstream from the San Mateo Avenue bridge. This section was dredged of sediment by the County contractor on behalf of OneShoreline as part of this year's maintenance work.

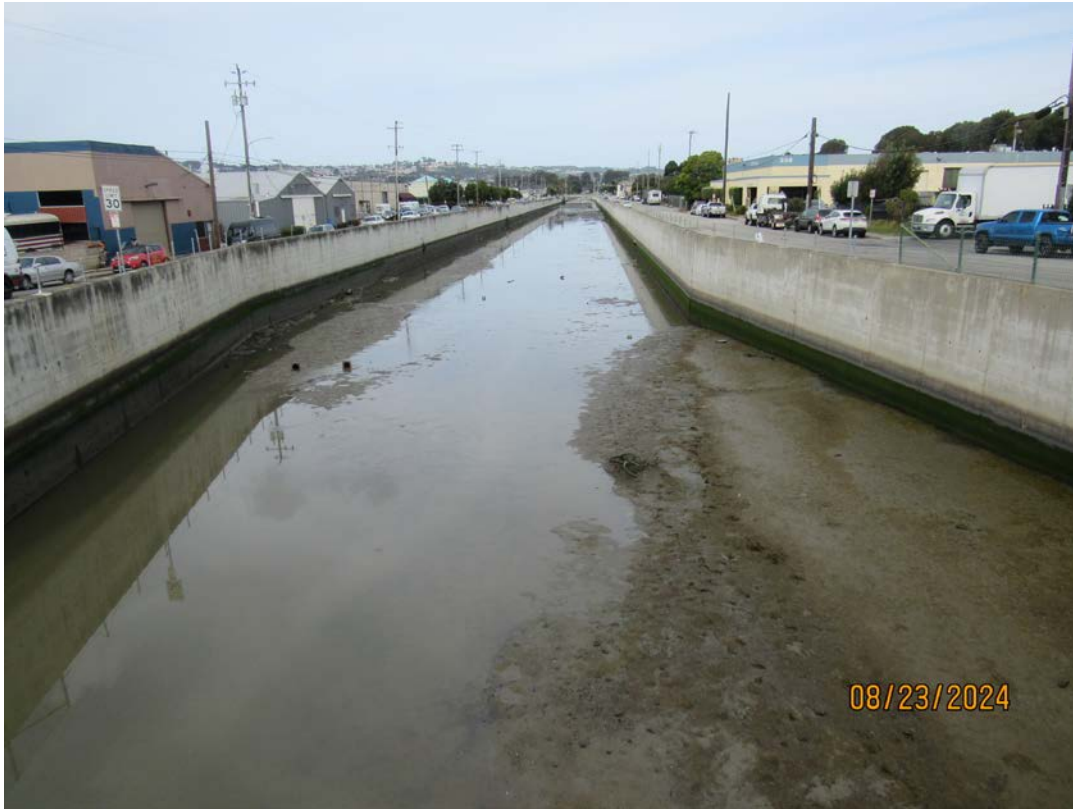
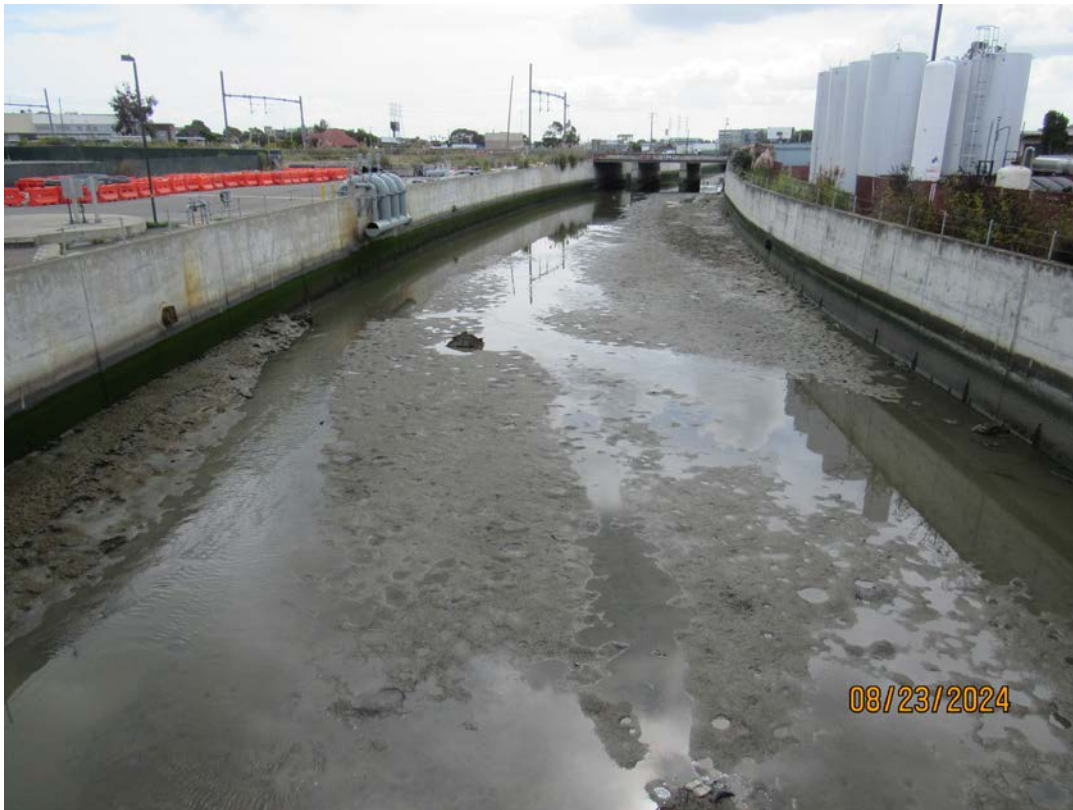
Photos 17 & 18 – Top photo shows Colma Creek looking upstream from Linden Avenue bridge. Bottom photo shows Colma Creek looking downstream from the Linden Avenue bridge. **The areas outside the channel walls were clear of active encampments.**

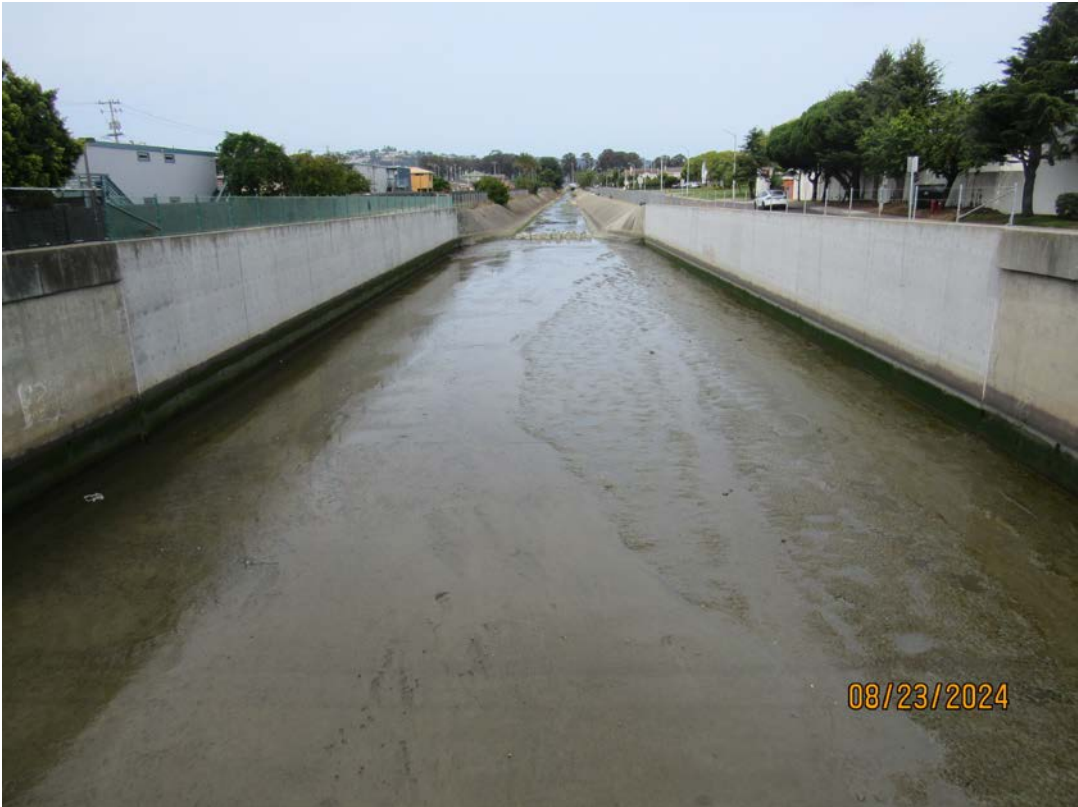
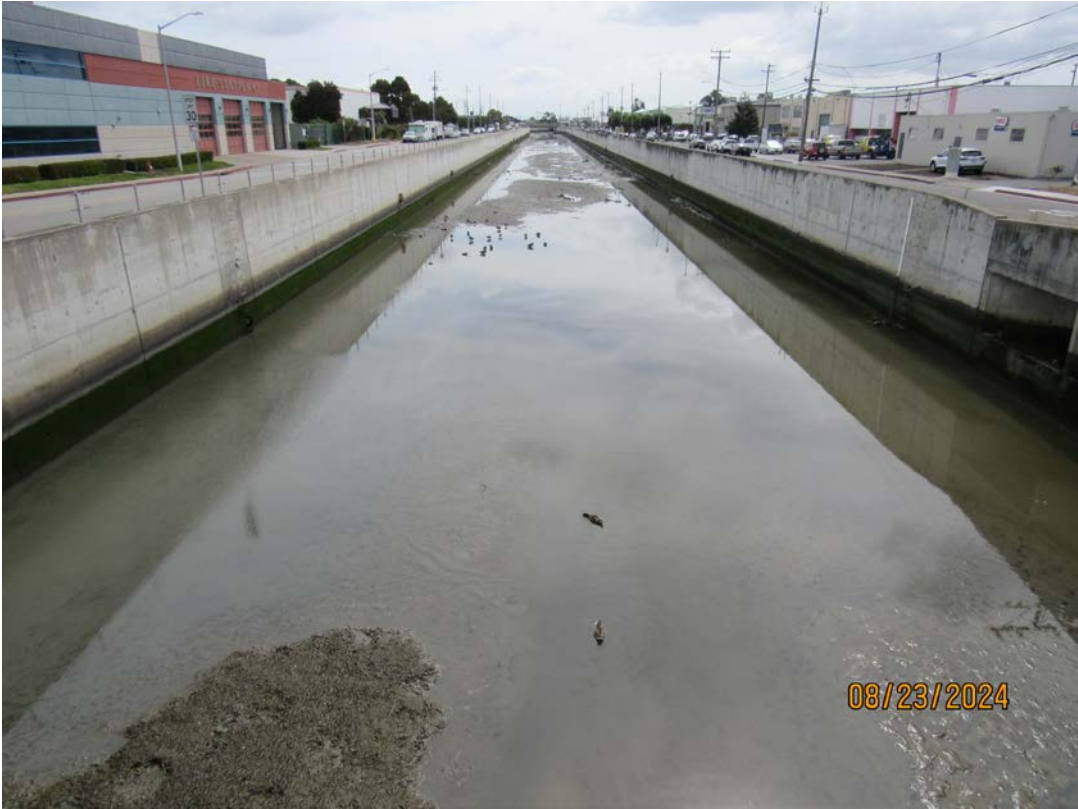
Photos 19 & 20 – Top photo shows Colma Creek looking upstream from Spruce Avenue bridge. Bottom photo shows Colma Creek looking downstream from Spruce Avenue bridge.

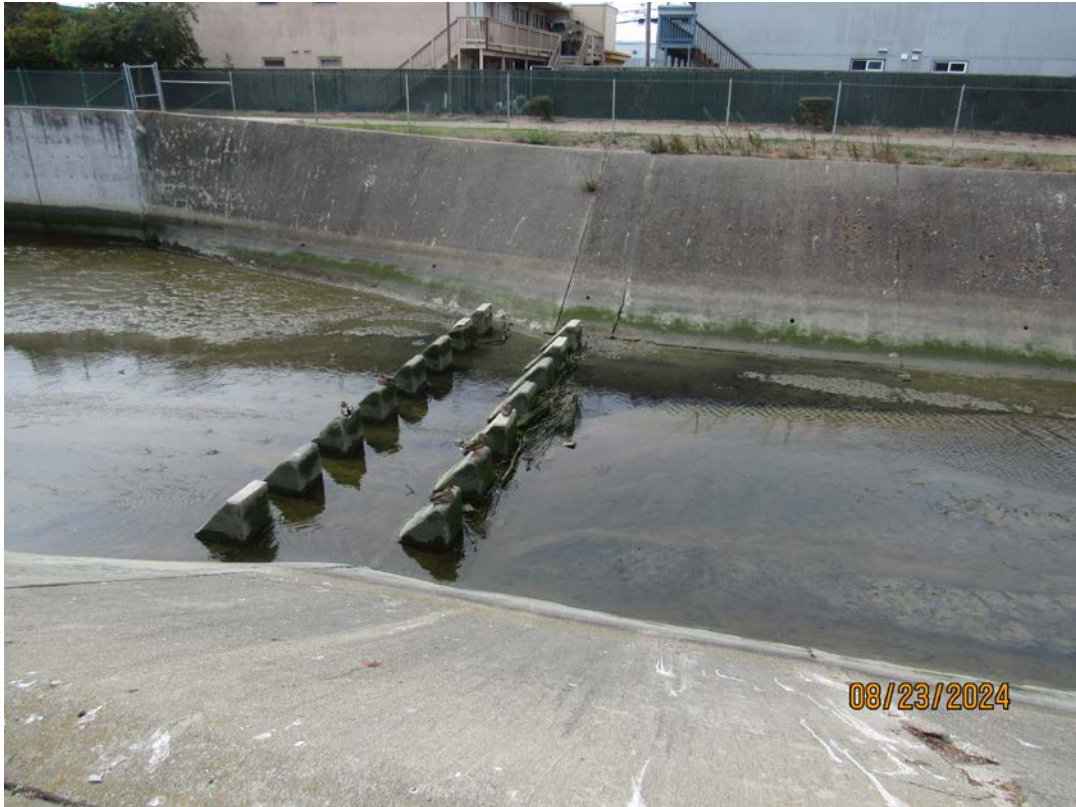
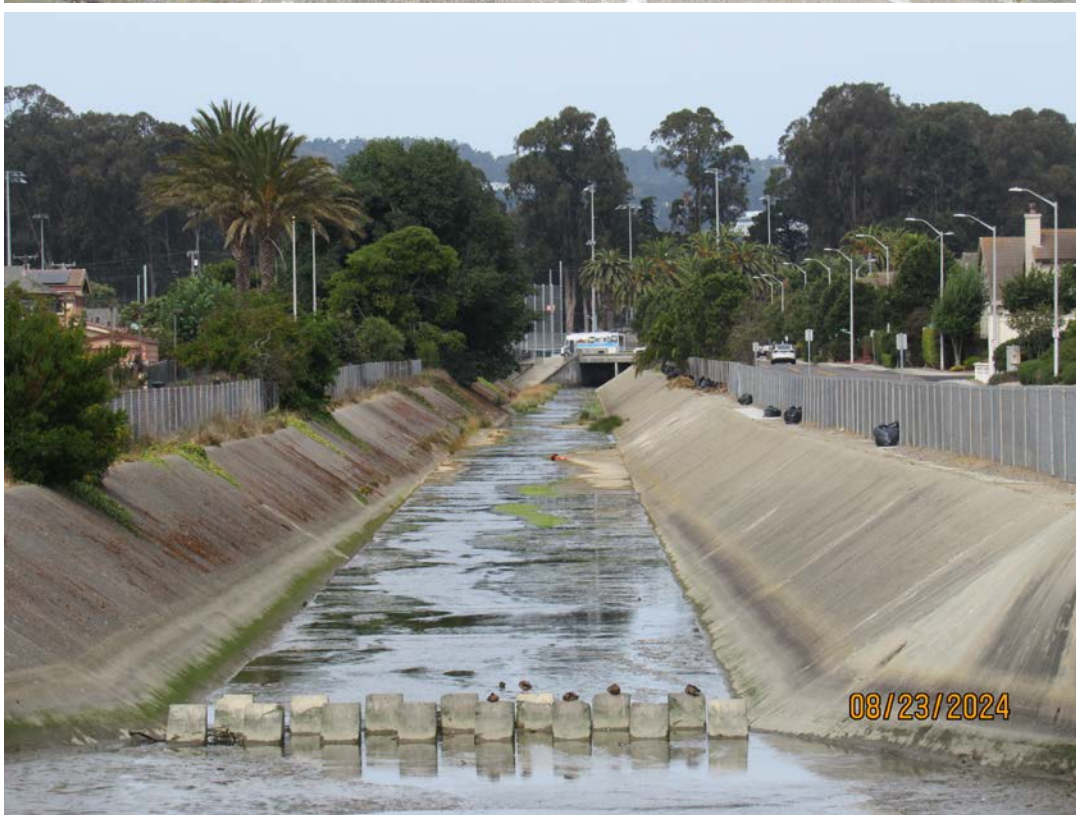
Photos 21 & 22 – Top photo shows minor debris accumulated at the dissipator teeth upstream of the Spruce Avenue bridge. Bottom photo shows channel upstream of dissipator teeth where **vegetation clearing** conducted by the County on behalf of OneShoreline, has been completed on the left side of the channel and is still ongoing along the right side. 11

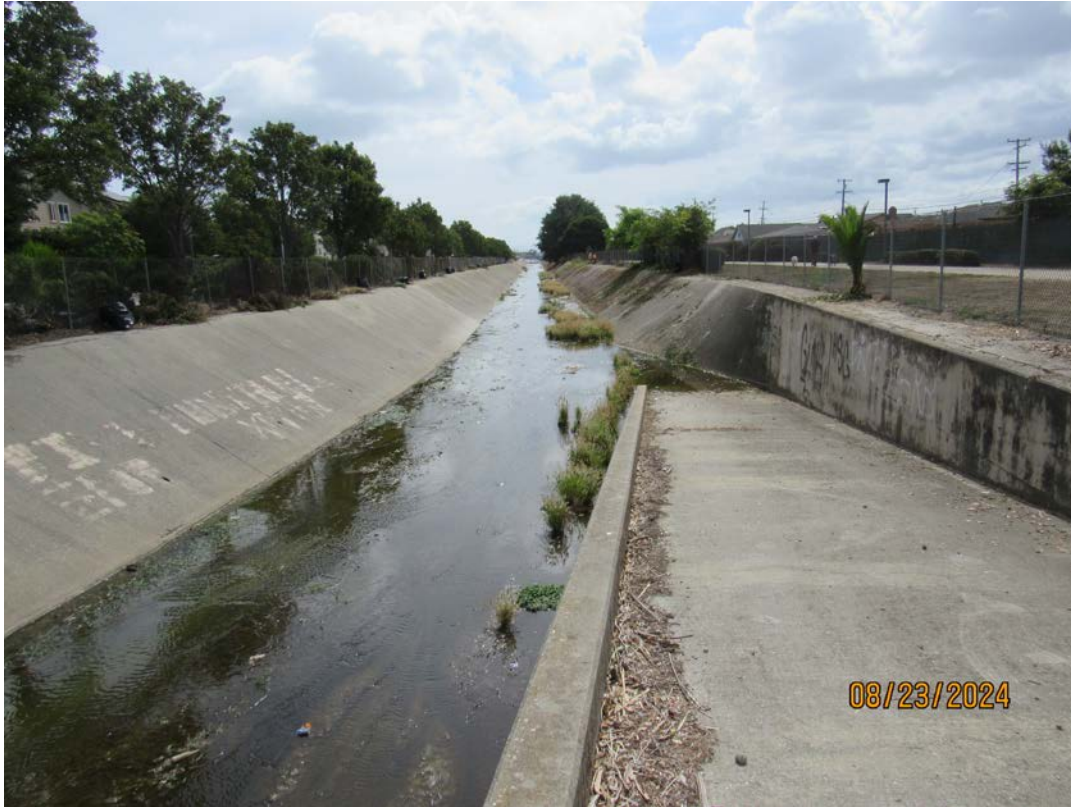
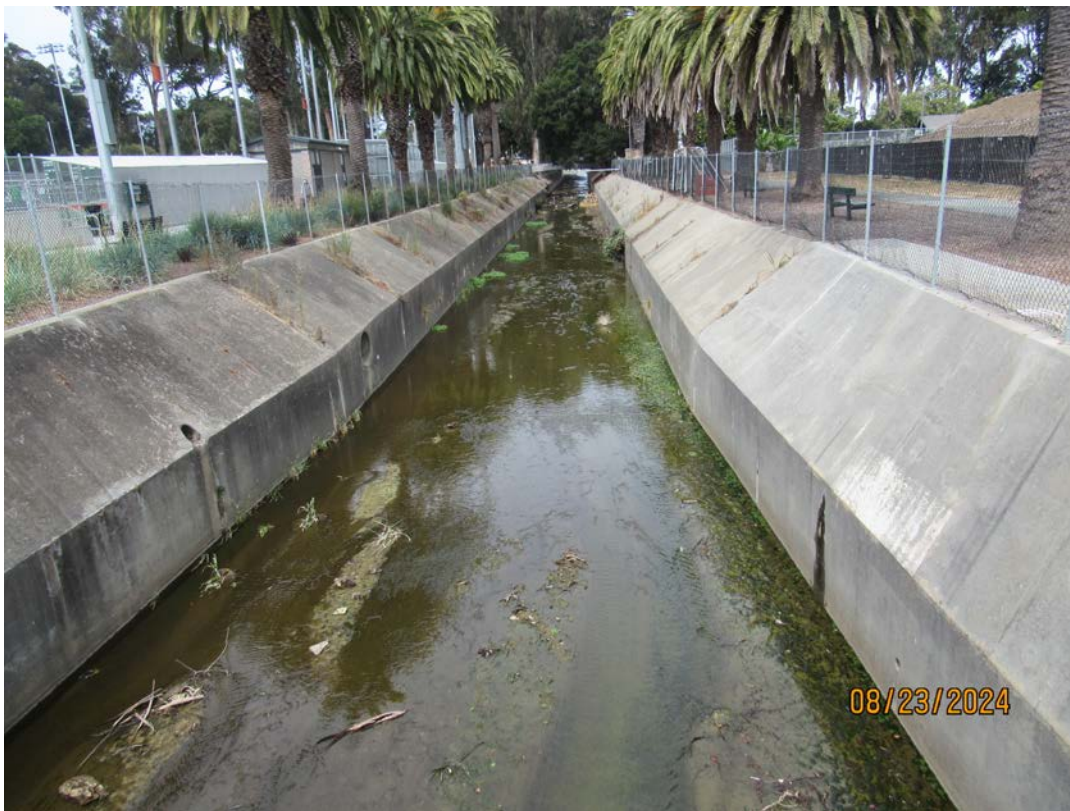
Photos 23 & 24 – Top photo shows Colma Creek looking downstream from the Orange Avenue bridge. Bottom photo shows Colma Creek looking upstream from Orange Avenue bridge. **The County on behalf of OneShoreline, will be removing and trimming vegetation in the joints and weepholes in this section of channel during this year's maintenance activity.**
