COLMA CREEK CITIZENS ADVISORY COMMITTEE MEETING

Colma Creek Flood Channel
Maintenance Matrix Monitoring Photos

Survey Date: August 23, 2024

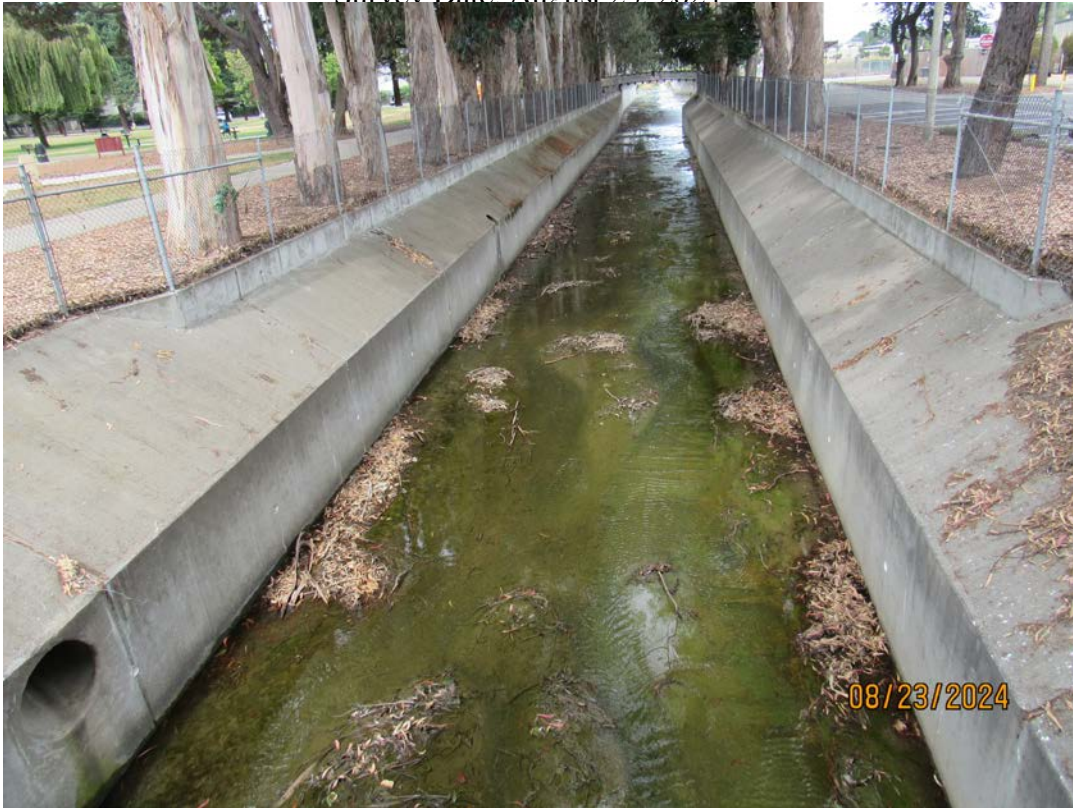
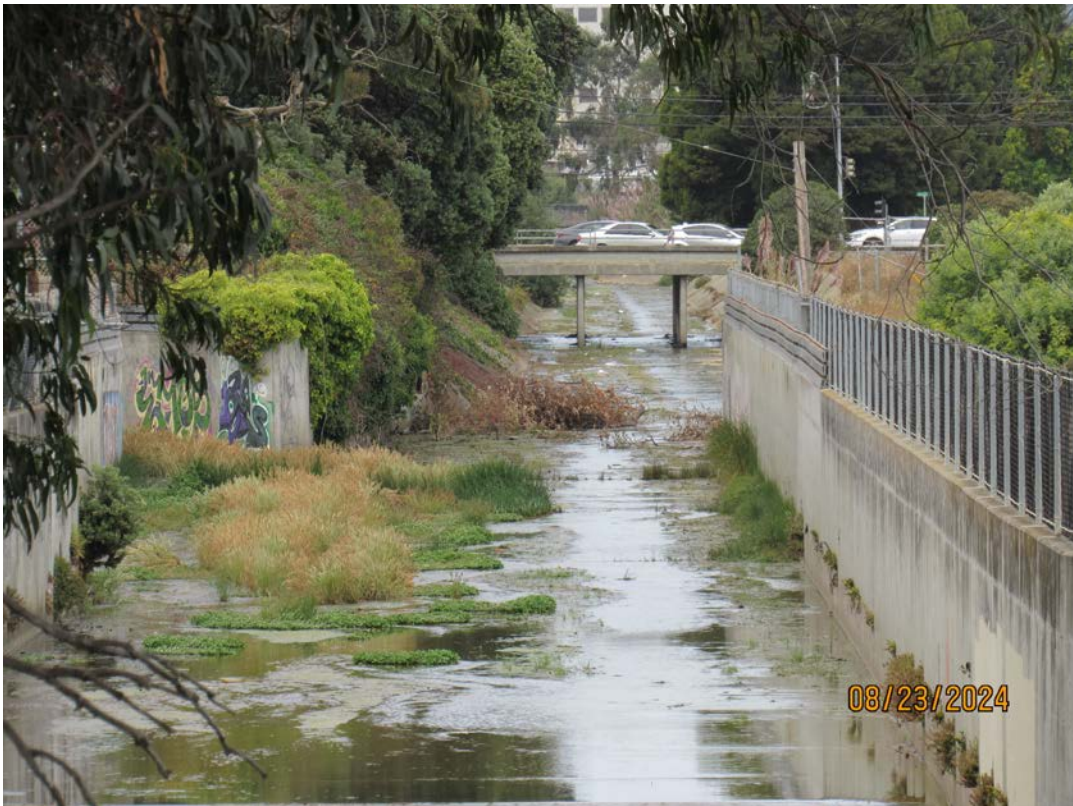
Photos 25 & 26 – Top photo shows channel looking downstream of the pedestrian bridge in Orange memorial park. Bottom photo shows Colma Creek looking upstream towards the 12-Mile Creek confluence. **Dead branches and overgrown vegetation observed in the wall joints and weepholes between the Orange Avenue bridge and 12-Mile Creek confluence. Vegetation clearing in this section of channel is to be completed during this year's maintenance activities by the County on behalf of OneShoreline.**

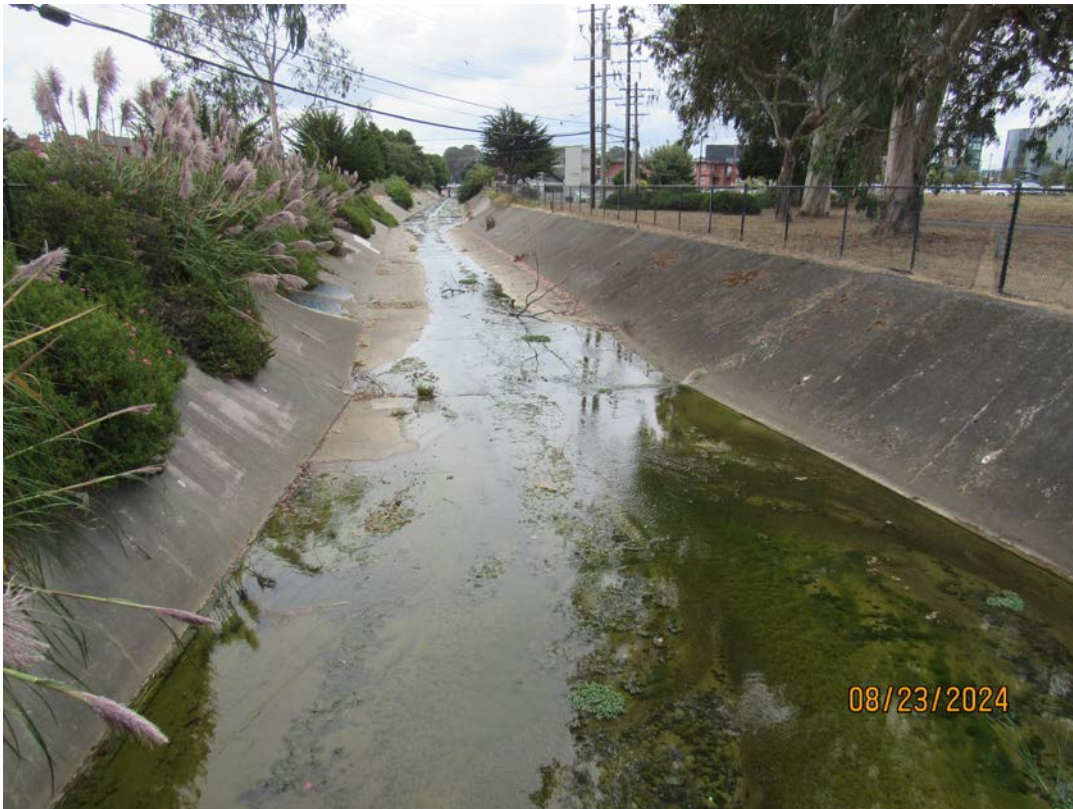
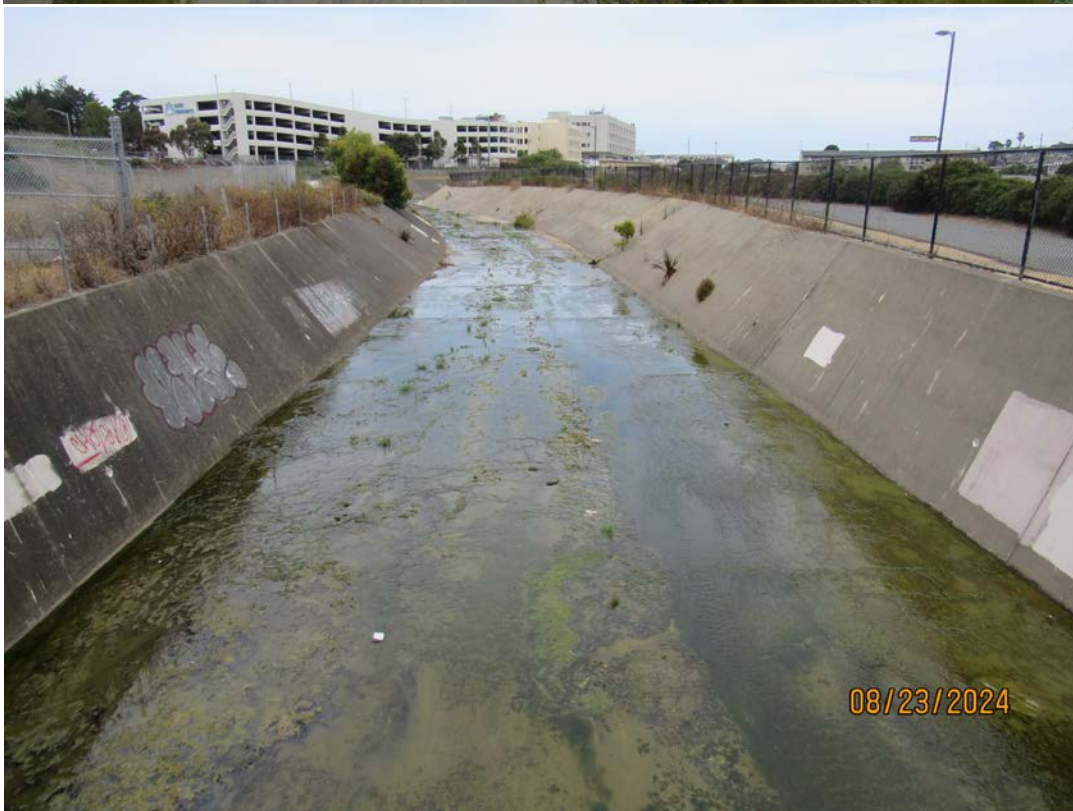
Photos 27 & 28 – Top photo shows Colma Creek looking downstream at the Centennial Way pedestrian bridge. Bottom photo shows Colma Creek looking upstream from the Centennial Way pedestrian bridge.

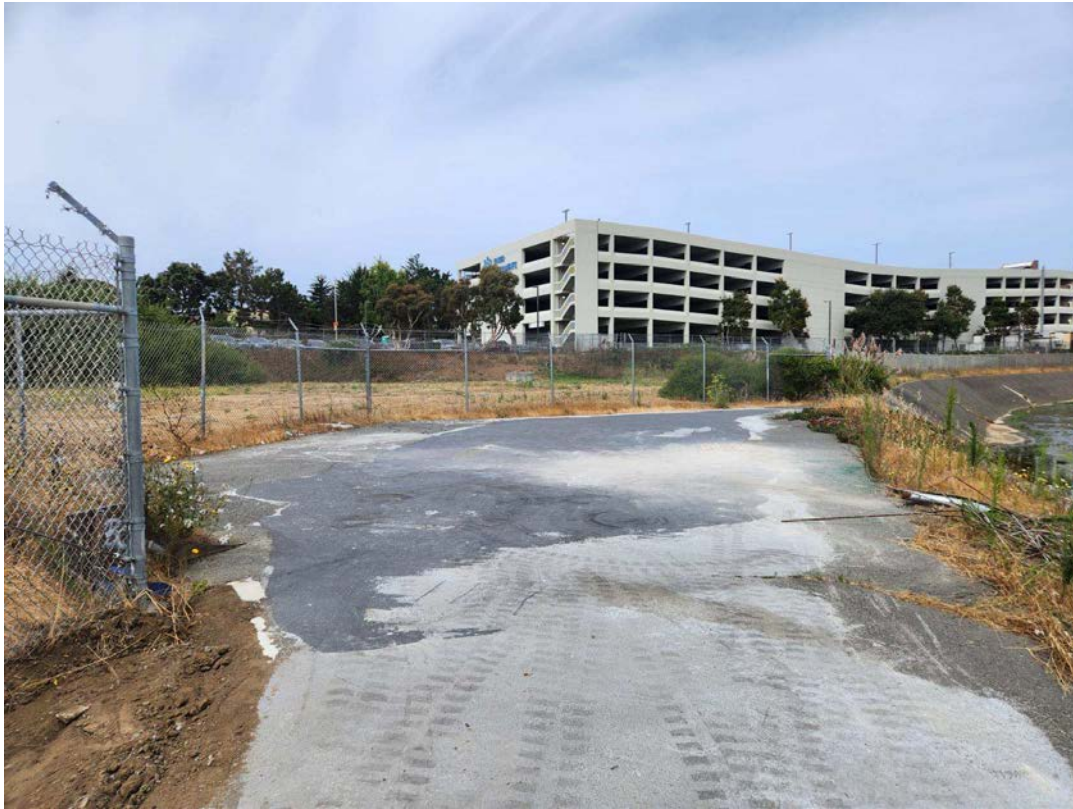
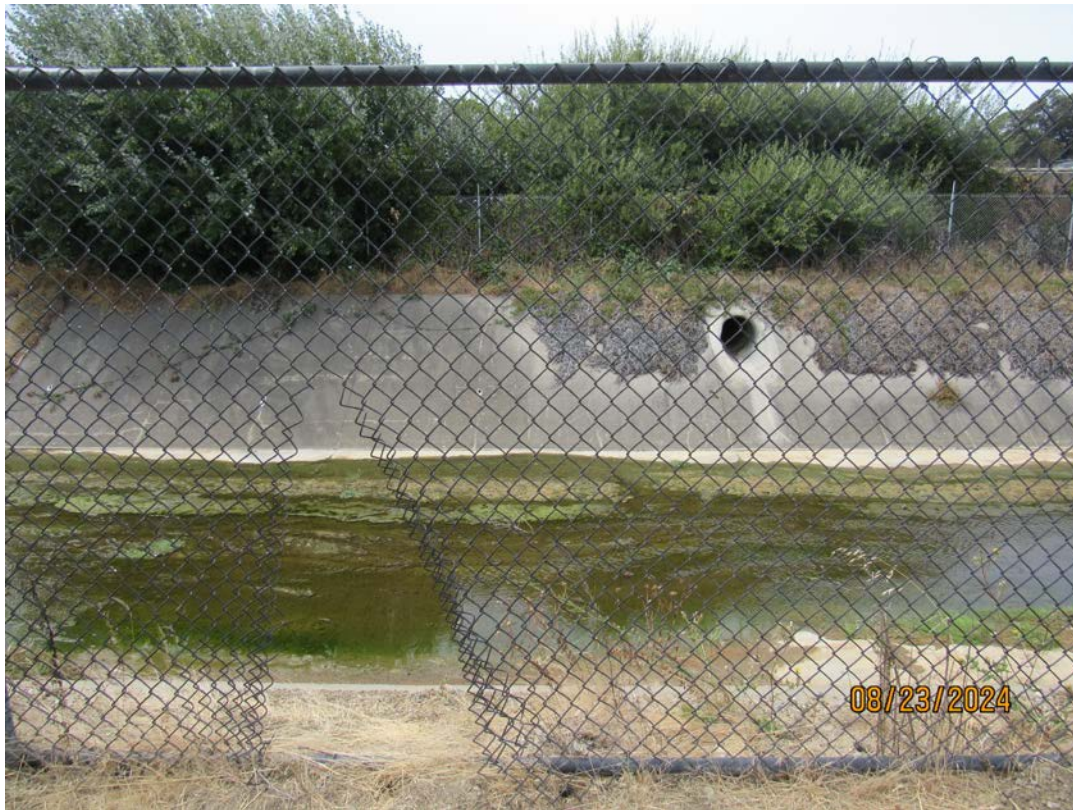
Photos 29 & 30 – Top photo shows area near Antoinette where illegal skate park and debris was removed as part of this year's maintenance activities by the County contractor on behalf of OneShoreline. Bottom photo shows fence cut along the Centennial trail near the BART station. Staff from the City of SSF Parks and Recreation Department were informed and have made the repair.

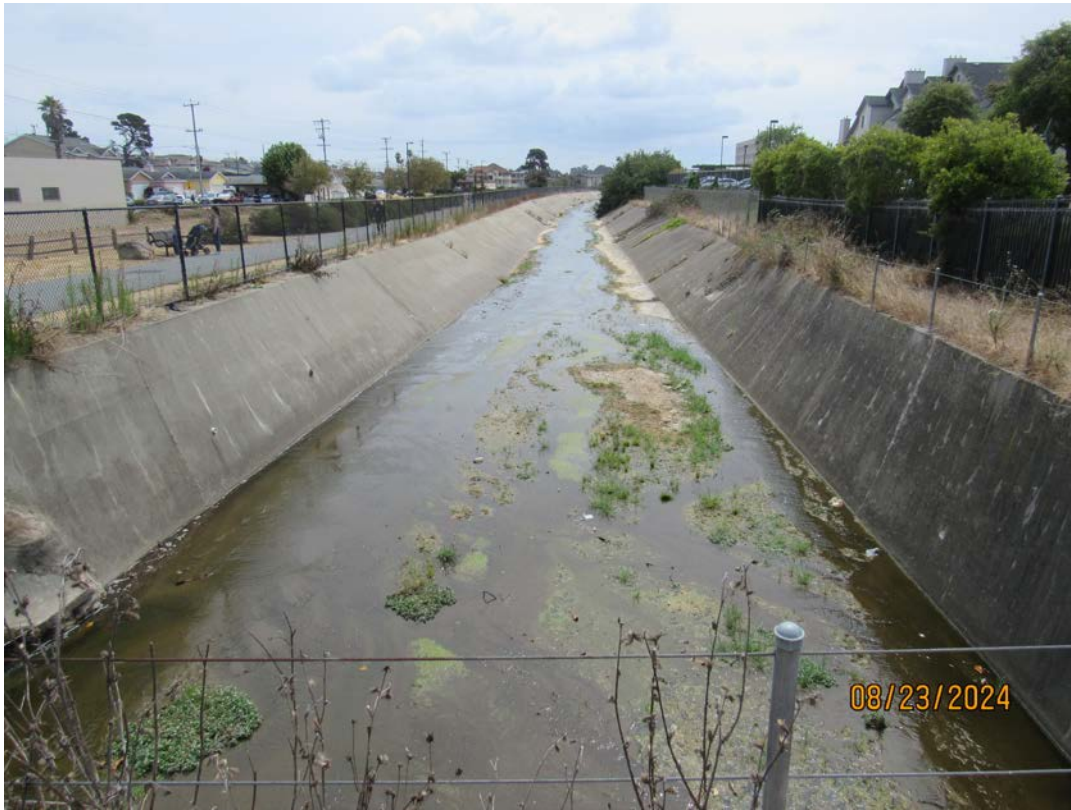
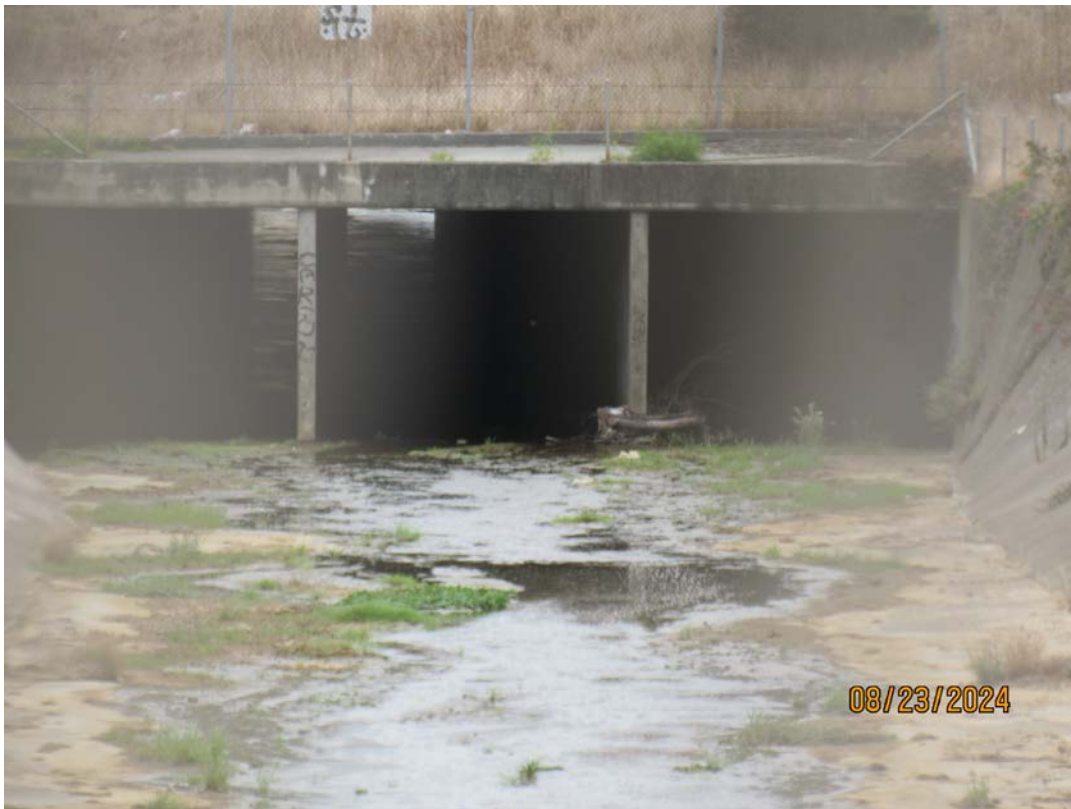
Photos 31 & 32 – Top photo shows Colma Creek looking downstream from the SSF BART Station culvert. Bottom photo shows Colma Creek looking downstream from the pedestrian trail near Costco at the box culvert.

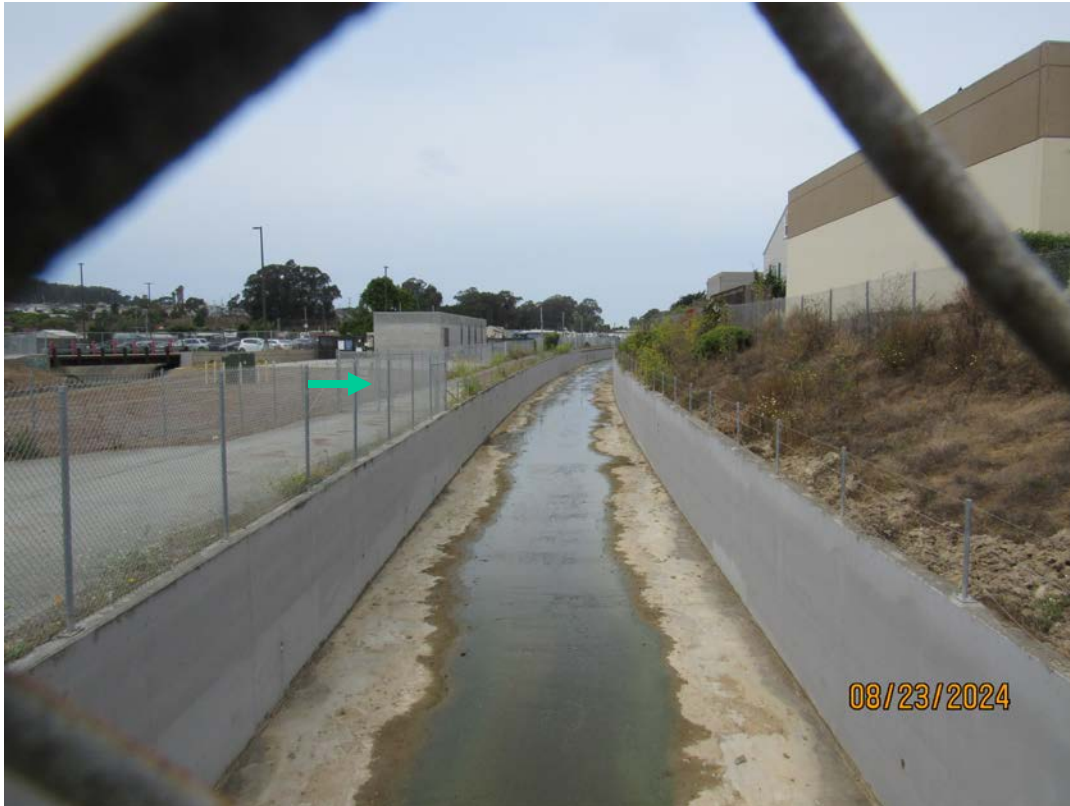
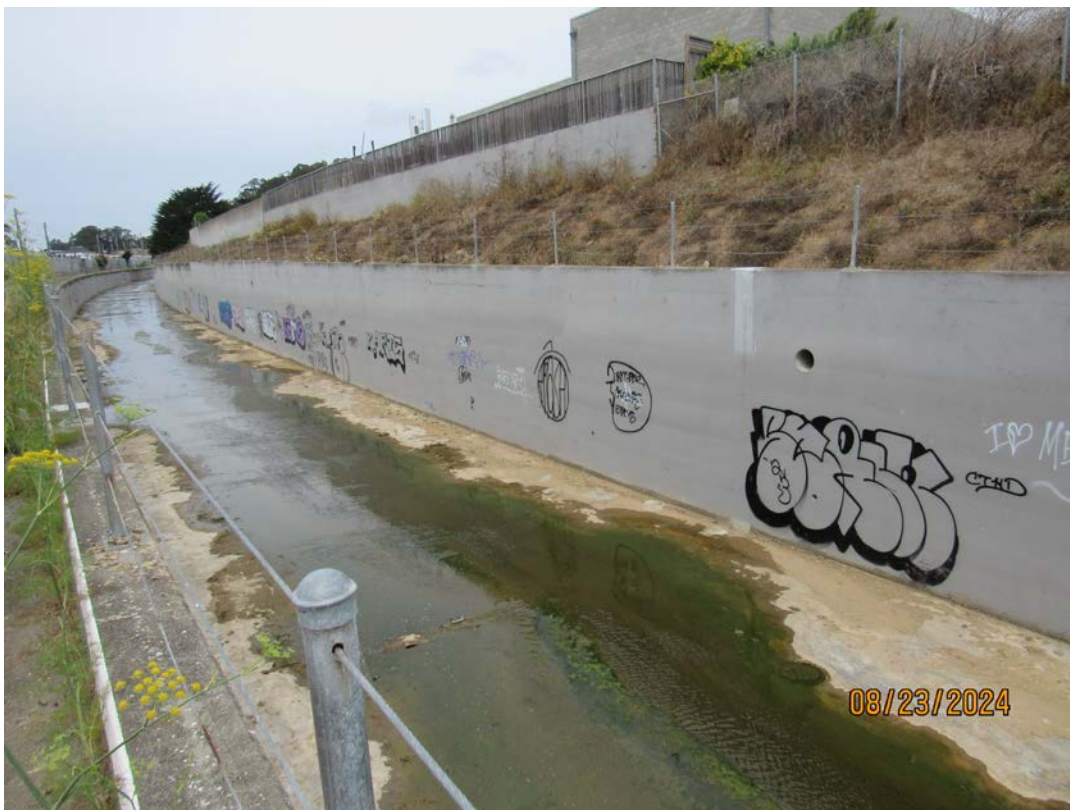
Photos 33 & 34 – Top photo shows Colma Creek looking upstream from Costco pedestrian bridge. **Note that walls remain graffiti free in this section. However, the channel upstream of here continues to receive fresh graffiti (bottom photo). County recommends OneShoreline to coordinate with Colma staff to replace chain and locks on the gate near the arrow.**

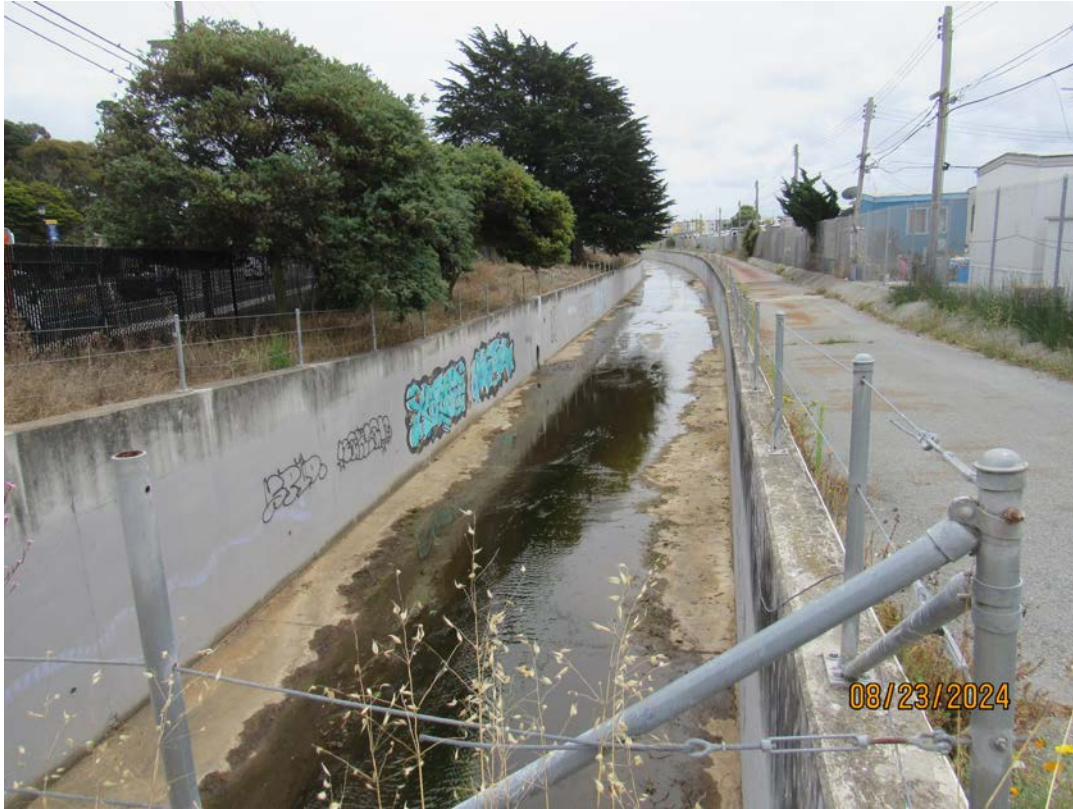
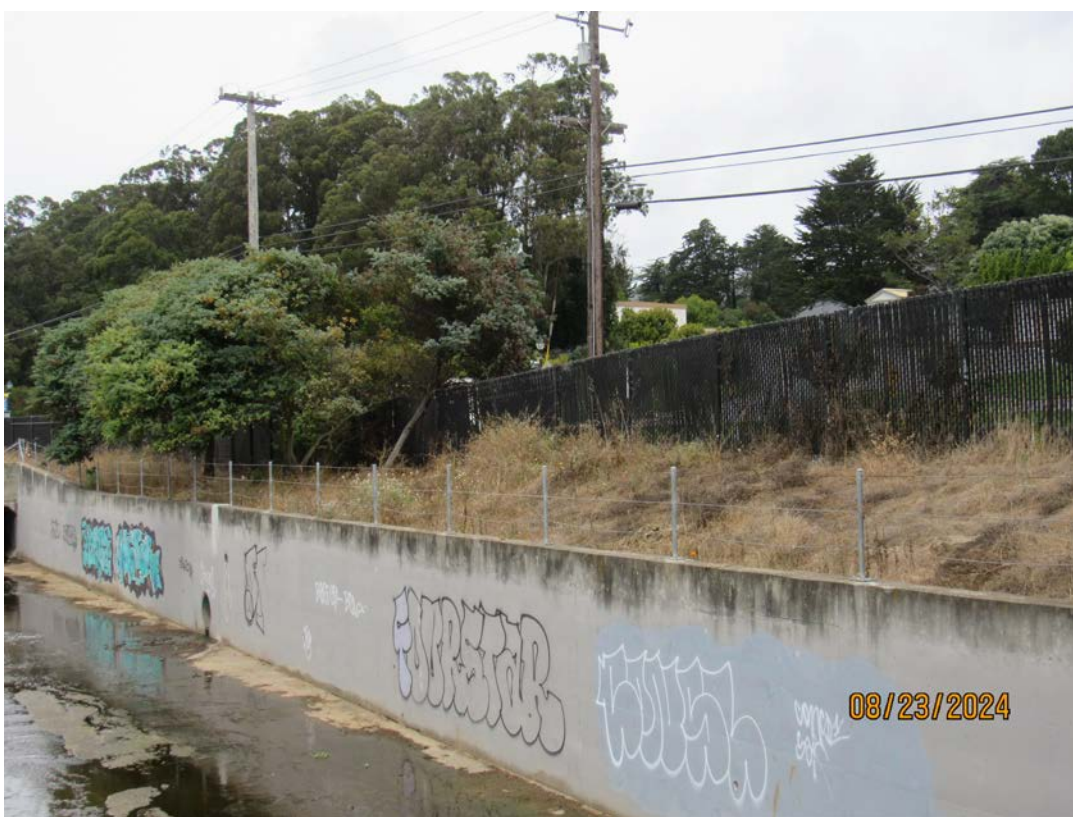
Photos 35 & 36 – Top photo shows Colma creek looking downstream from the outlet of Mission Road Box Culvert. Bottom photo shows split tree limb falling on fence near the Mission Road Box Culvert. County recommends OneShoreline to coordinate with Colma staff to address uprooted tree leaning on the fence towards Mission Road.

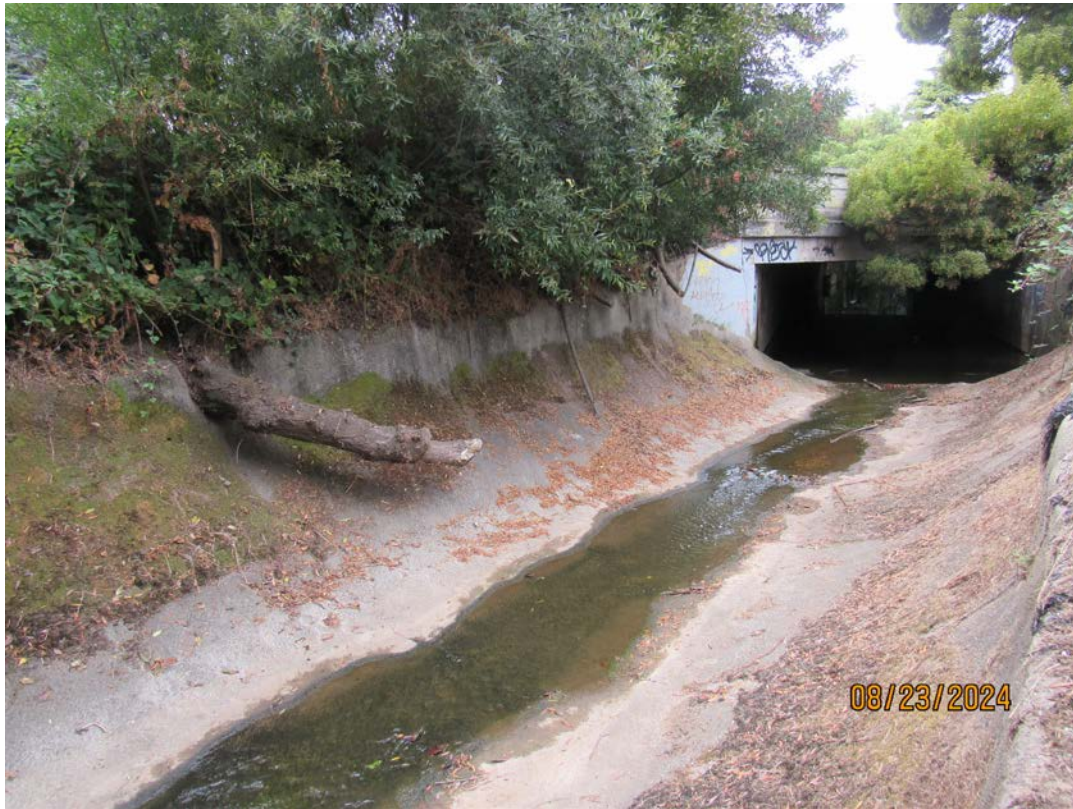
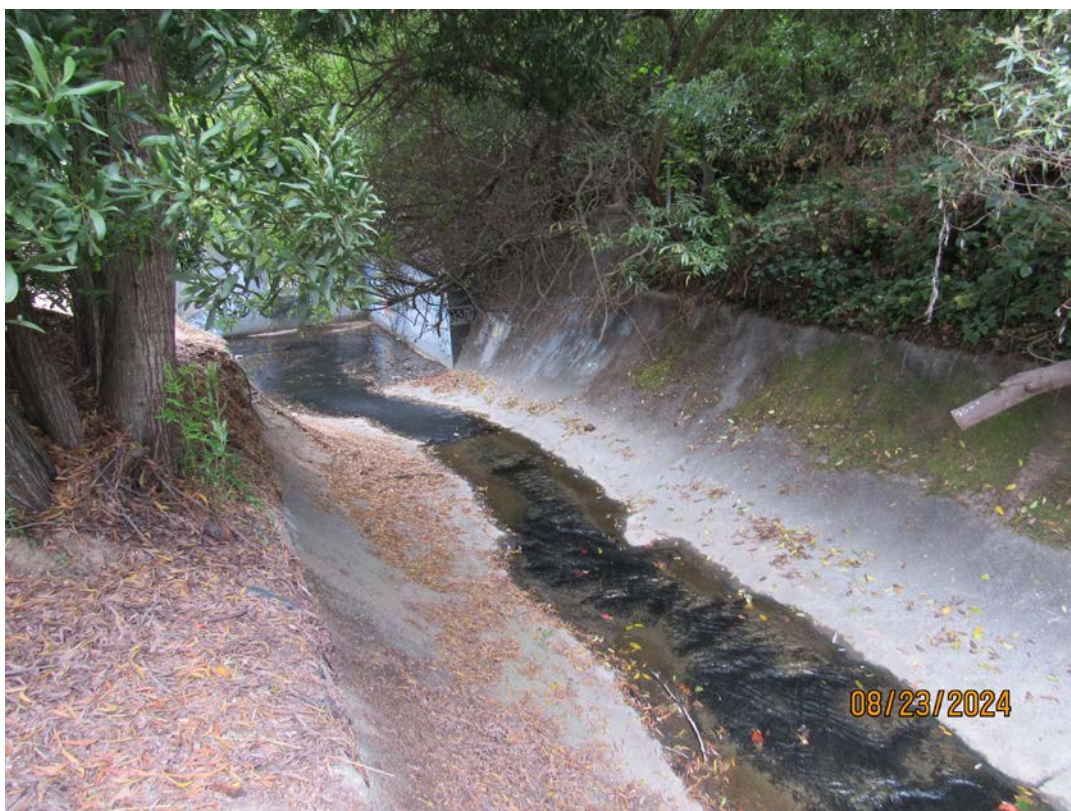
Photos 37 & 38 – Top photo shows old Colma Creek channel downstream of the El Camino Real bridge at the Mission Road intersection. Bottom photo shows Colma Creek channel facing downstream looking at the diversion structure and junction with the Old Channel.
