COLMA CREEK CITIZENS ADVISORY COMMITTEE MEETING

Tuesday, March 11, 2025, at 3:00 pm

Status of the Colma Creek Flood Zone Projects and Maintenance Activities

**Colma Creek Flood Control Channel Maintenance Matrix
Monitoring Photos**

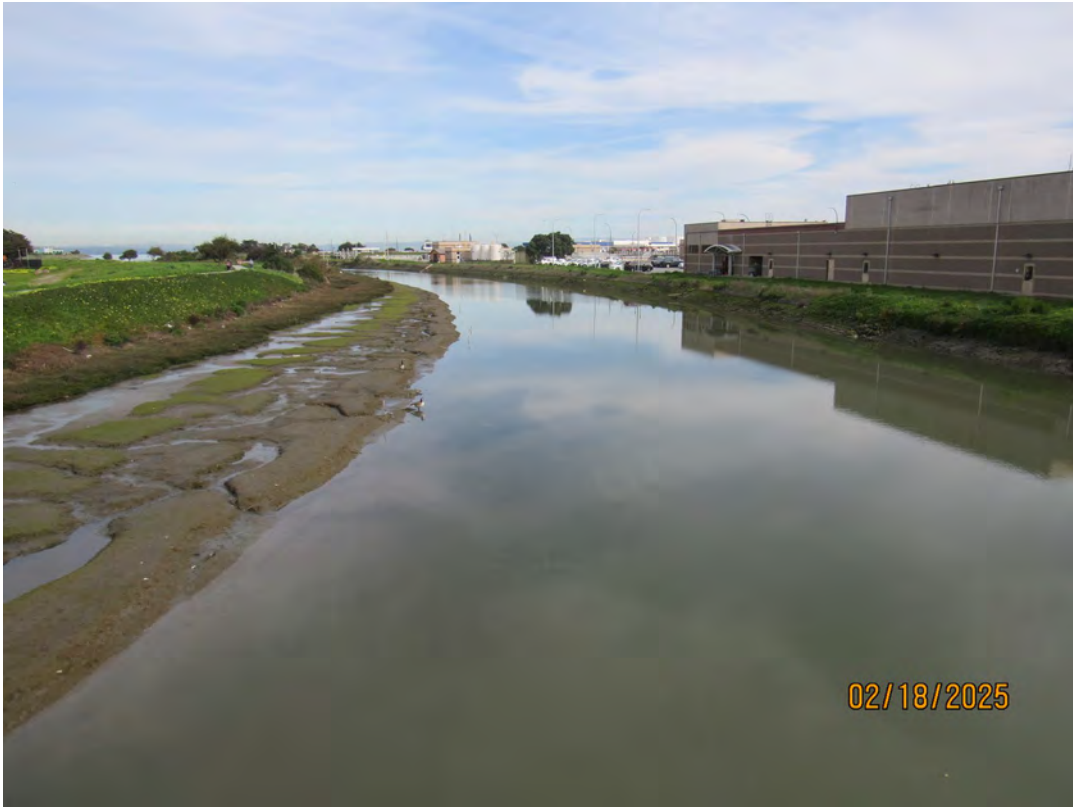
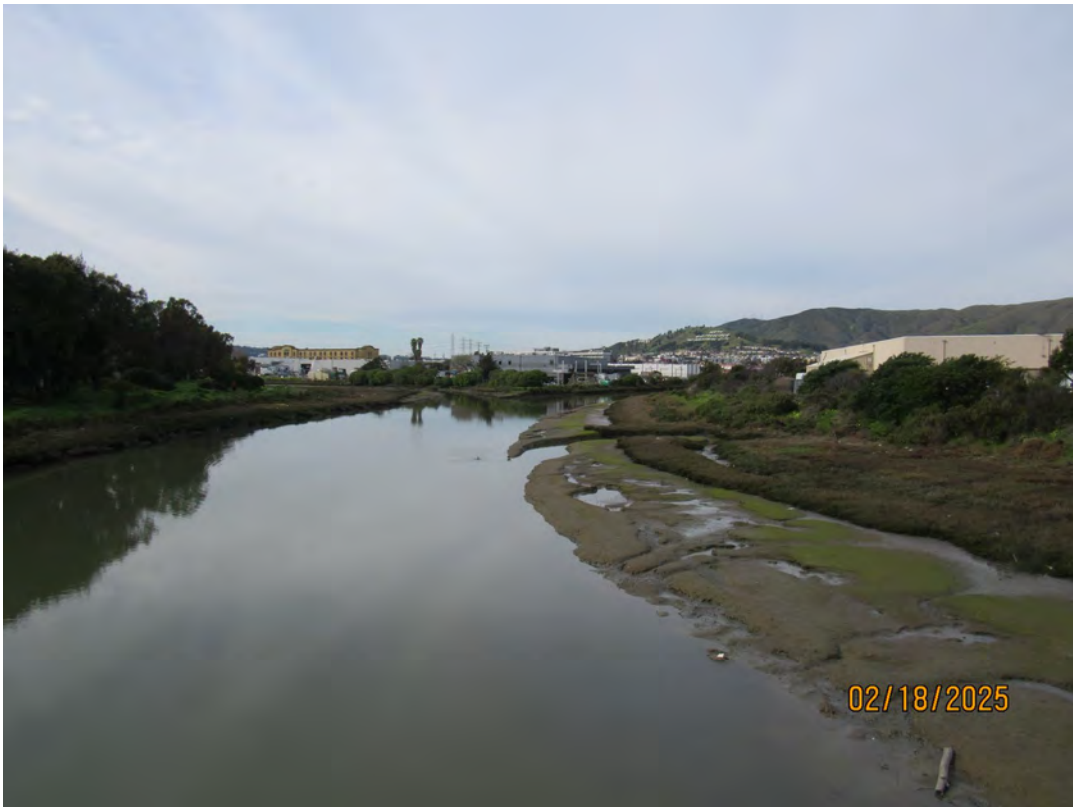
Photos 1 & 2 – Top photo shows Colma Creek looking downstream from the Bay Trail pedestrian bridge. Bottom photo shows Colma Creek looking upstream from the pedestrian bridge.

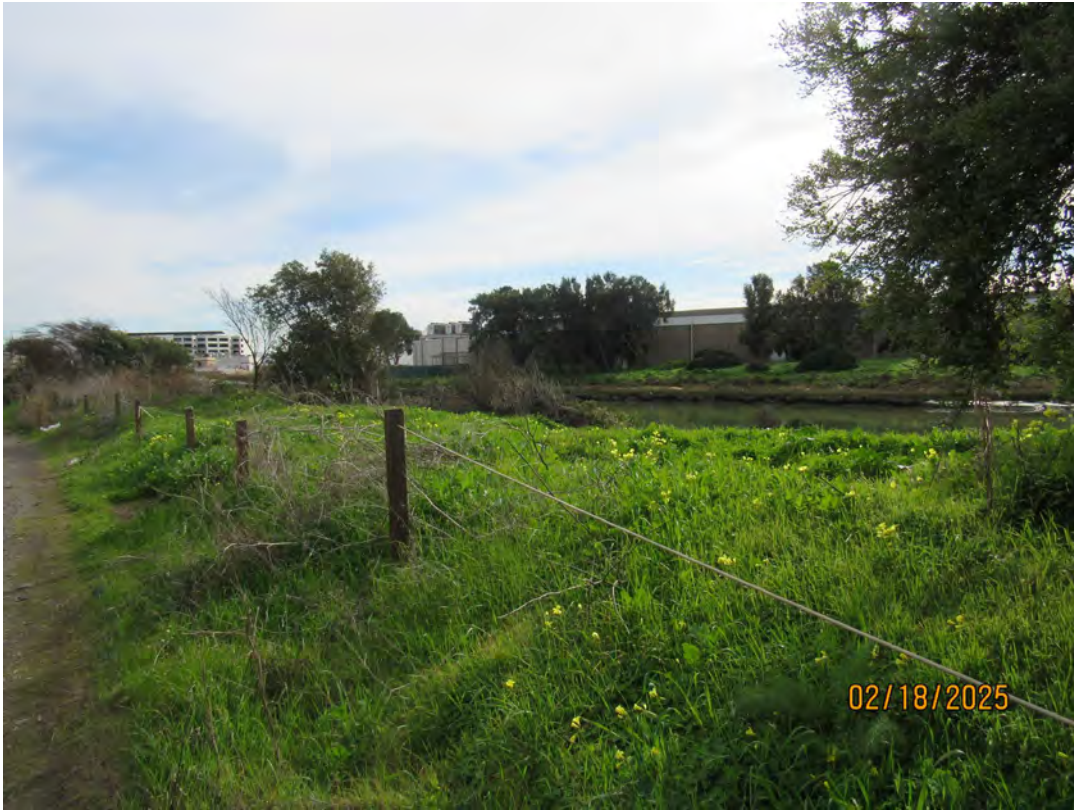
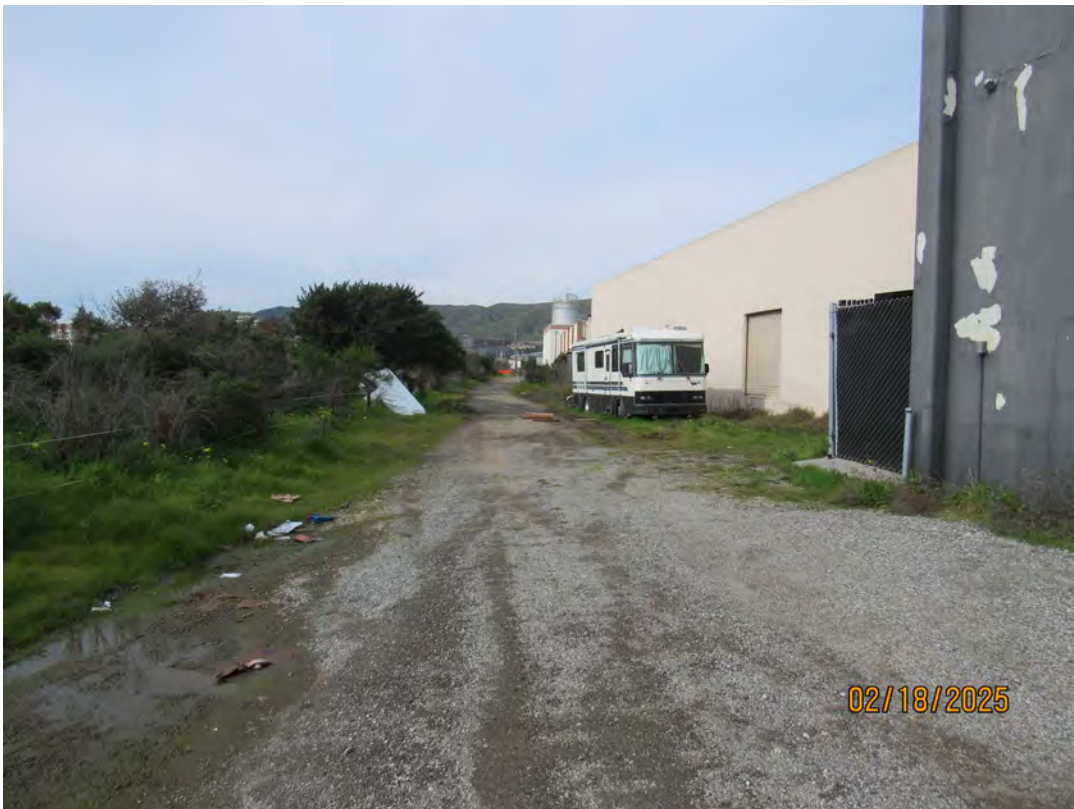
Photos 3 & 4 – Top and bottom photos show access road and mitigation Site 2 between the Bay Trail pedestrian bridge and Utah Avenue. Trash and illegal dumping as well as one potentially occupied motorhome were observed along the service road. **No encampments observed along the banks of Colma Creek.**

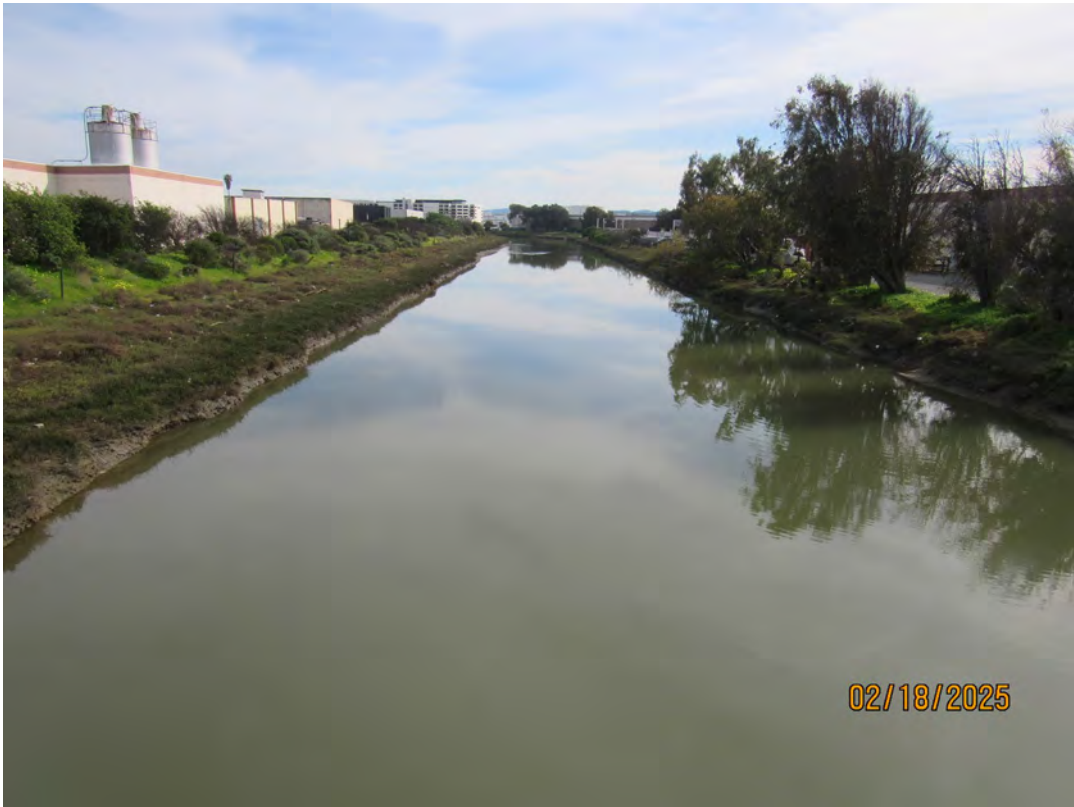
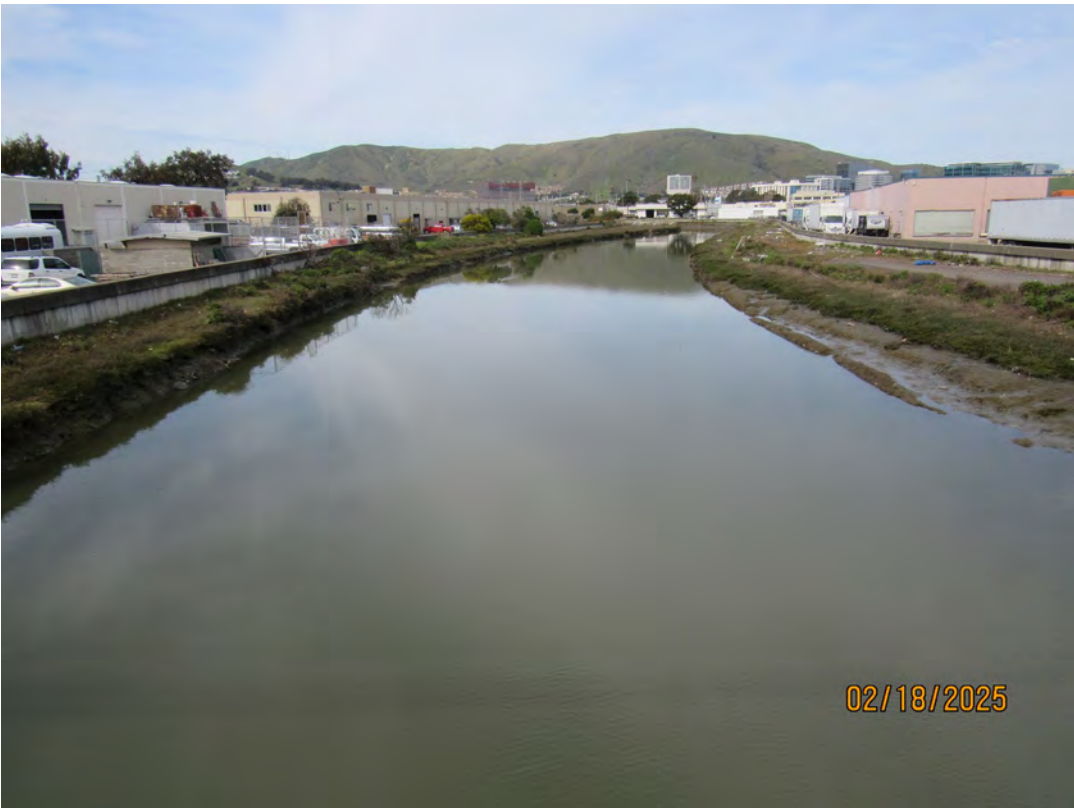
Photos 5 & 6 – Top photo shows Colma Creek looking downstream from the Utah Avenue bridge. Bottom photo shows Colma Creek looking upstream from Utah Avenue.

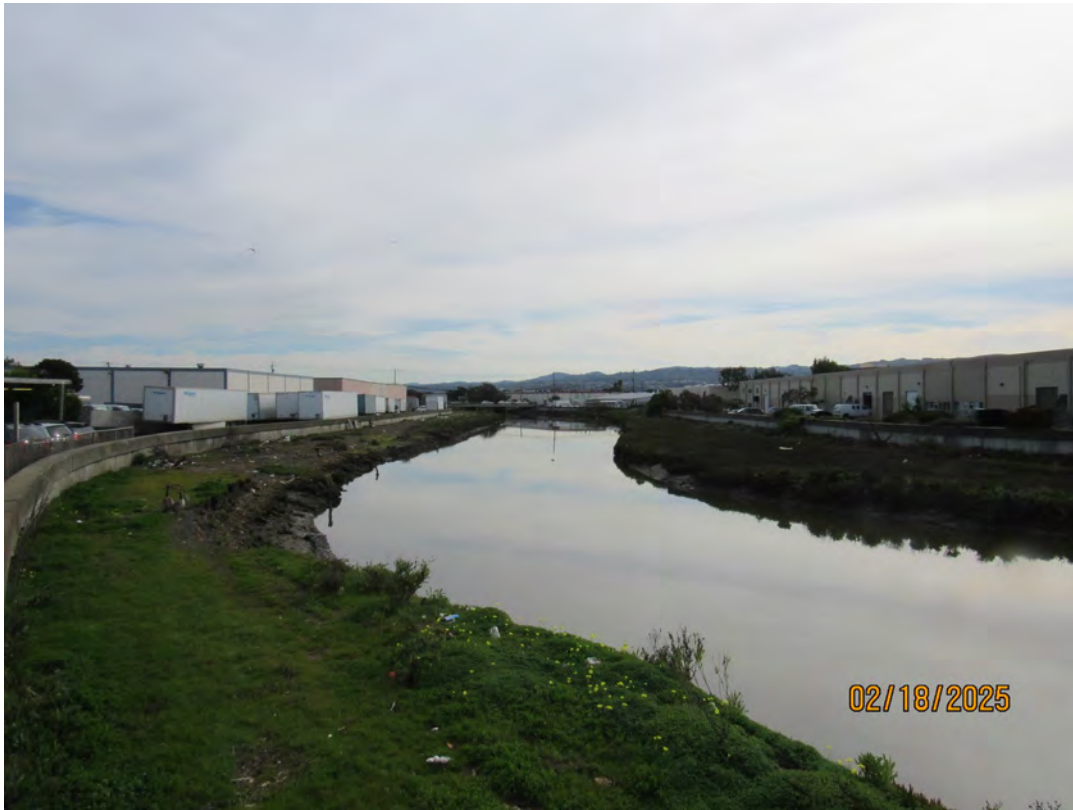
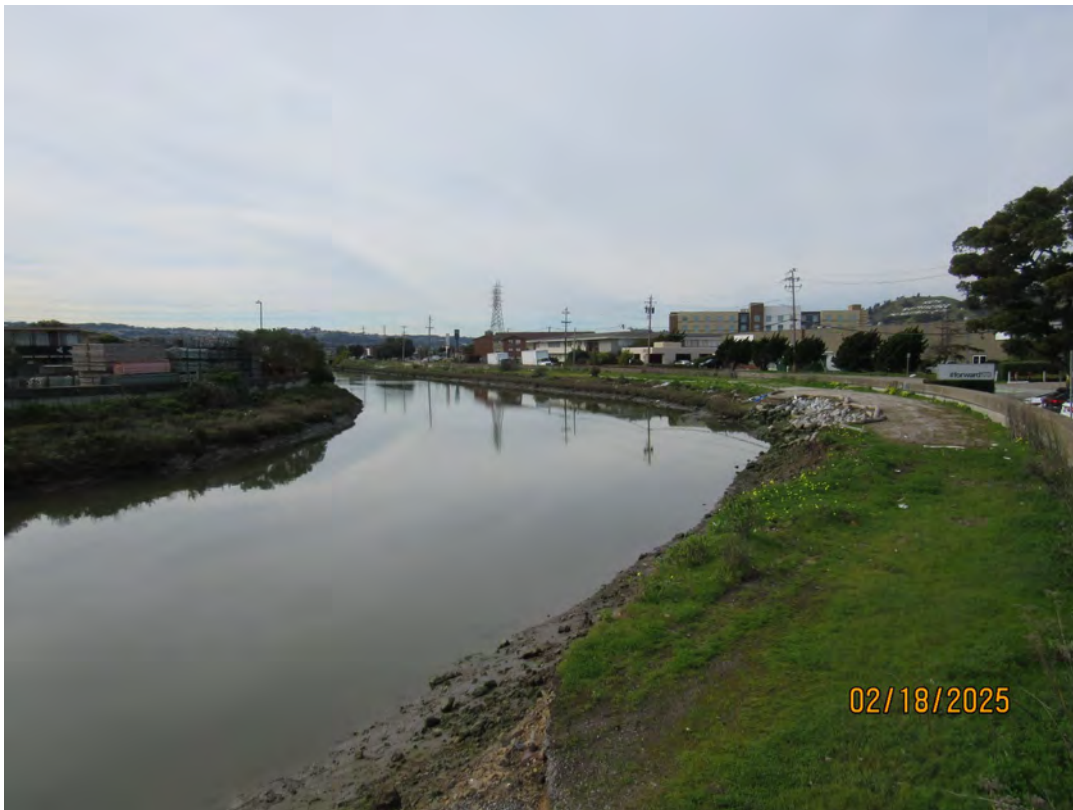
Photos 7 & 8 – Top photo shows Colma Creek looking downstream towards the Utah Avenue bridge. Bottom photo shows Colma Creek looking upstream towards the S. Airport Blvd. bridge. **Trash from various sources including storm drains and illegal dumping continues to be an issue.**

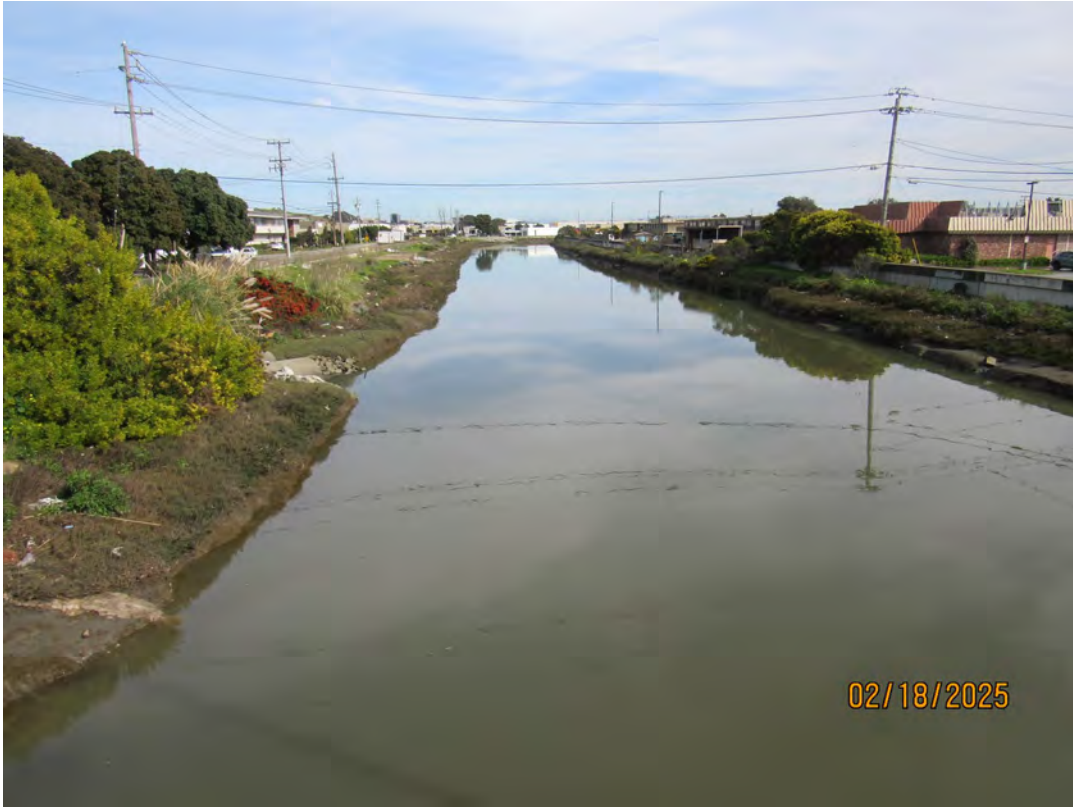
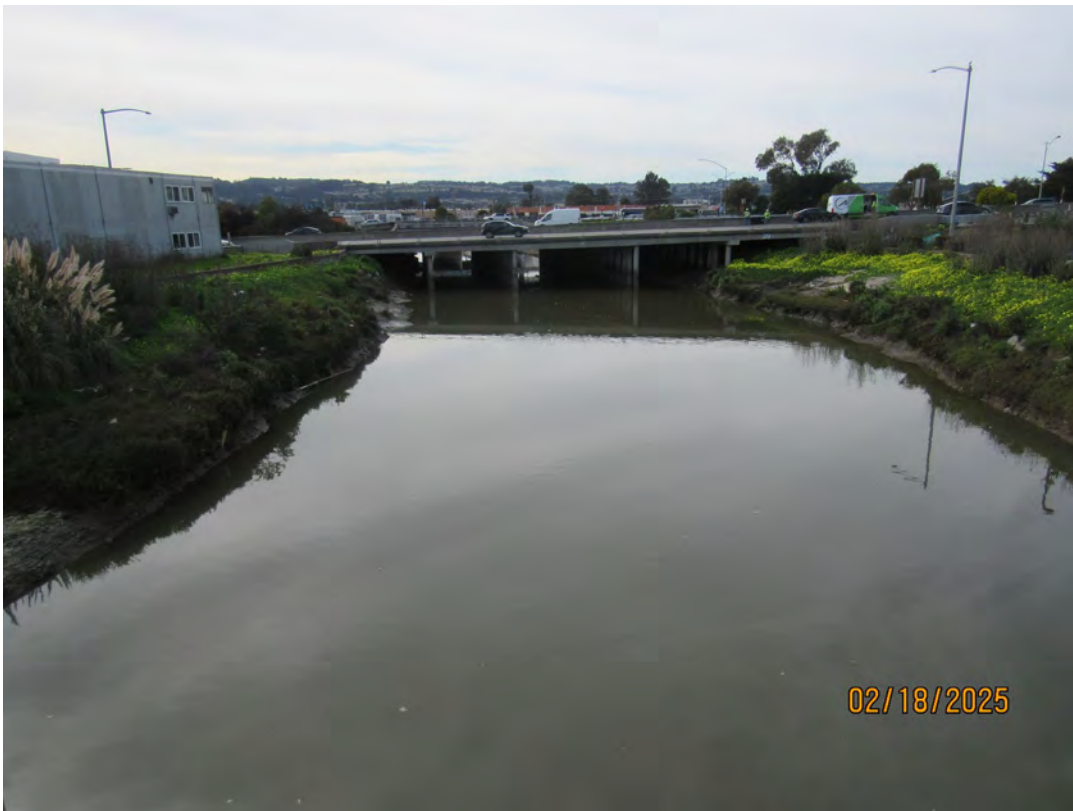
Photos 9 & 10 – Top photo shows Colma Creek looking downstream from the S. Airport Blvd. bridge. Bottom photo shows Colma Creek looking upstream from S. Airport Blvd. facing the Hwy 101 crossing. **Trash from various sources including storm drains and illegal dumping continues to be an issue. No encampments observed under S. Airport Blvd..**

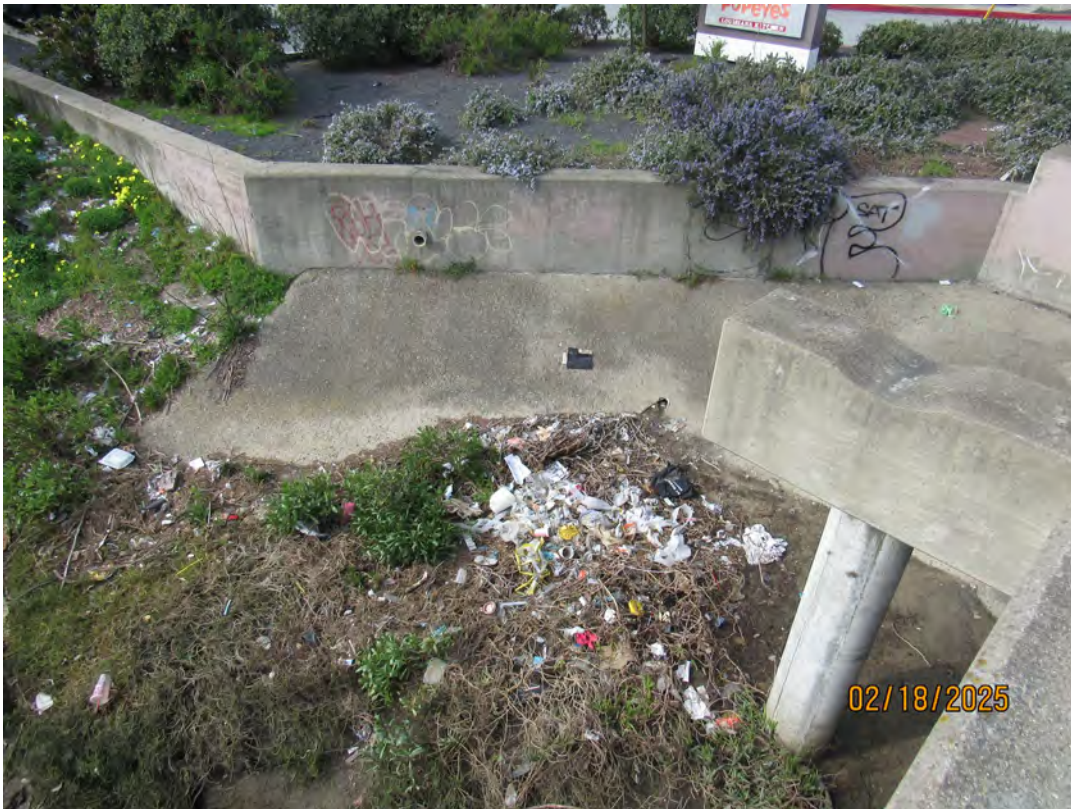
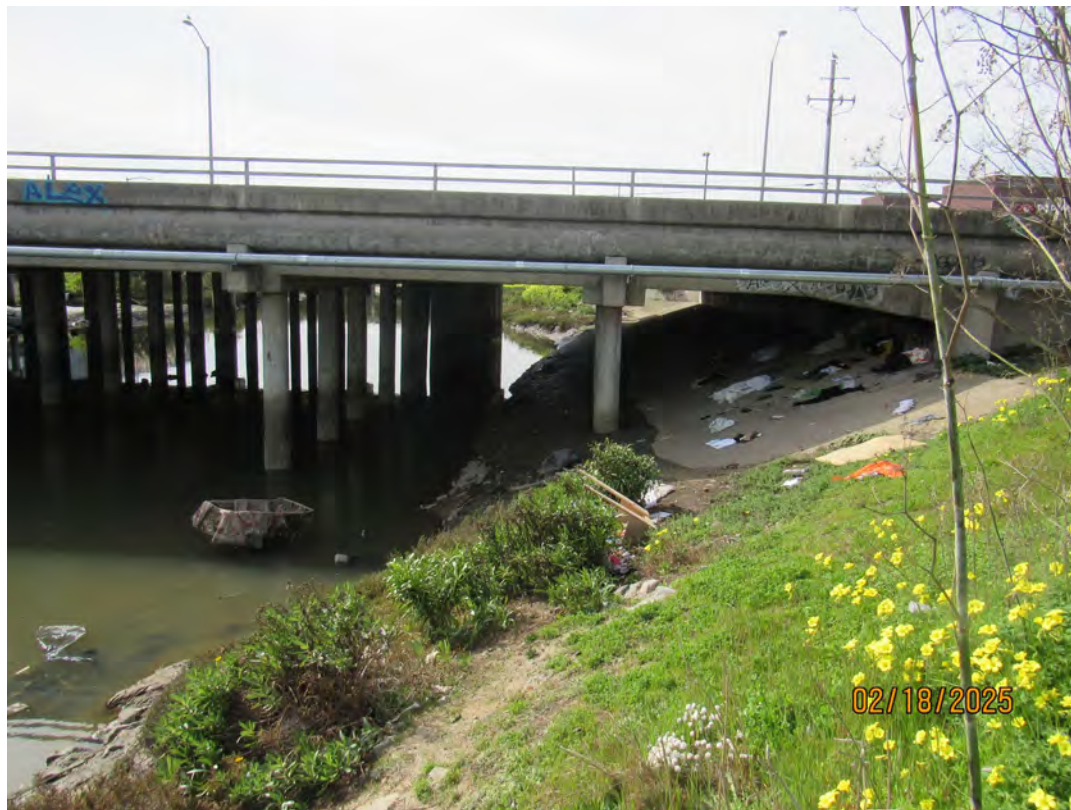
Photos 11 & 12 – Top photo shows Colma Creek looking upstream of the south end of S. Airport Blvd. bridge. Bottom photo shows Colma Creek looking upstream under the south end of S. Airport Blvd. bridge. Trash and illegal dumping related to homeless encampment activities under the S. Airport Blvd. bridge were visible in this vicinity. County recommends coordinating with City of SSF to remove the trash.

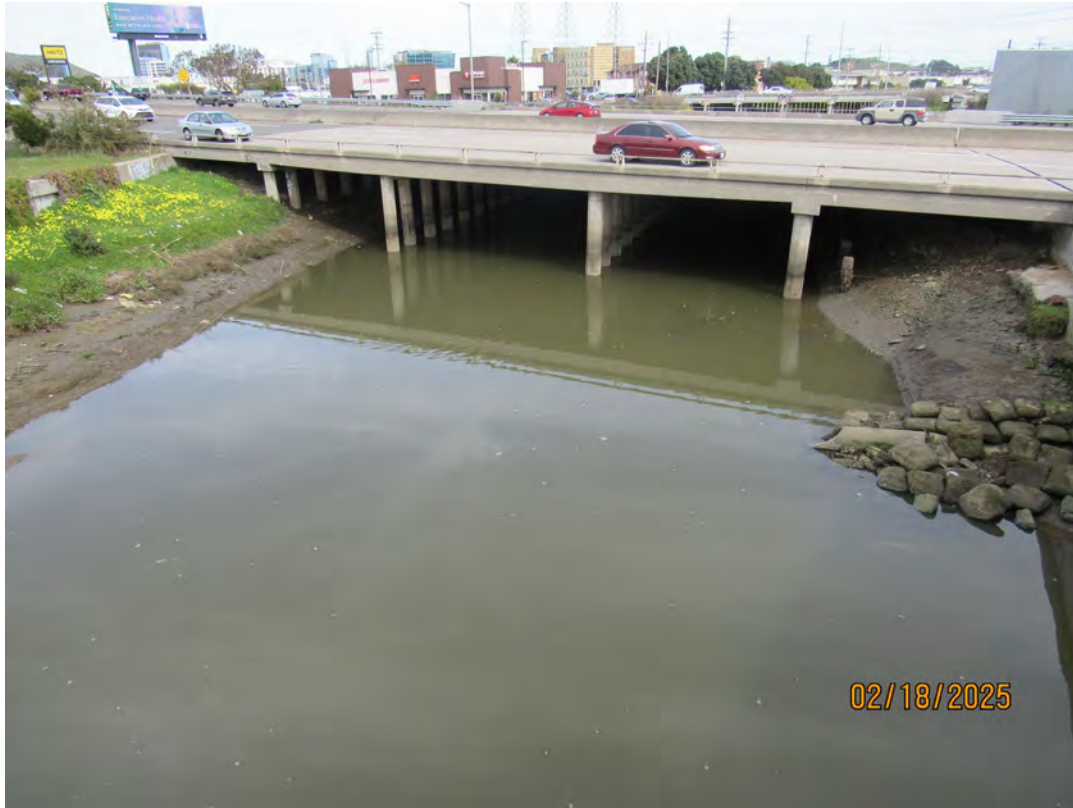
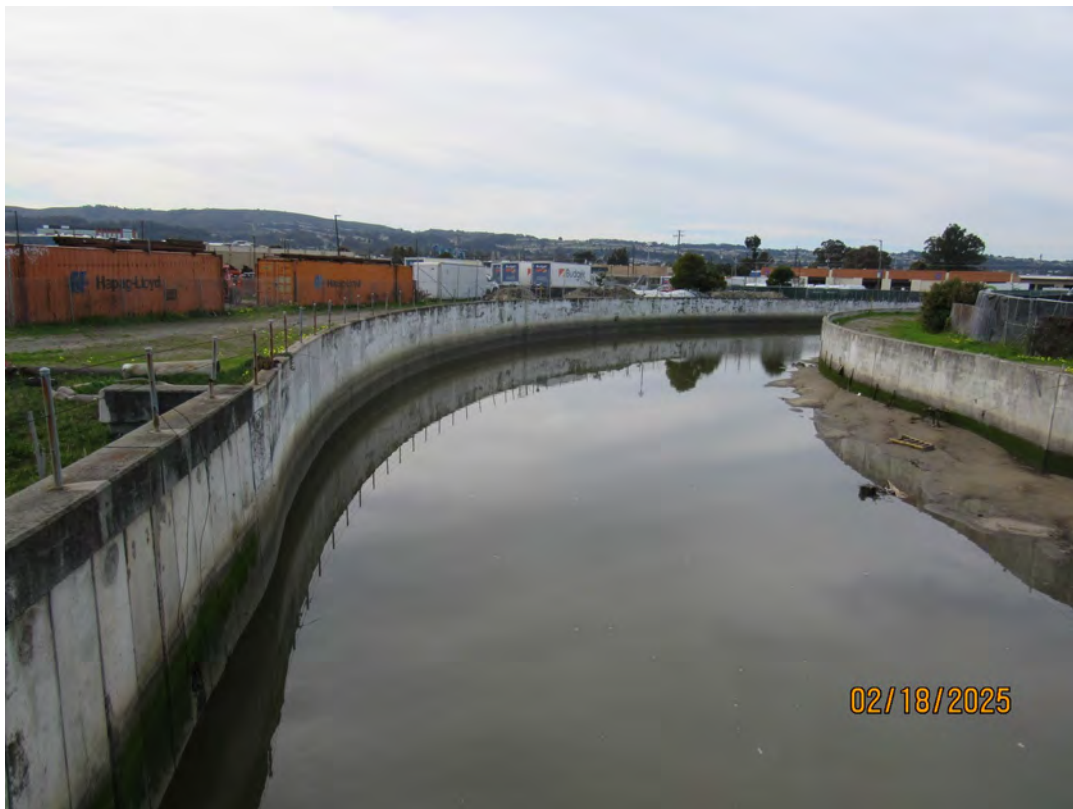
Photos 13 & 14 – Top photo shows Colma Creek looking downstream from the Produce Avenue bridge facing the Hwy 101 crossing. Bottom photo shows Colma Creek looking upstream from the Produce Avenue bridge.

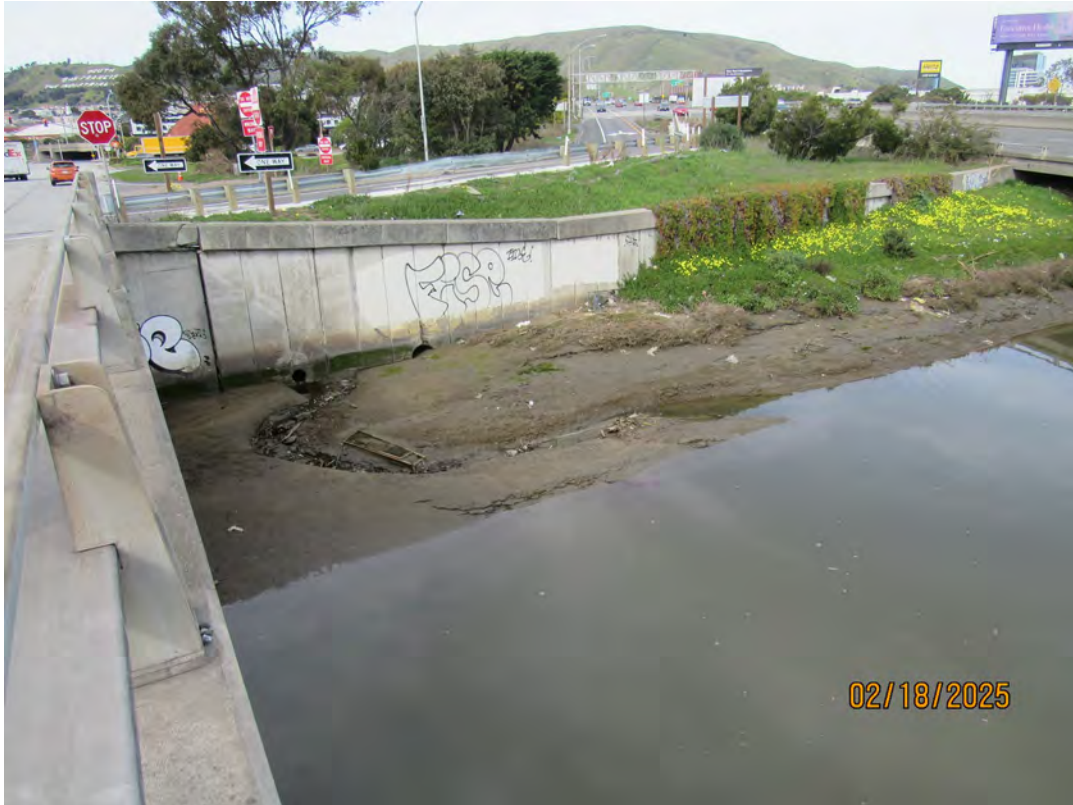
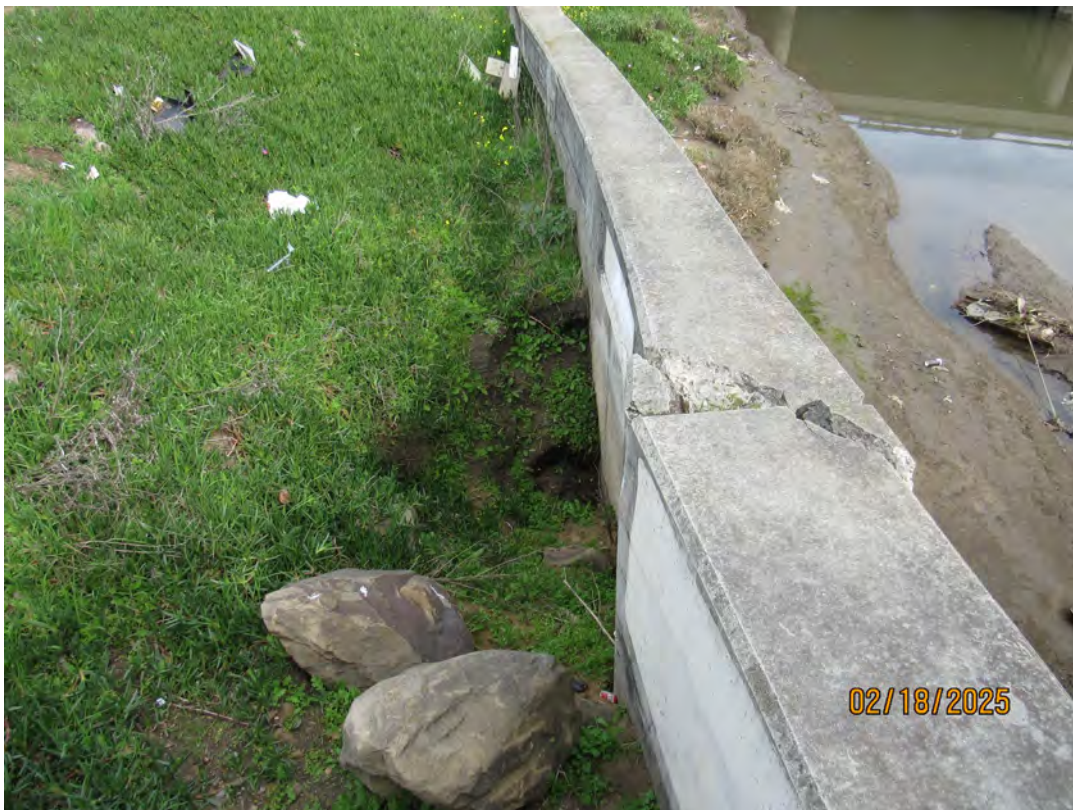
Photos 15 & 16 – Top photo shows damage on channel wall and partially blocked culvert outfall downstream from the Produce Avenue bridge facing the Hwy 101 crossing. Bottom photo shows void outside the channel wall. **County recommends continuing to monitor the area and contacting Caltrans to clear vegetation at the drain inlet.**

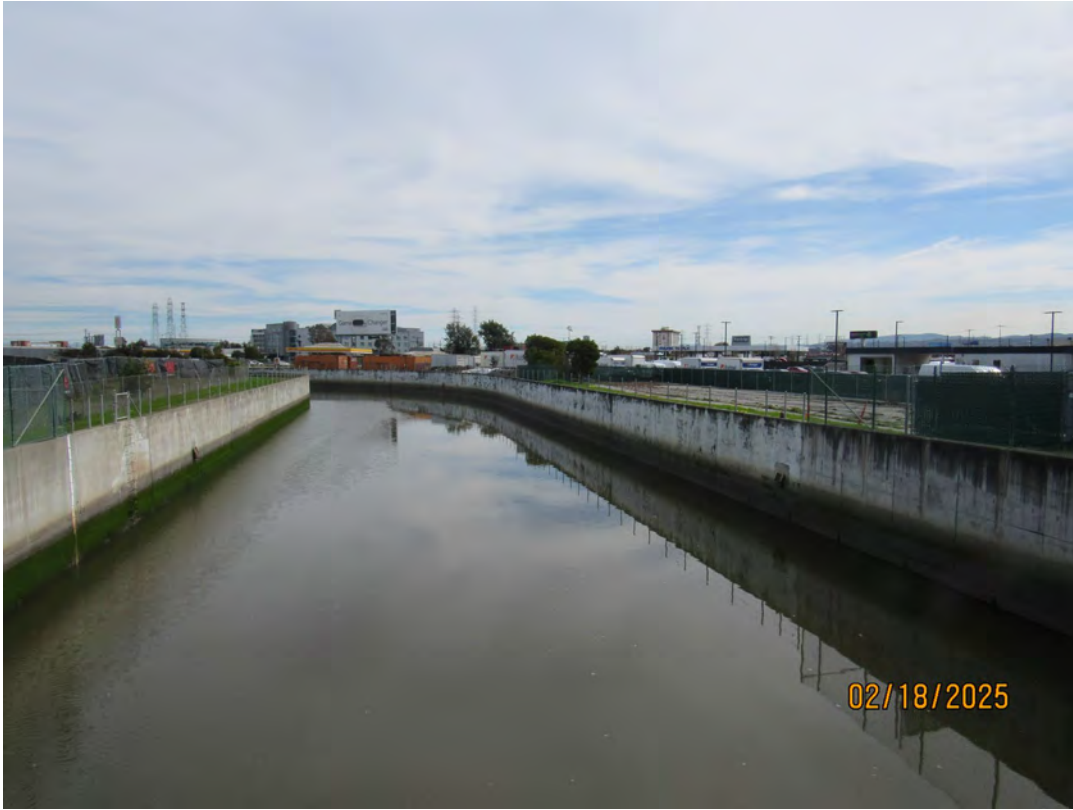
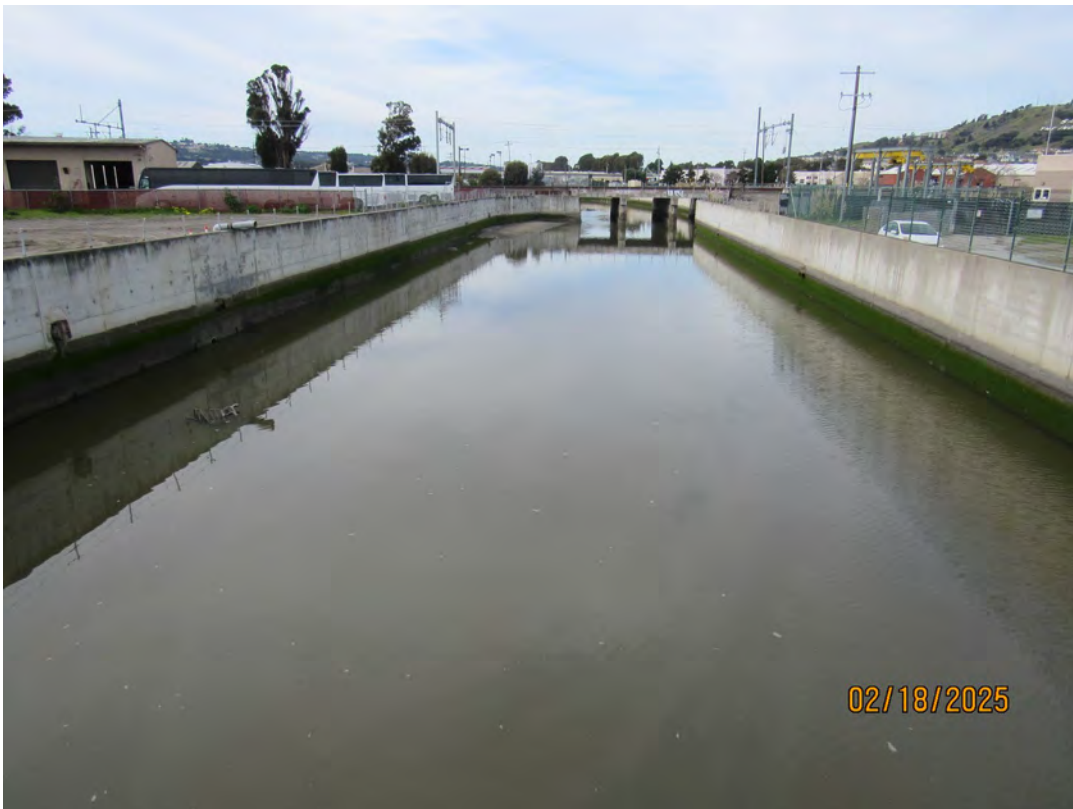
Photos 17 & 18 – Top photo shows Colma Creek looking downstream from the San Mateo Avenue bridge. Bottom photo shows Colma Creek looking upstream from the San Mateo Avenue bridge.

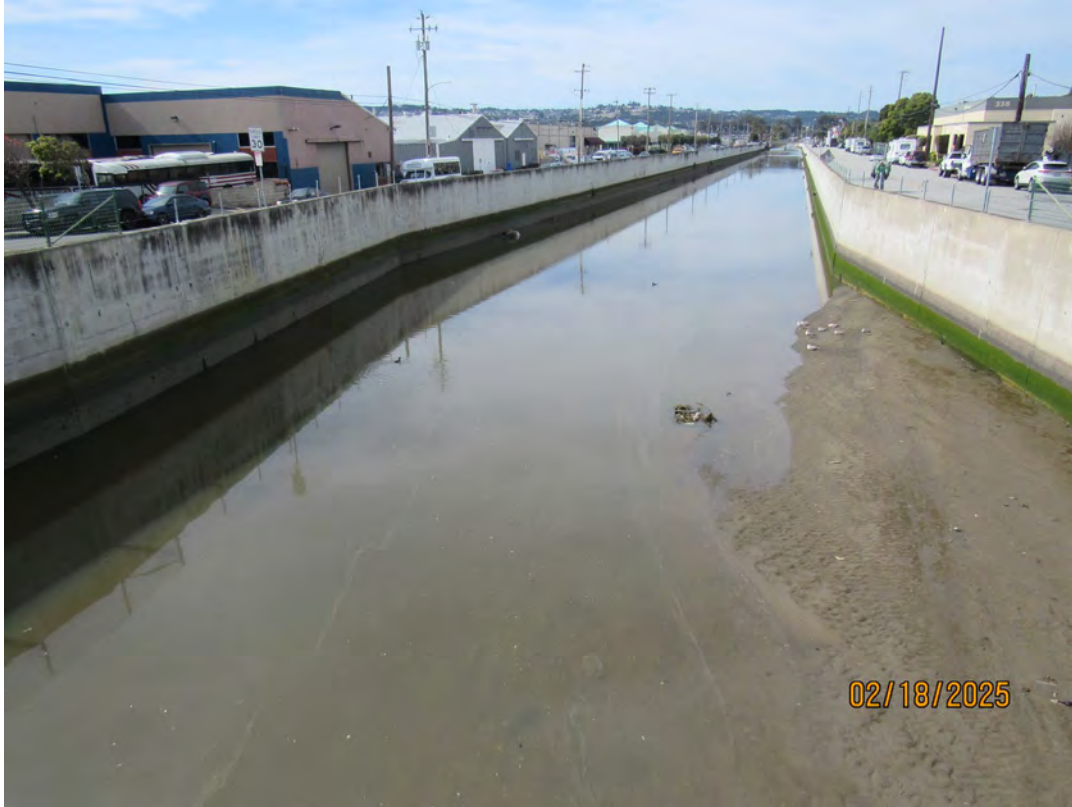
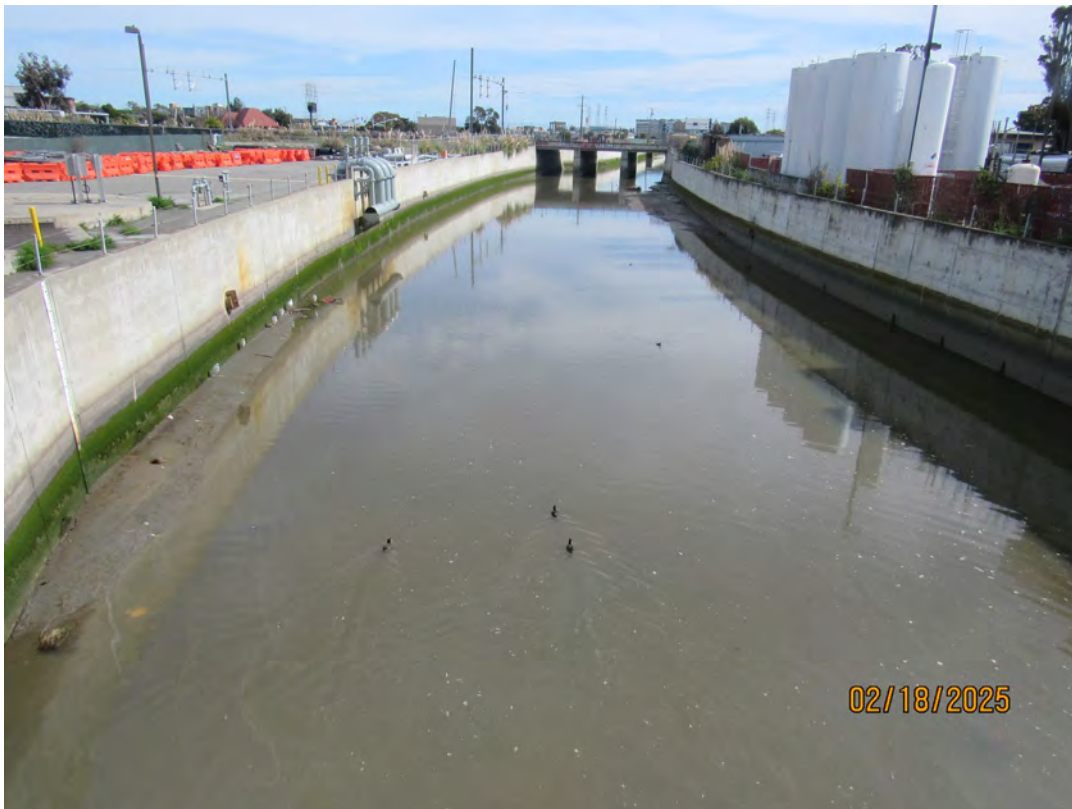
Photos 19 & 20 – Top photo shows Colma Creek looking upstream from Linden Avenue bridge. Bottom photo shows Colma Creek looking downstream from the Linden Avenue bridge.

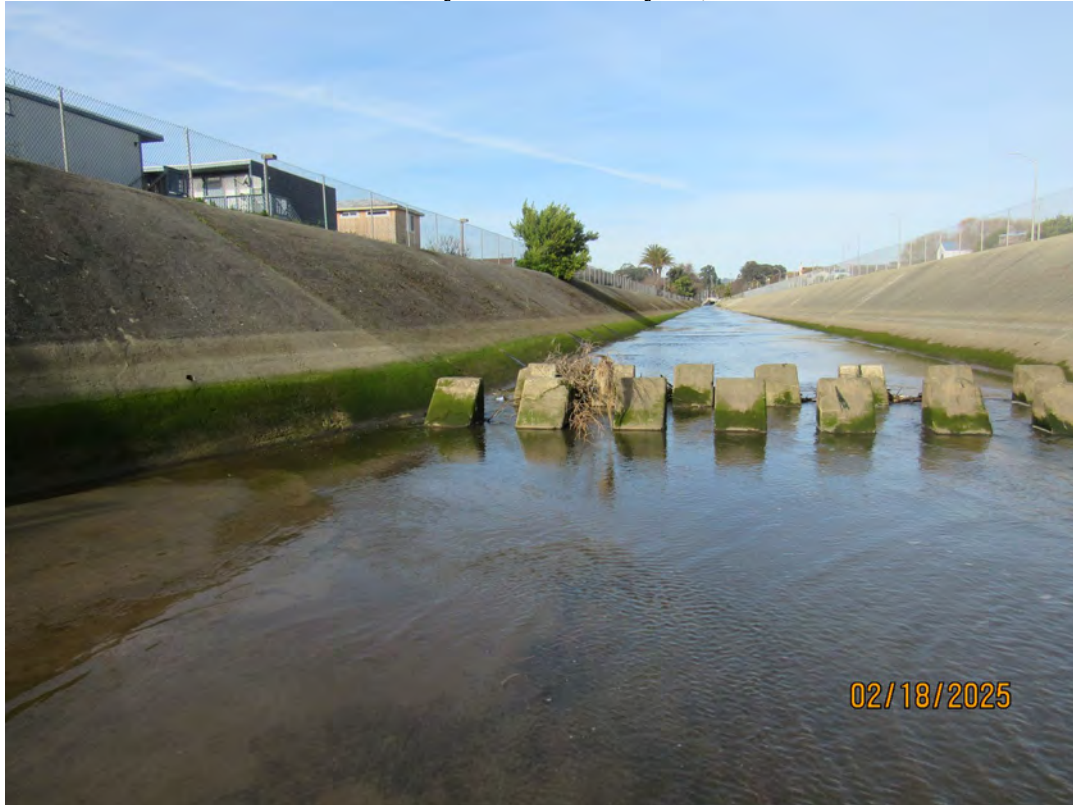
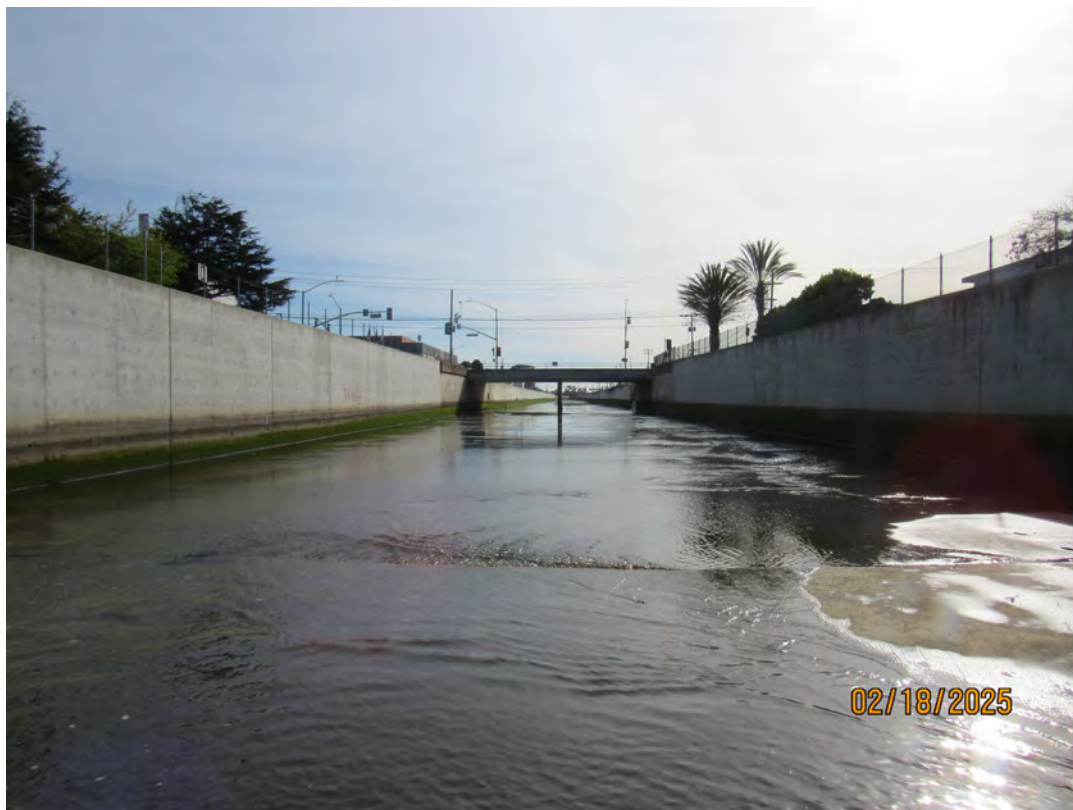
Photos 21 & 22 – Top photo shows Colma Creek looking upstream from dissipater teeth. Bottom photo shows Colma Creek looking downstream from dissipater teeth at Spruce Avenue bridge.

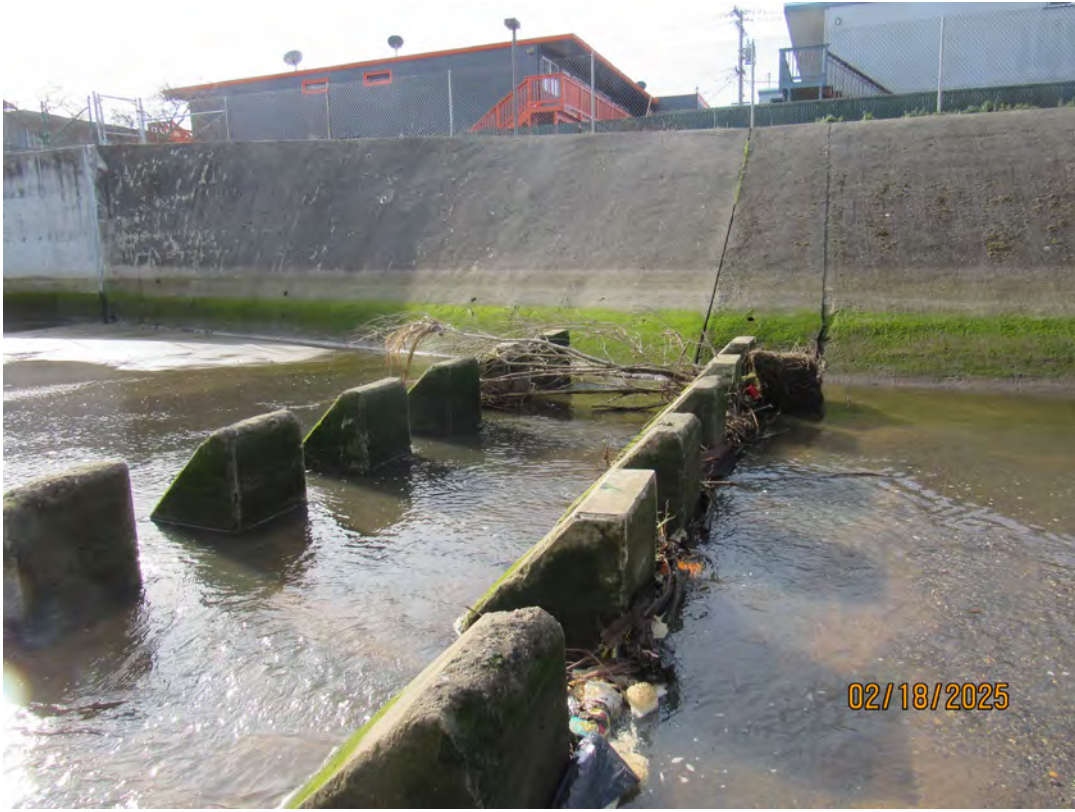
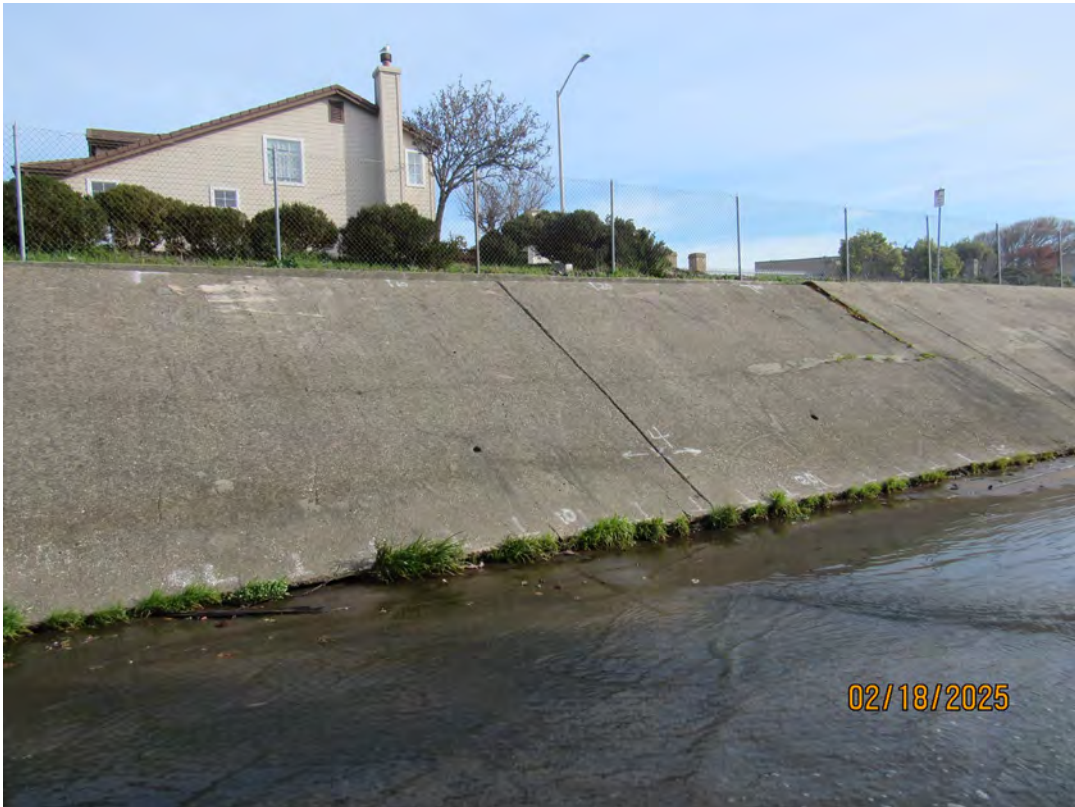
Photos 23 & 24 – Top photo shows minor debris accumulated at the dissipater teeth upstream of the Spruce Avenue bridge. Bottom photo shows trapezoidal wall separation at channel floor developing upstream of the Spruce Avenue bridge. This section was included in a geotechnical investigation to identify causes for the soil settlement. County recommends OneShoreline to continue monitoring the separation in future inspections.
