COLMA CREEK CITIZENS ADVISORY COMMITTEE MEETING

Tuesday, March 11, 2025, at 3:00 pm

Status of the Colma Creek Flood Zone Projects and Maintenance Activities

**Colma Creek Flood Control Channel Maintenance Matrix
Monitoring Photos**

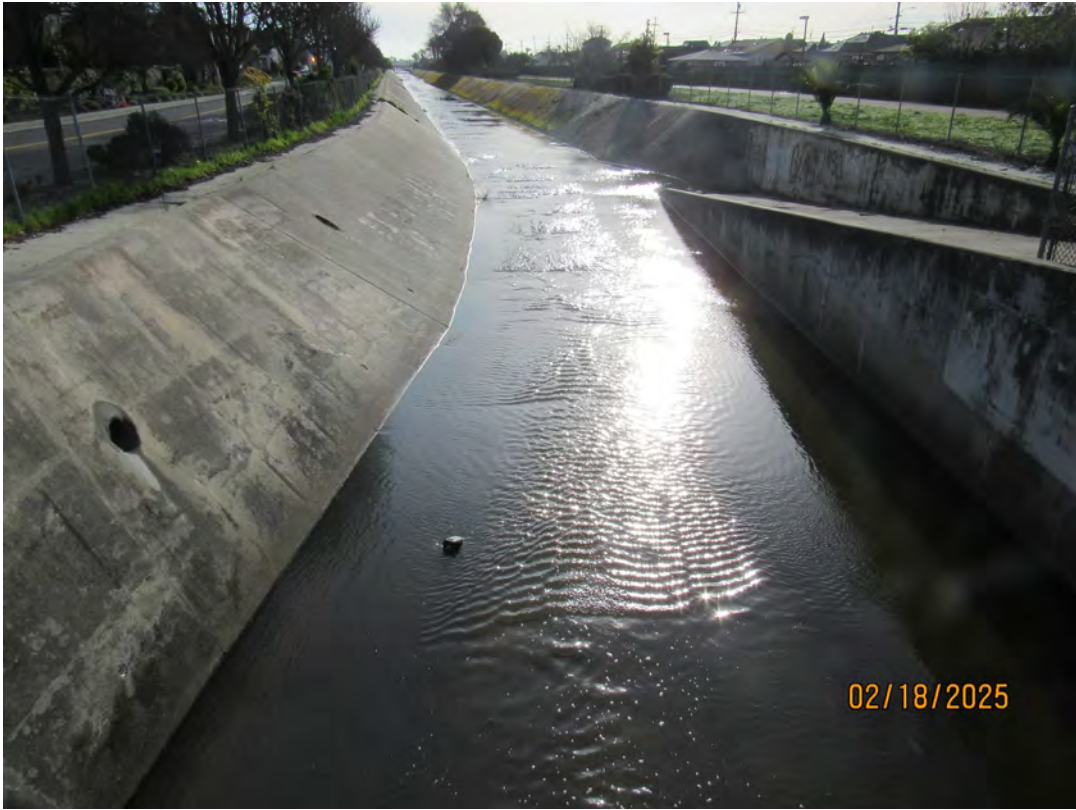
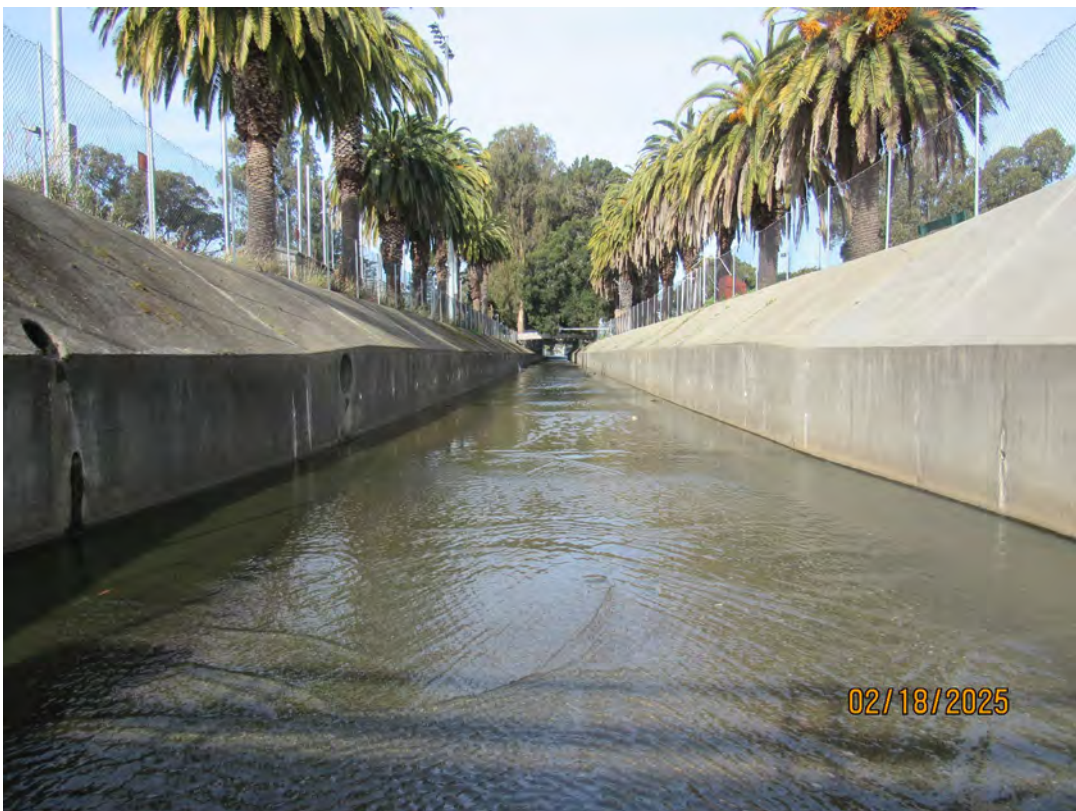
Photos 25 & 26 – Top photo shows Colma Creek looking downstream from the Orange Avenue bridge. Bottom photo shows Colma Creek looking upstream from Orange Avenue bridge.

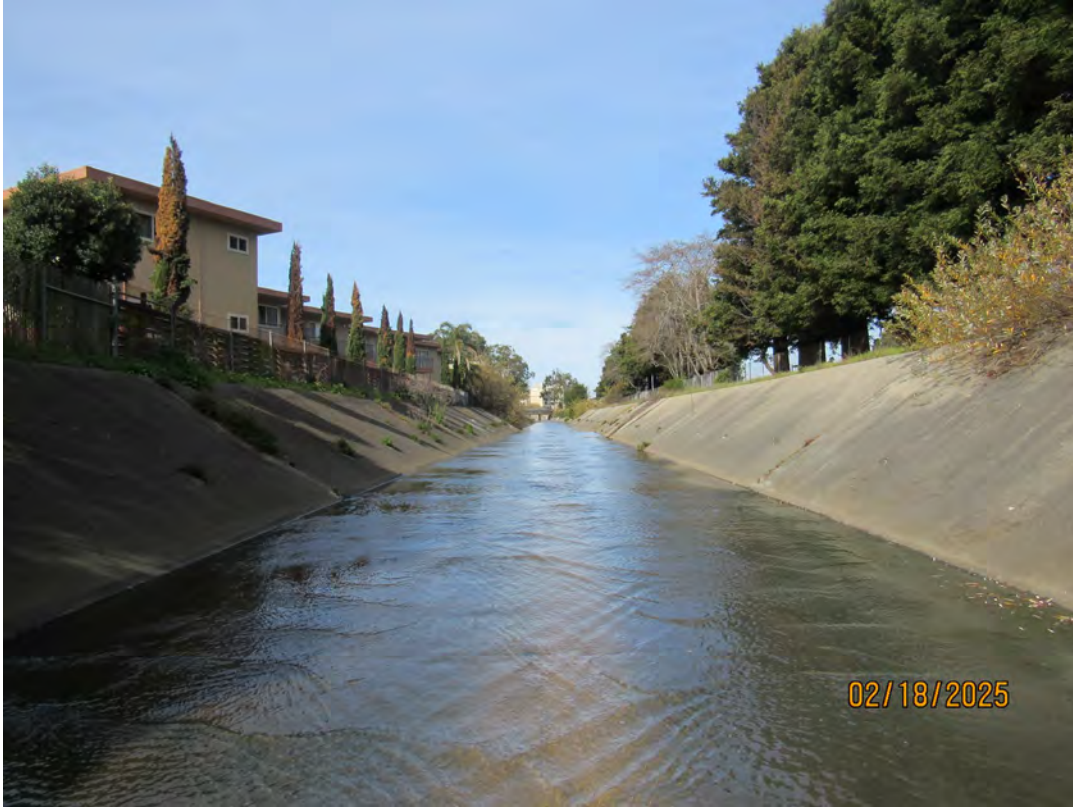
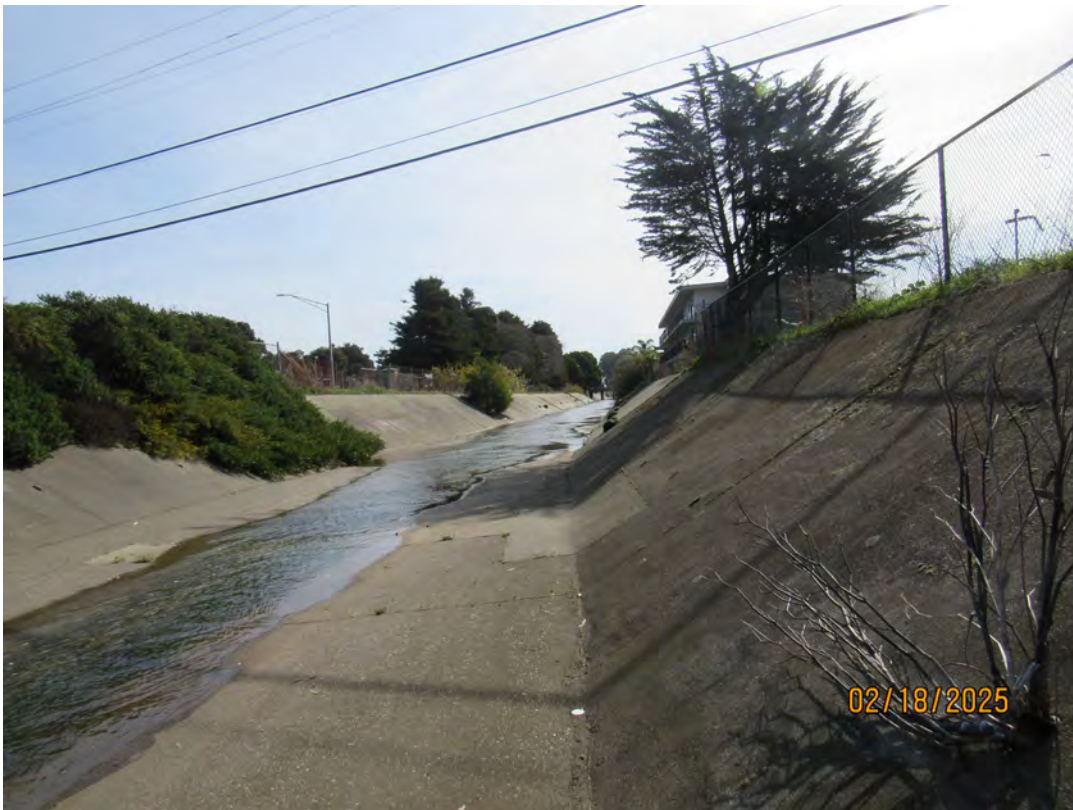
Photos 27 & 28 – Top photo shows Colma Creek looking upstream towards Centennial Way pedestrian bridge. Bottom photo shows Colma Creek looking downstream from Centennial Way pedestrian bridge. County recommends vegetation clearing in the wall joints and weepholes and outfalls in this section of channel to be included on the proposed list of maintenance activities for 2025.

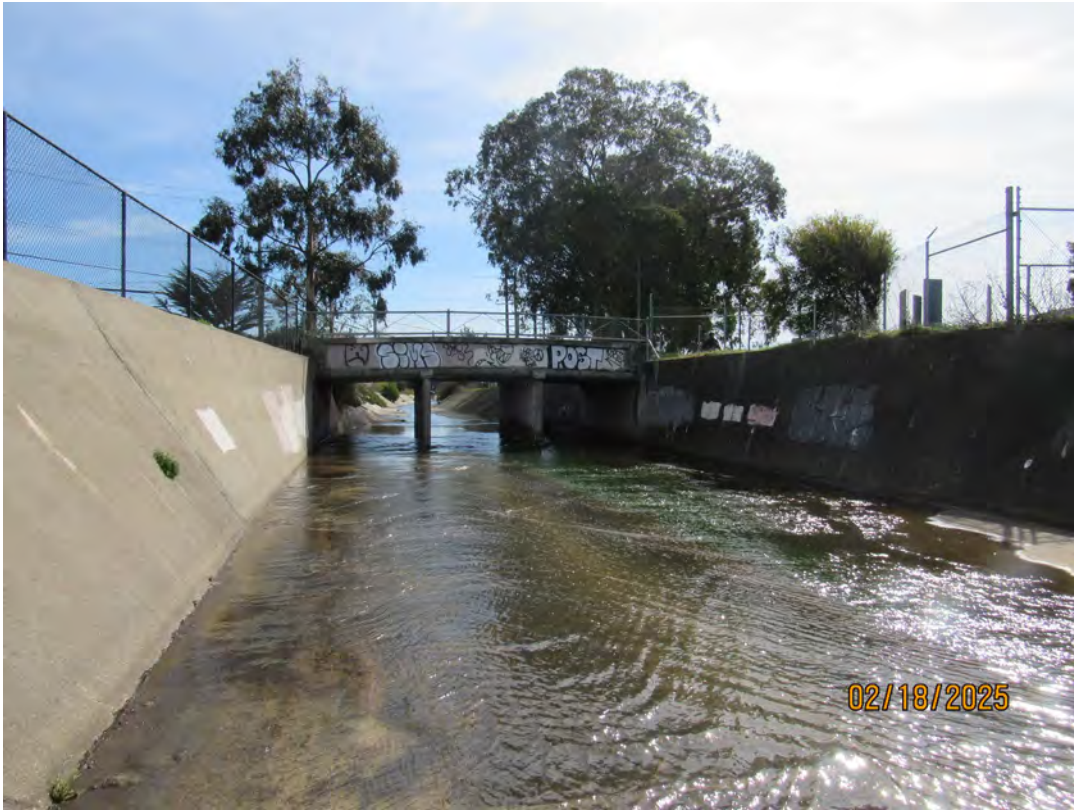
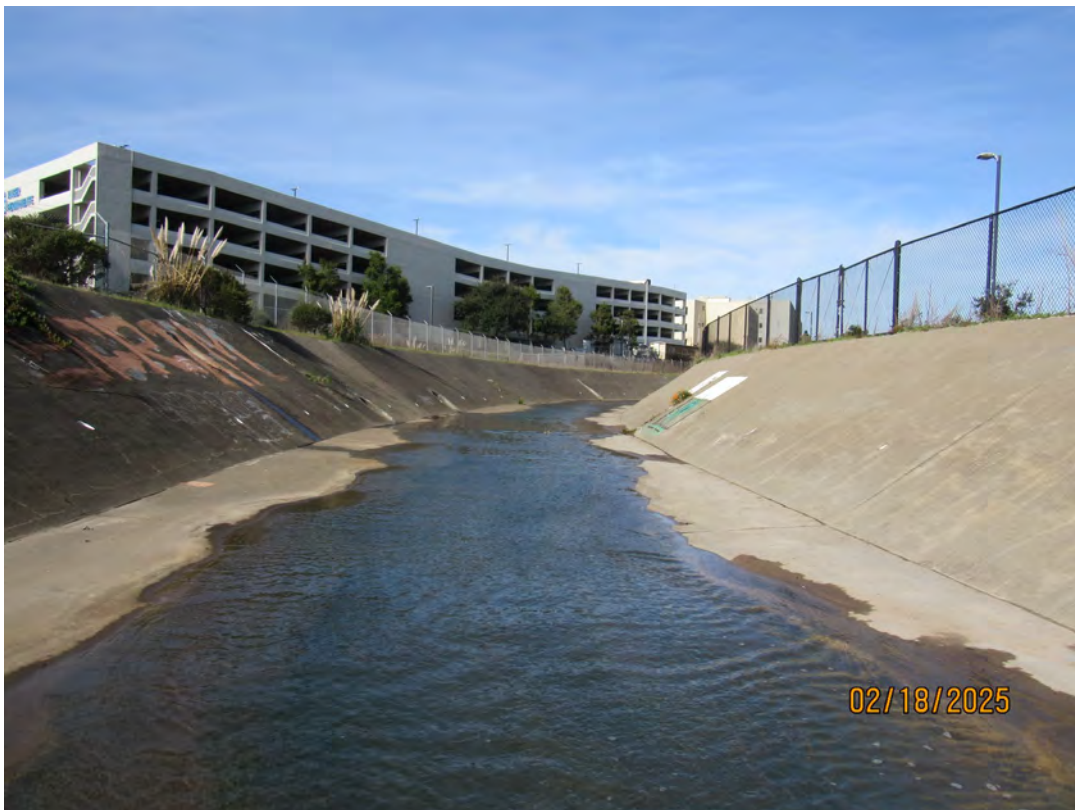
Photos 29 & 30 – Top photo shows Colma Creek looking downstream at the Centennial Way pedestrian bridge. Bottom photo shows Colma Creek looking upstream from the Centennial Way pedestrian bridge.

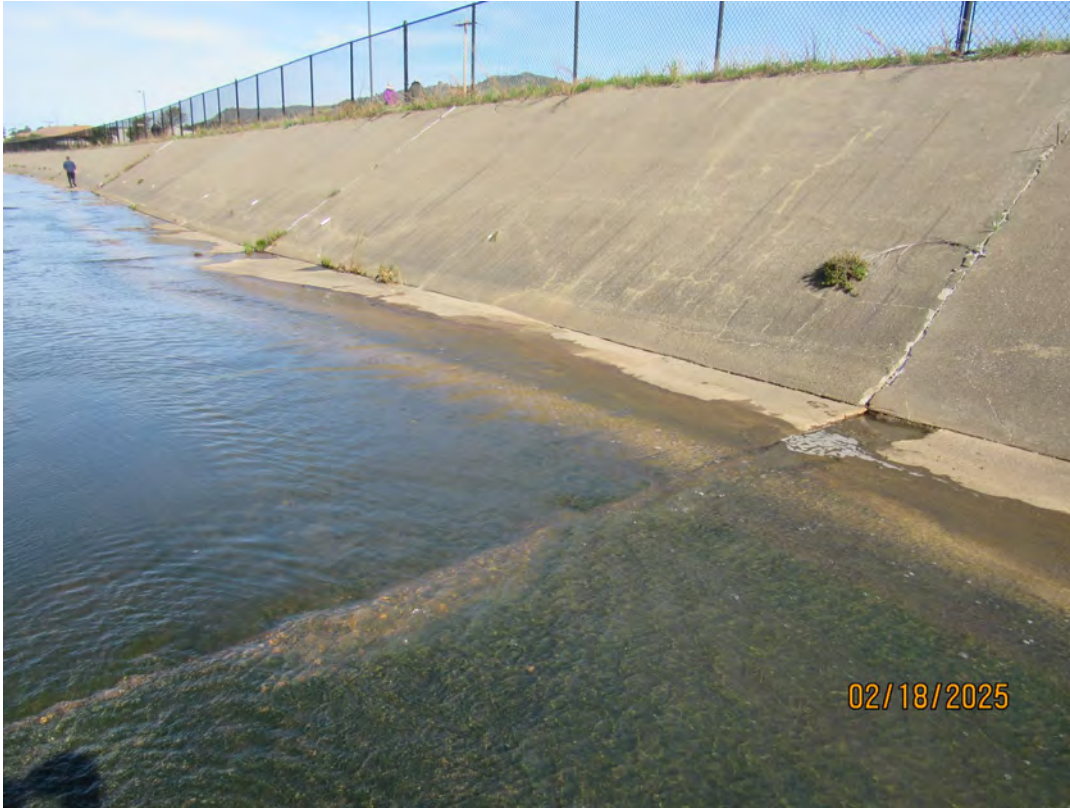
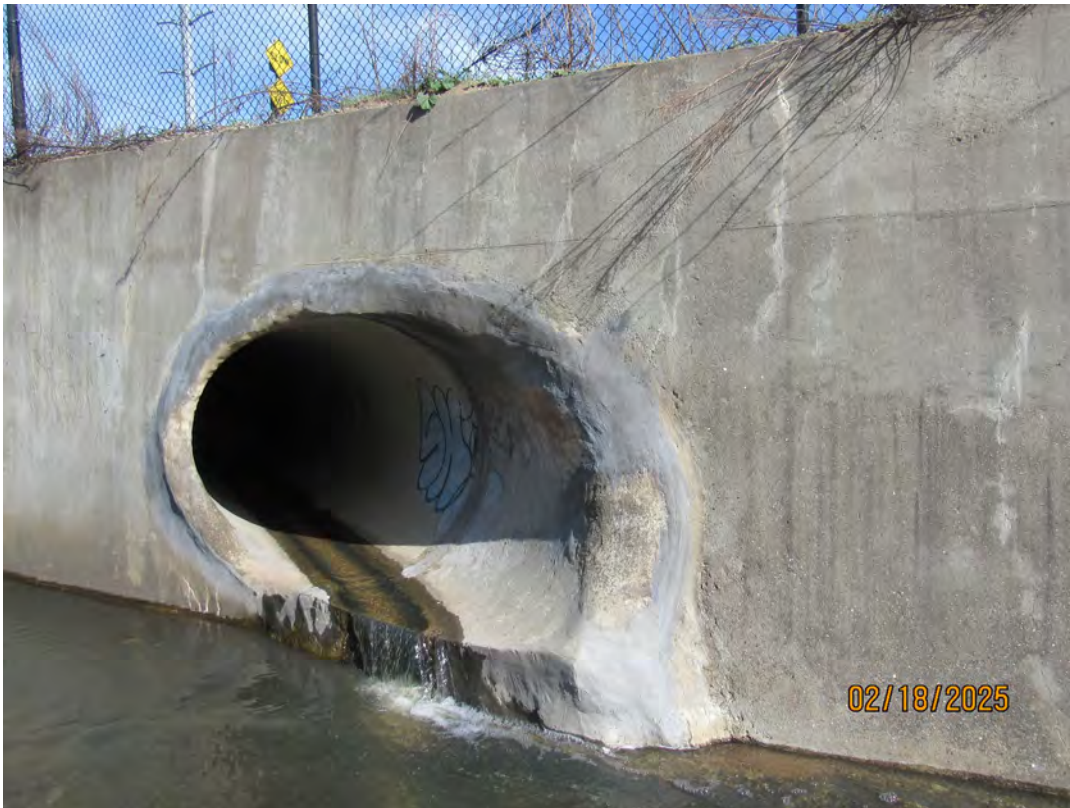
Photos 31 & 32 – Top photo shows degraded channel floor downstream from the BART box culvert. **The 2023 condition assessment of the concrete channel in this section recommends continued monitoring of the defect in future inspections.** Bottom photo shows repaired culvert downstream from the SSF BART Station.

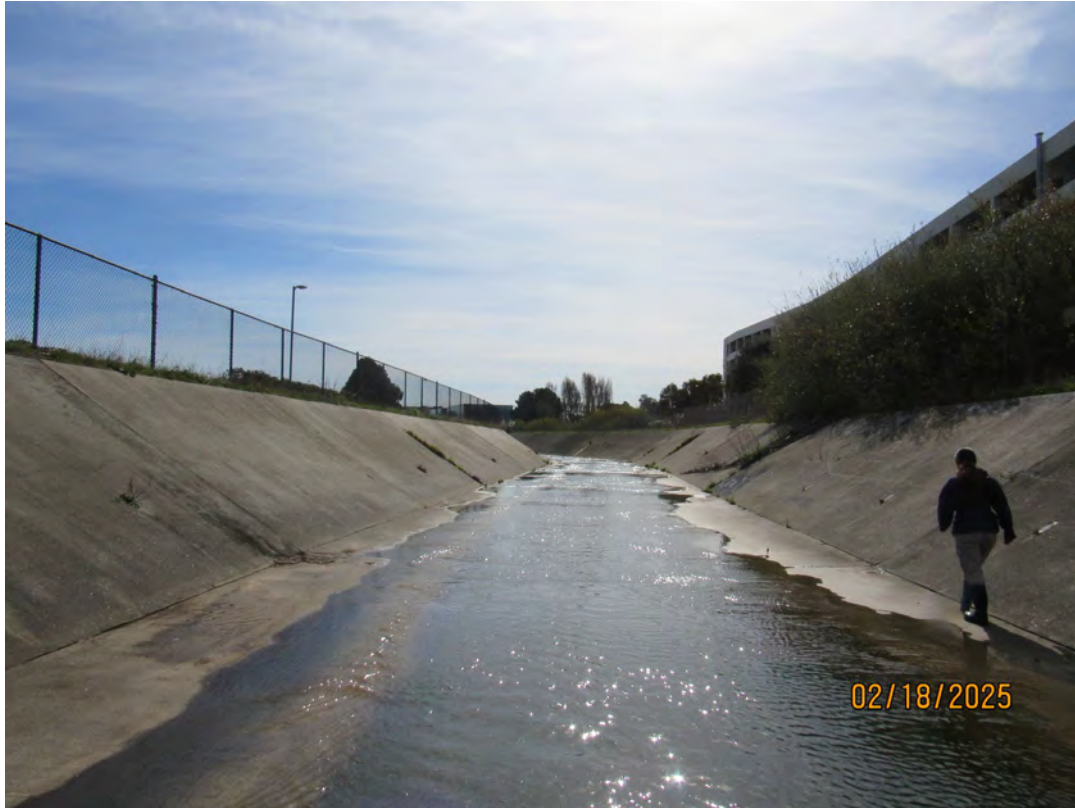
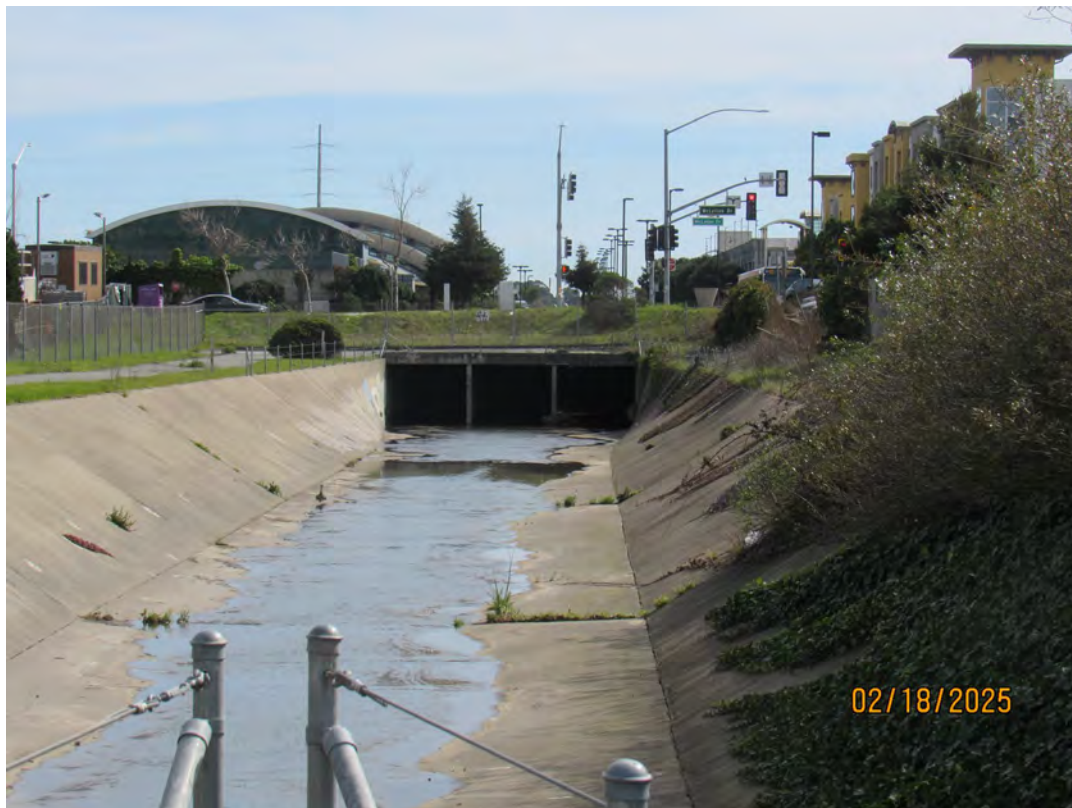
Photos 33 & 34 – Top photo shows Colma Creek looking downstream from channel section from the BART box culvert. Bottom photo shows Colma Creek looking downstream from the pedestrian trail near Costco at the box culvert.

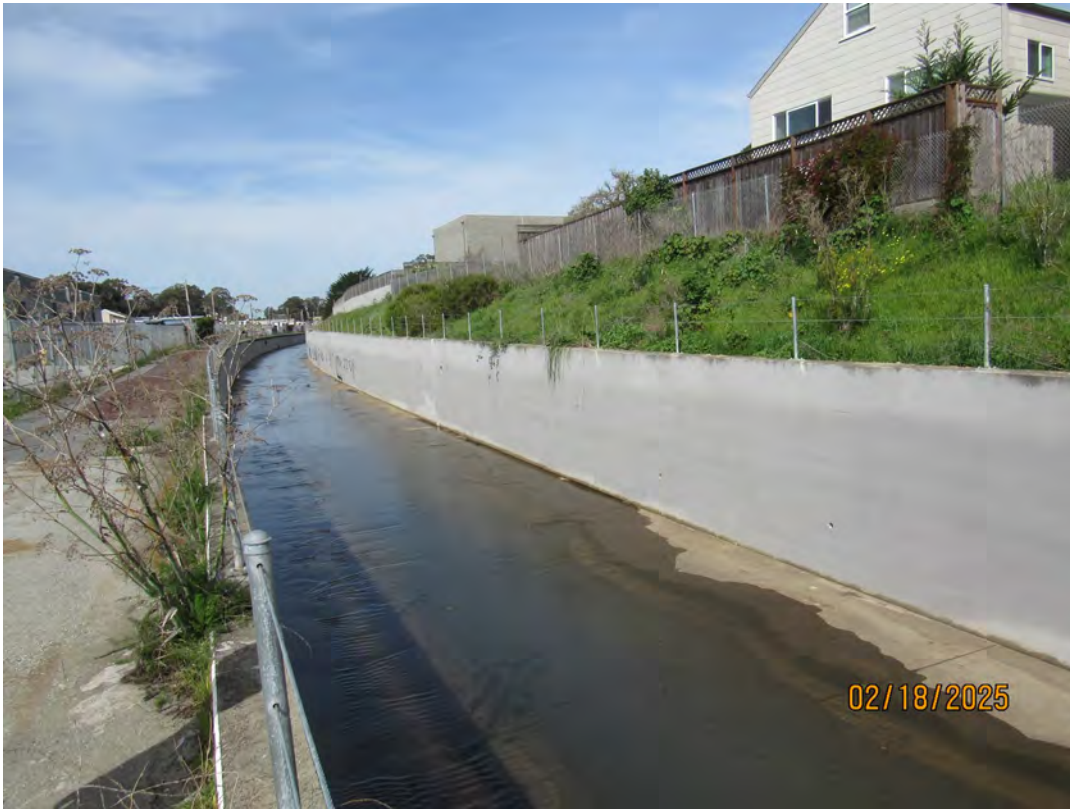
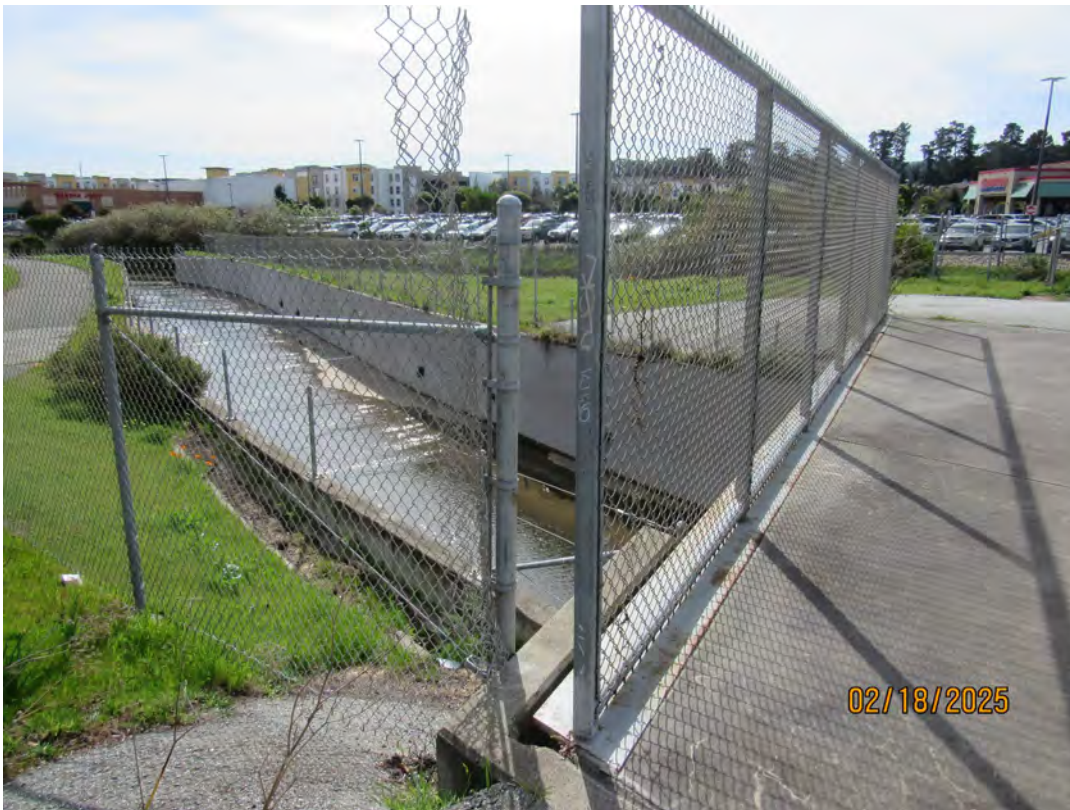
Photos 35 & 36 – Top photo shows Colma Creek looking upstream from Costco pedestrian bridge. **Note that walls remain graffiti free in this section. However, the channel upstream and downstream of here continues to receive fresh graffiti.** Bottom photo shows cut in fence on south end of pedestrian bridge downstream. County also observed locks removed at downstream gate and recommends OneShoreline to coordinate with Colma staff to repair fence and replace lock for access.

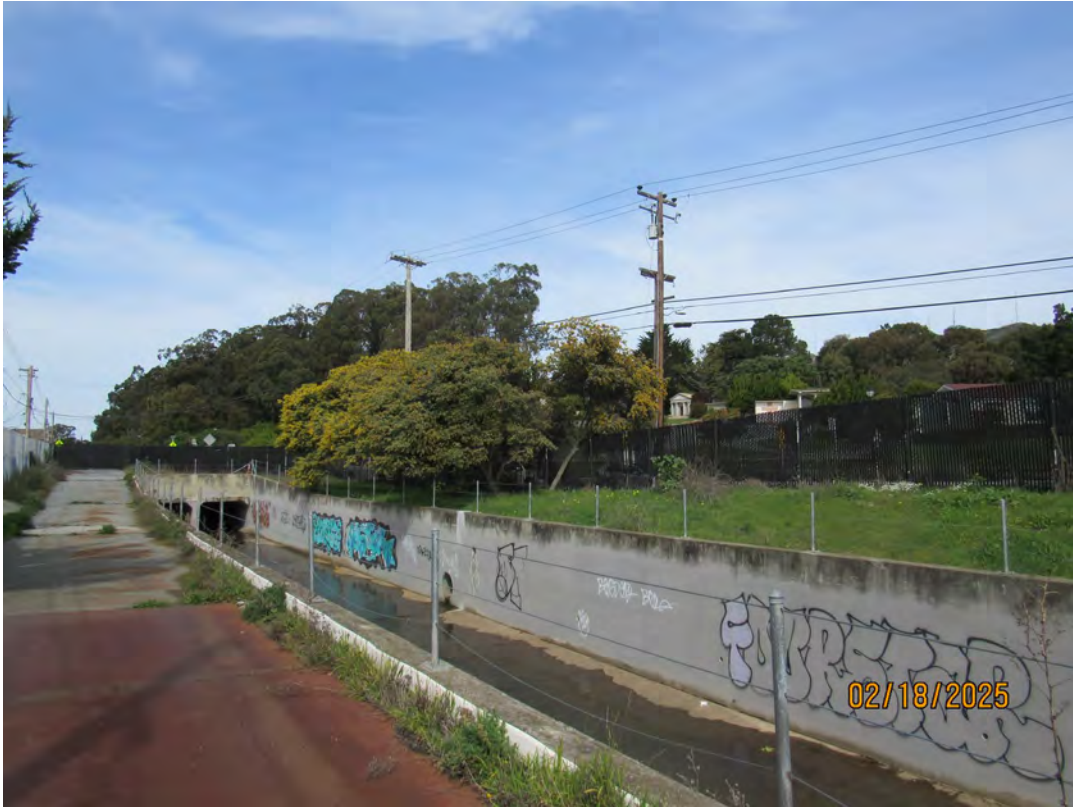
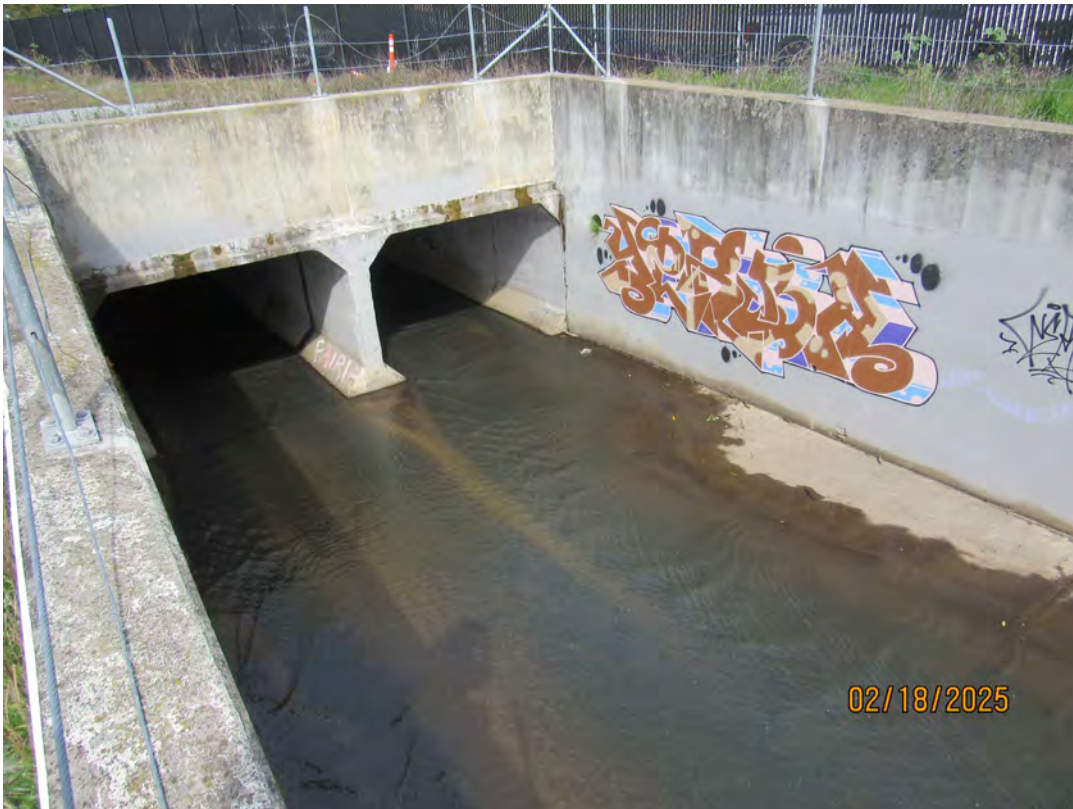
Photos 37 & 38 – Top and bottom photo shows Colma Creek looking upstream at the Mission Road Box Culvert.

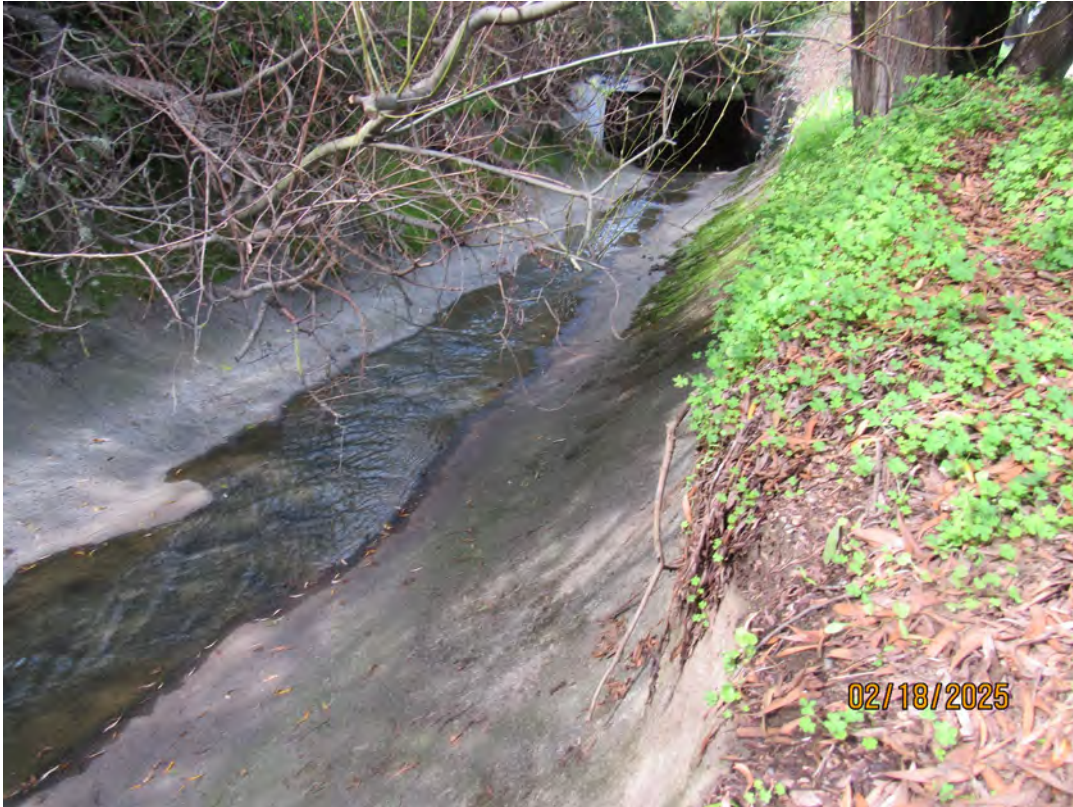
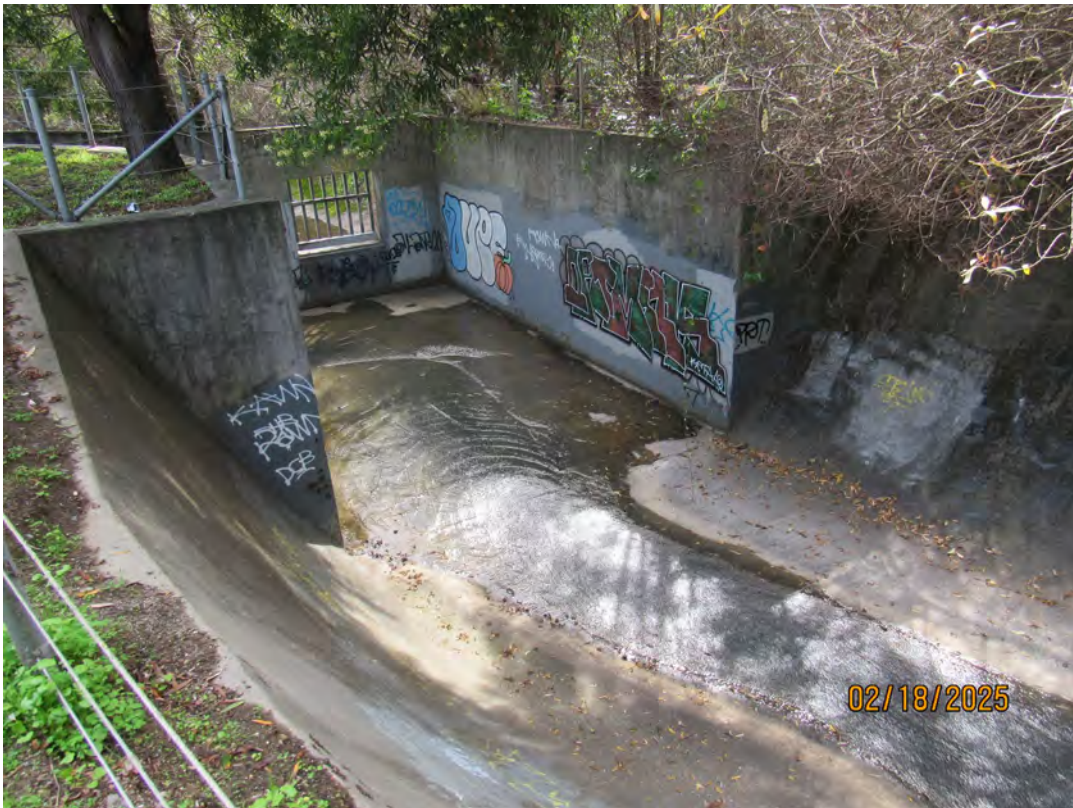
Photos 39 & 40 – Top photo shows old Colma Creek channel downstream of the El Camino Real bridge at the Mission Road intersection. Bottom photo shows Colma Creek channel facing downstream looking at the diversion structure and junction with the Old Channel.
