COLMA CREEK CITIZENS ADVISORY COMMITTEE MEETING

San Mateo County Flood Control District
Colma Creek Flood Control Zone Citizens Advisory Committee

Survey Date: August 17, 2020

Colma Creek Flood Control Channel Maintenance Matrix

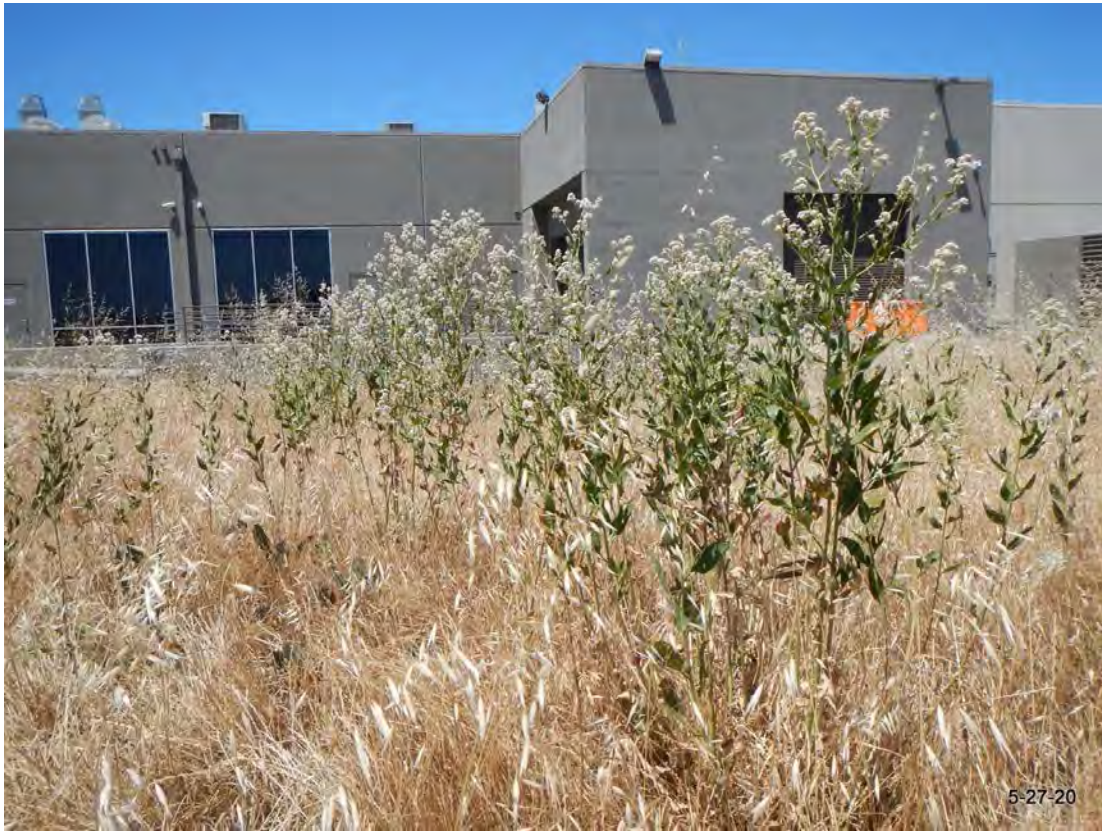
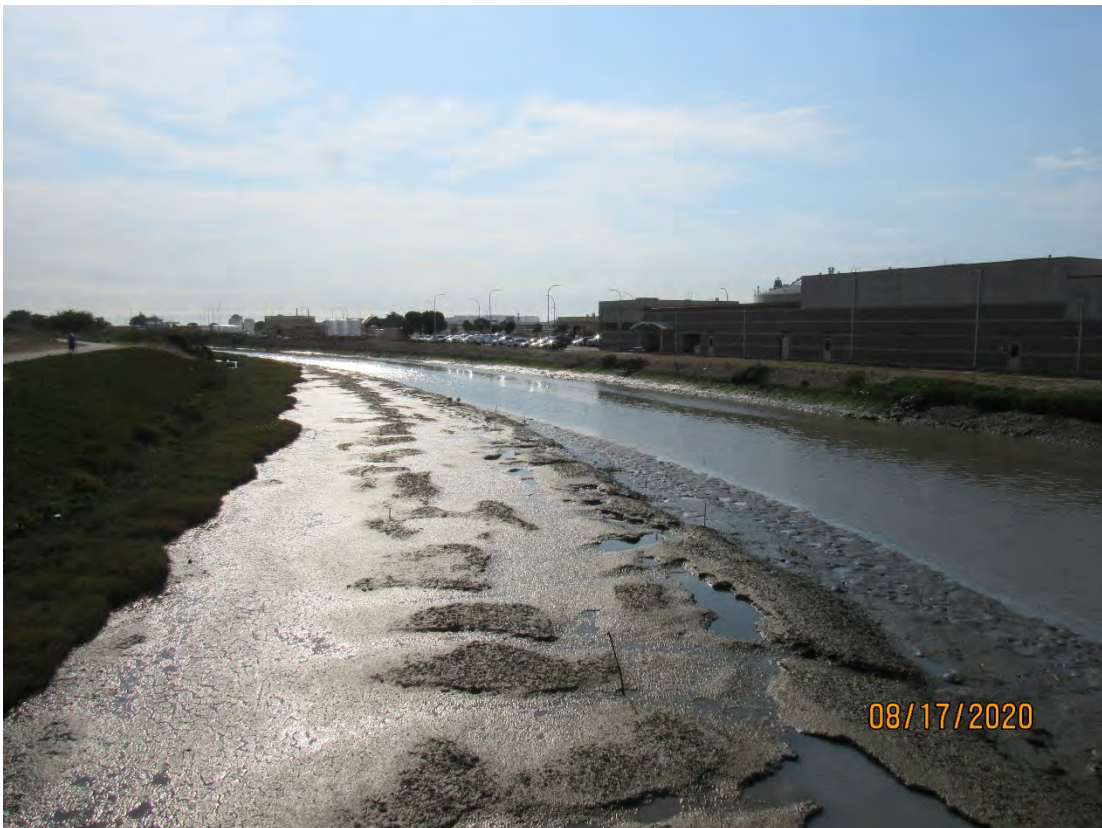
Photos 1 & 2 – Top photo shows invasive weed, perennial pepperweed, observed off the San Francisco Bay Trail and behind 310 Utah Avenue (outside of Mitigation Site 3). **Perennial pepperweed is highly invasive and it is recommended that SSF work to eradicate this patch.** Bottom photo shows Colma Creek looking downstream from the Bay Trail pedestrian bridge.

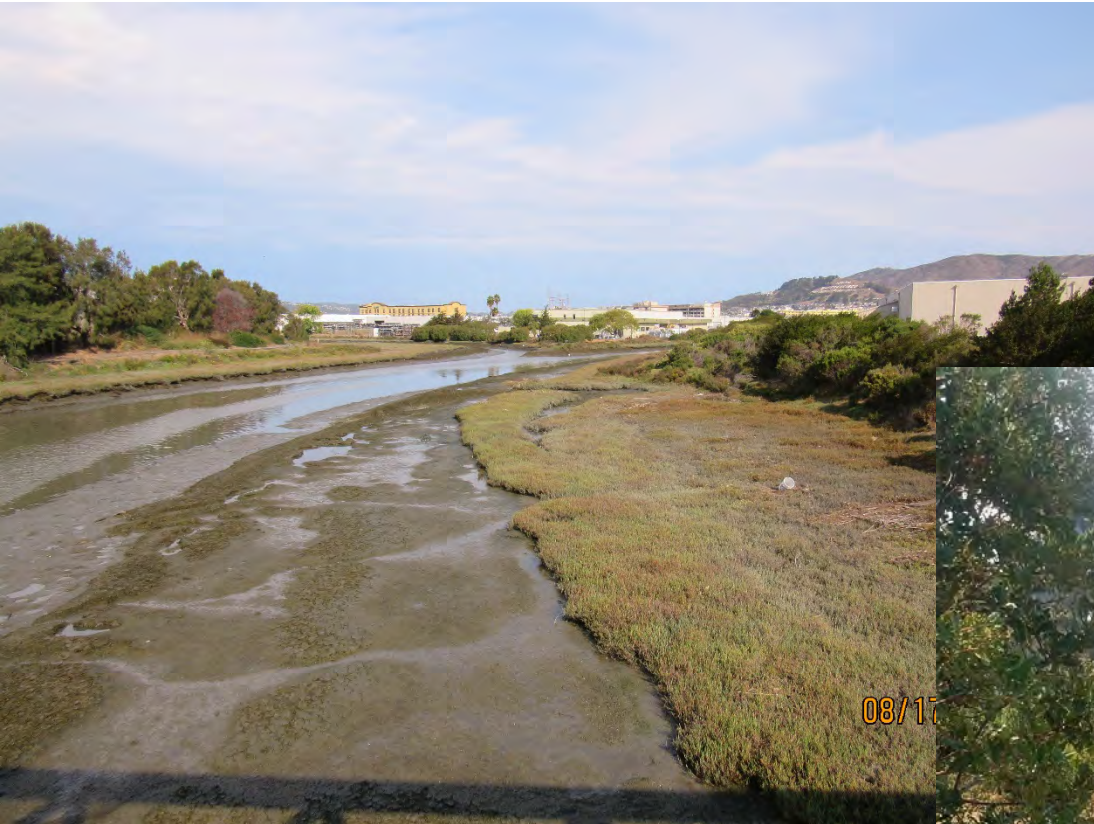
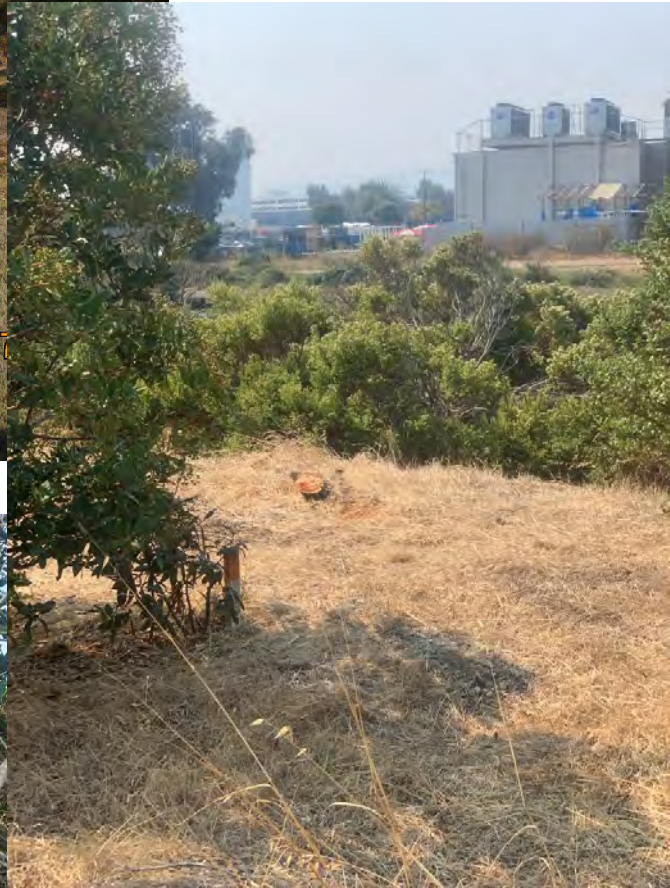
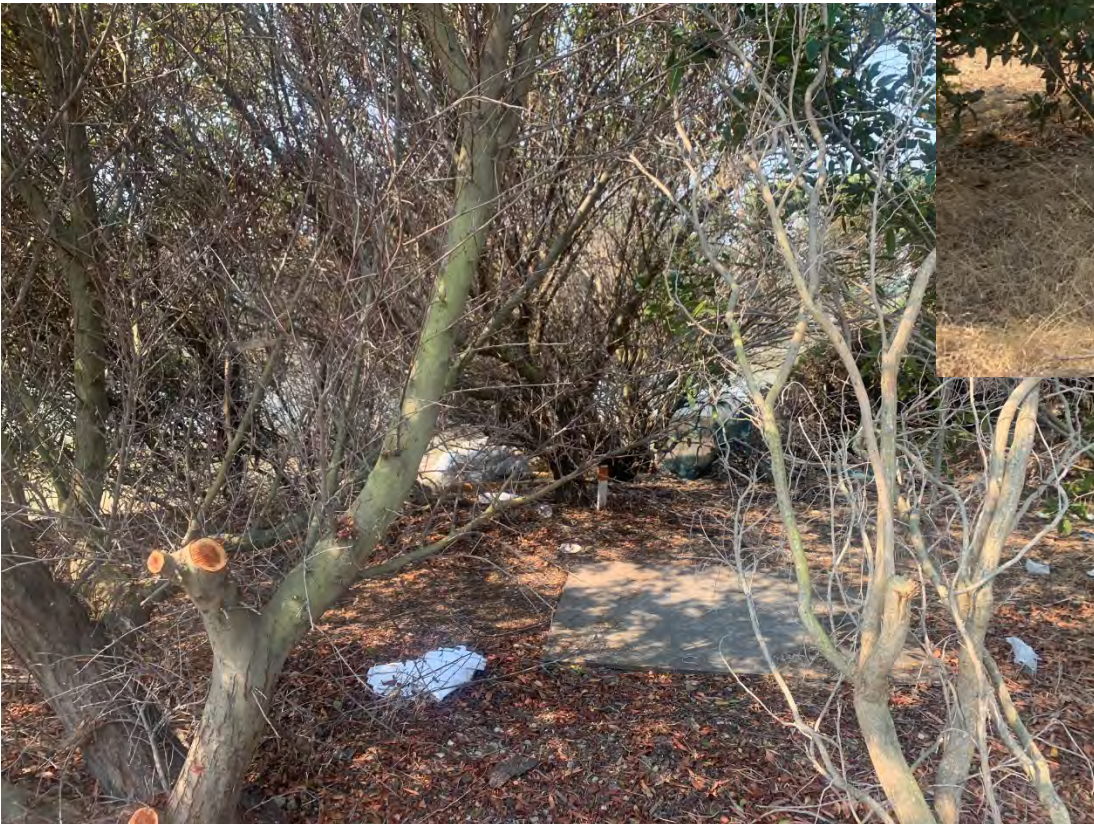
Photos 3, 4 & 5 – Top photo shows Colma Creek looking upstream from the Bay Trail pedestrian bridge. Middle photo shows native vegetation within Mitigation Site 2 removed by SSF maintenance crew, presumably to discourage homeless activities. Bottom photo shows homeless encampment activity on Mitigation Site 2. SSF and County staff to work together to prevent similar action from occurring in the future.

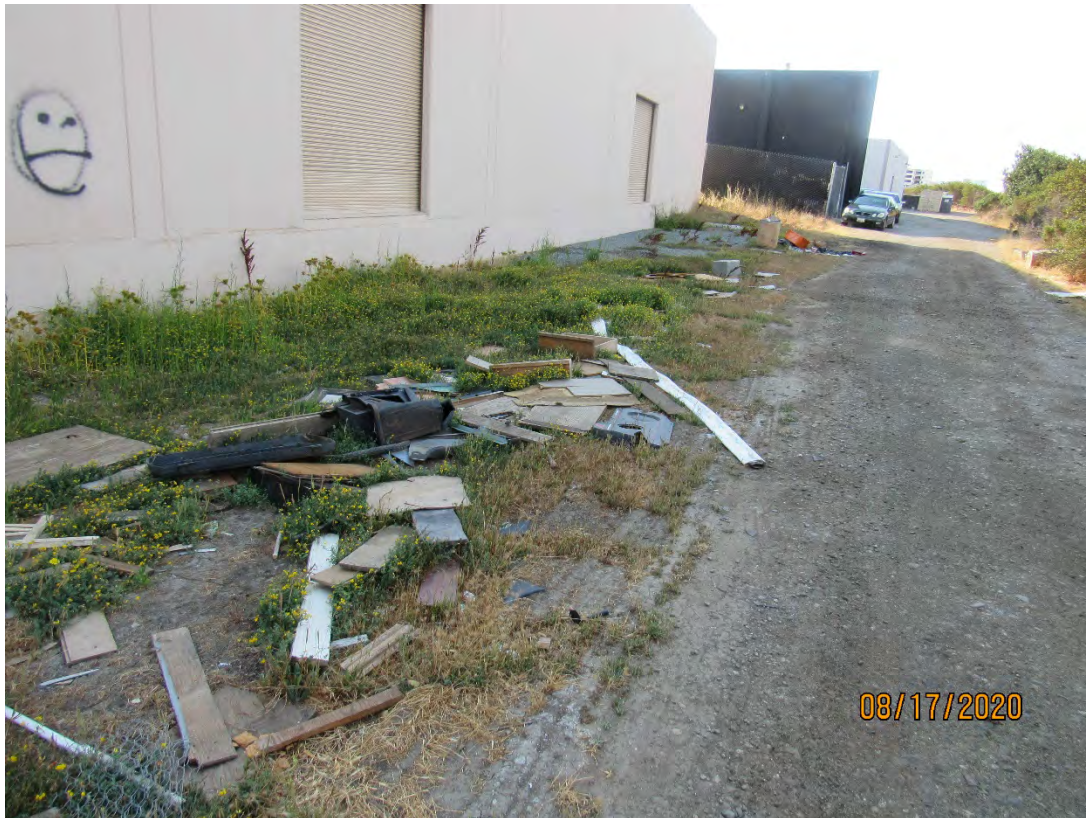
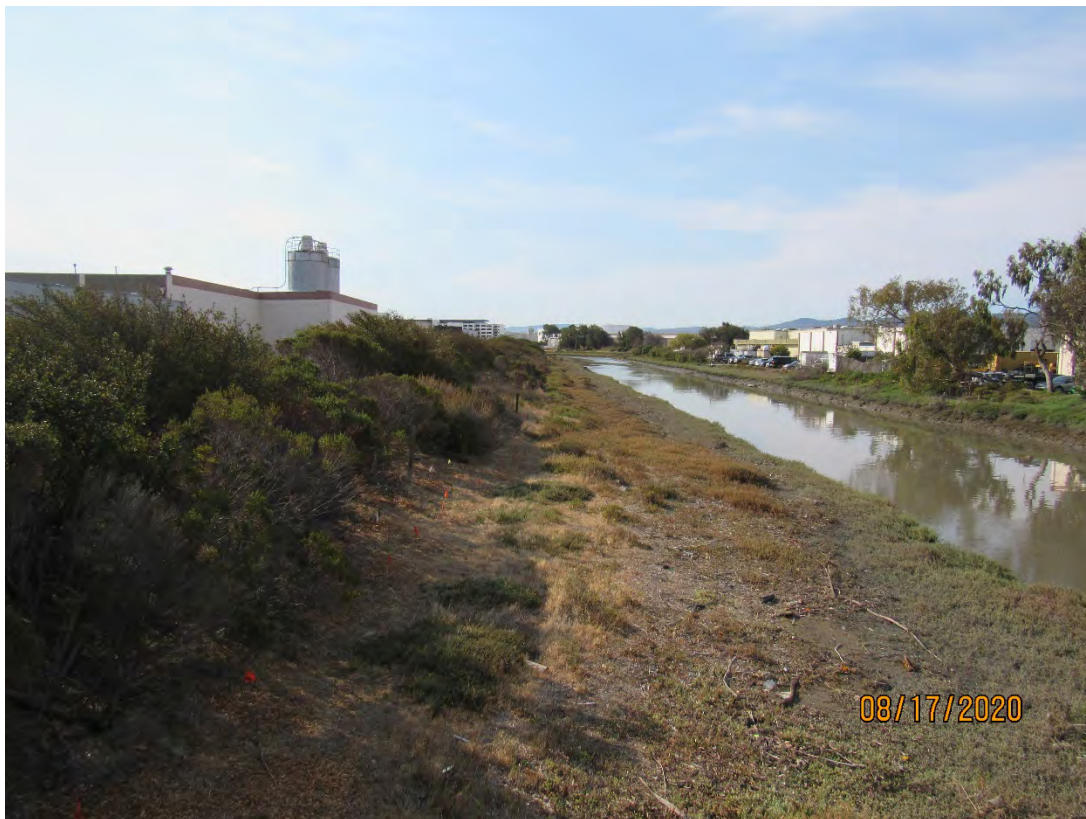
Photos 6 & 7 – Top photo shows continued illegal dumping that persists on the Colma Creek service road. SSF has been notified of these observations through See-Click-Fix and e-mail. Local businesses have also been contacted for installing security cameras to discourage illegal dumping. Bottom photo shows Colma Creek looking downstream from the Utah Avenue bridge.

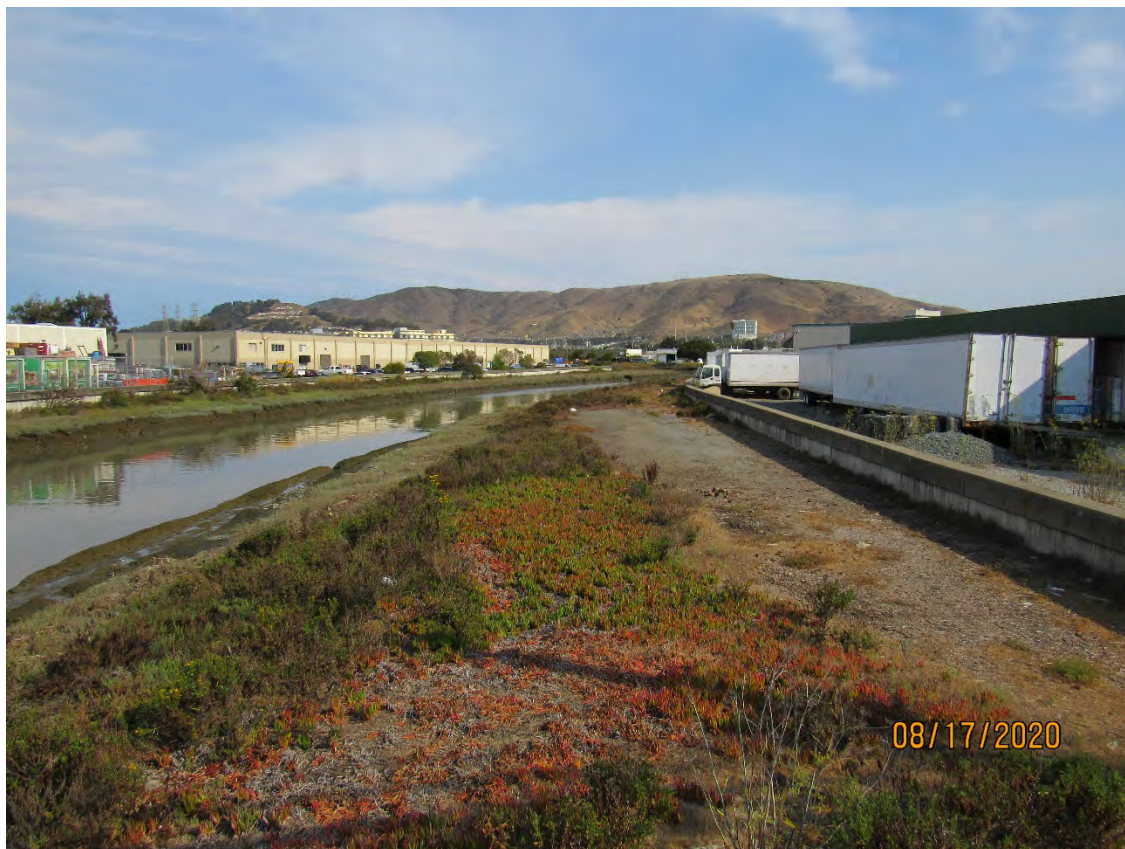
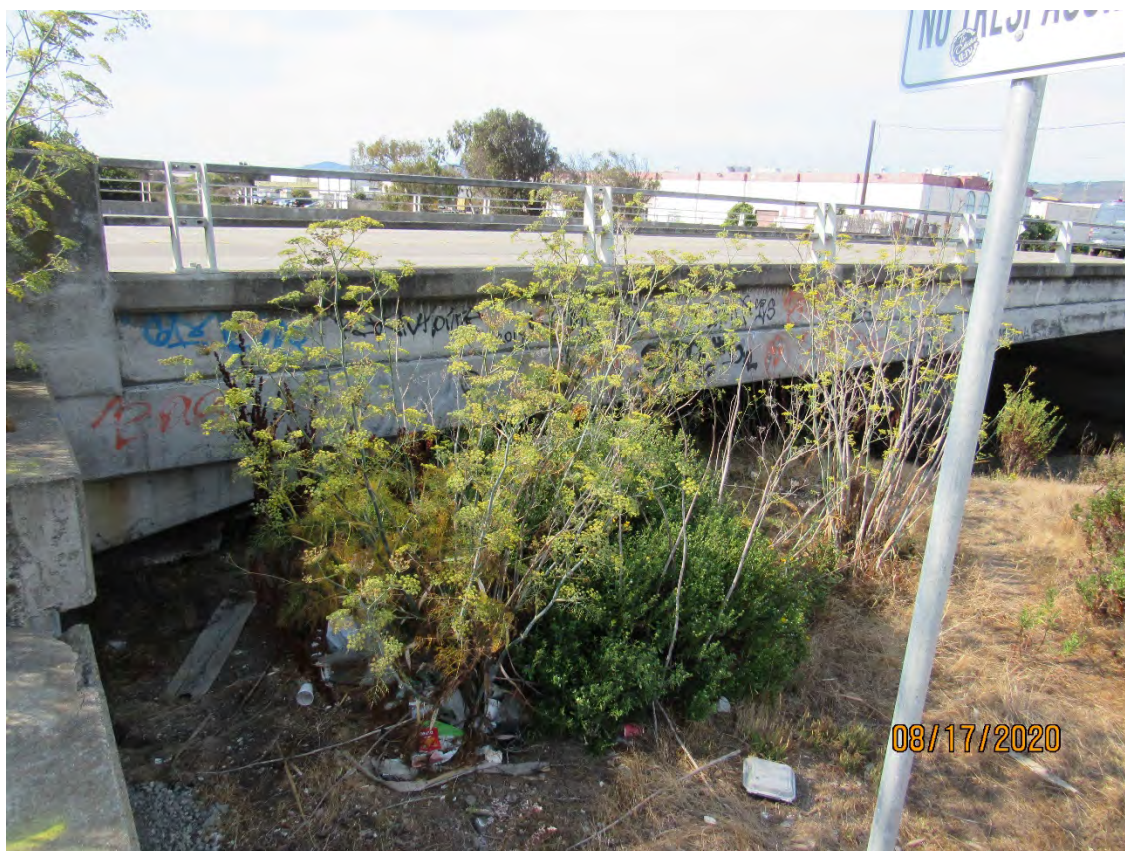
Photos 8 & 9 – Top photo shows Colma Creek looking upstream from the Utah Avenue bridge. Bottom photo shows homeless encampment activity beneath the Utah Avenue bridge.

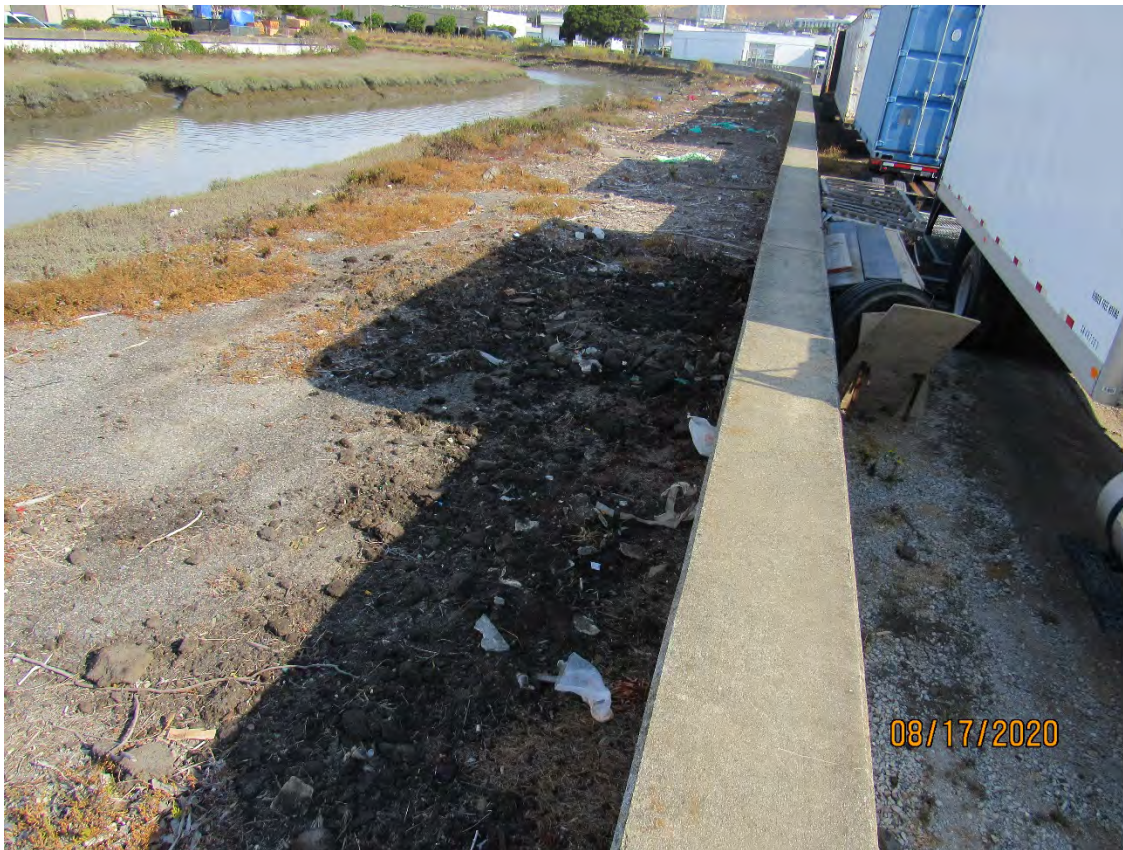
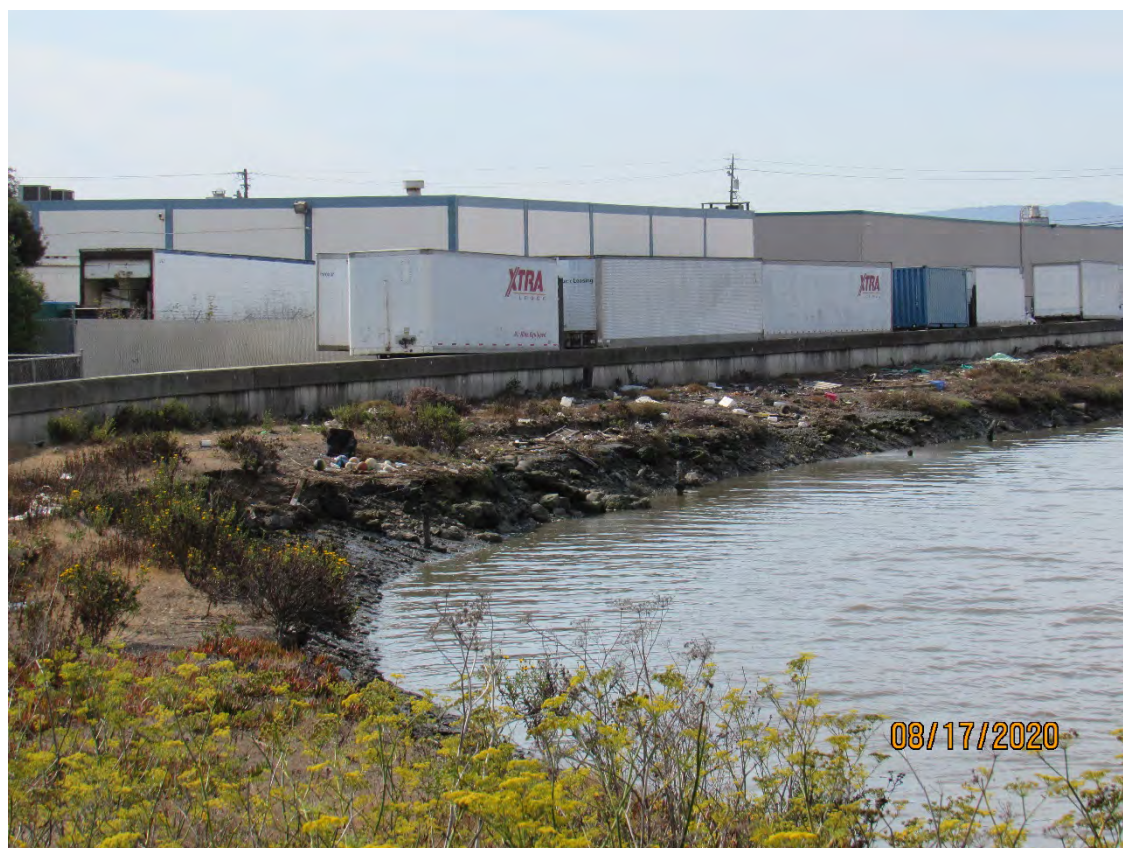
Photos 10 & 11 – Top photo shows evidence of soil spoil deposited on the bank of Colma Creek channel from outside of the wall. Bottom photo shows trash accumulation between the Utah Avenue bridge and Mitchell Road. **Due to COVID-19 work suspension and restrictions, recent Sheriff Work Program events have focused on cleaning up the mitigation sites and planting efforts.**

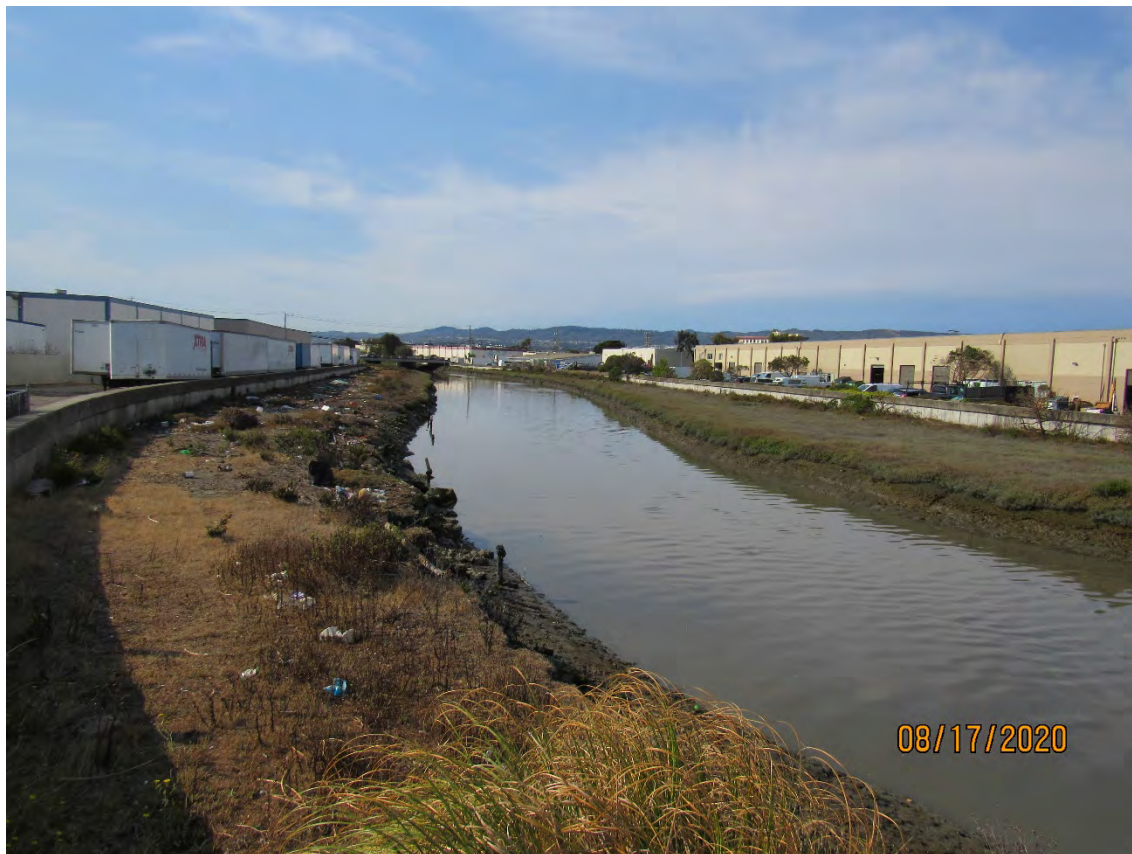
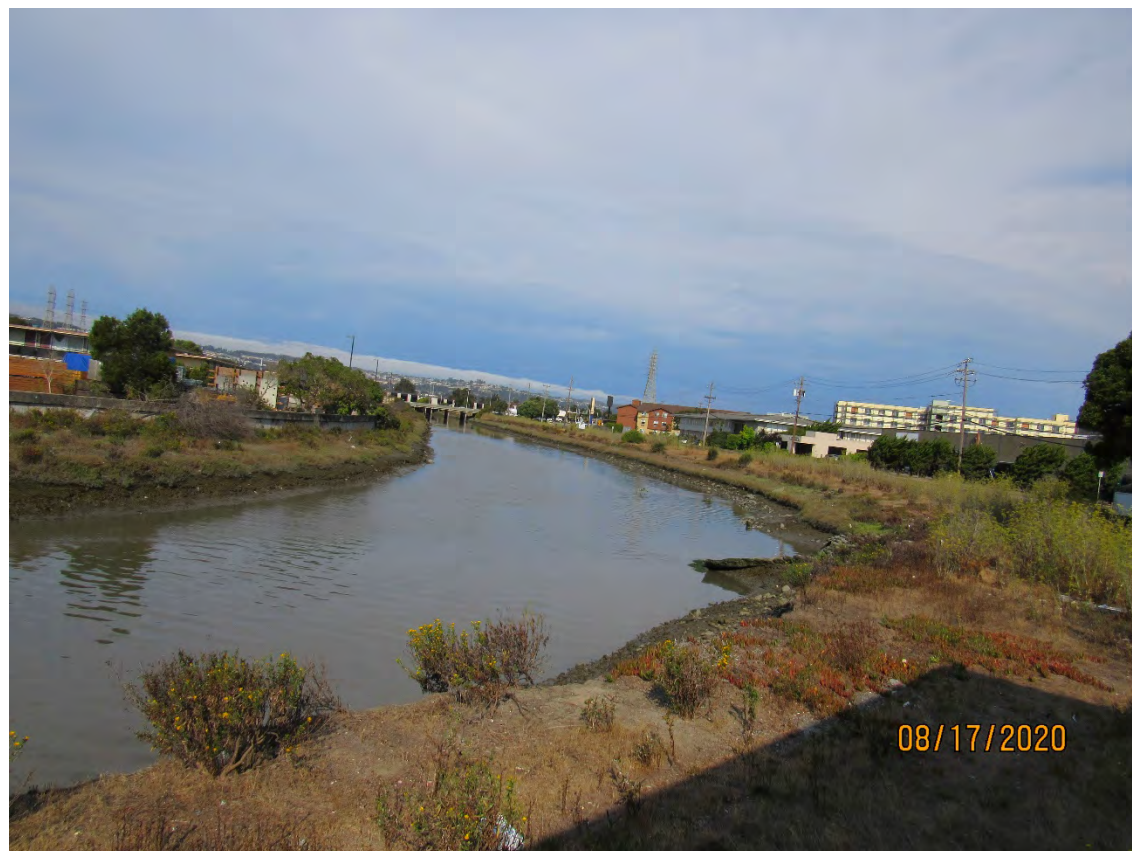
Photos 12 & 13 – Top photo shows Colma Creek looking downstream toward the Utah Avenue bridge. Considerable trash and debris, along with illegal dumping, was observed. Bottom photo shows Colma Creek looking upstream toward the South Airport Boulevard bridge.

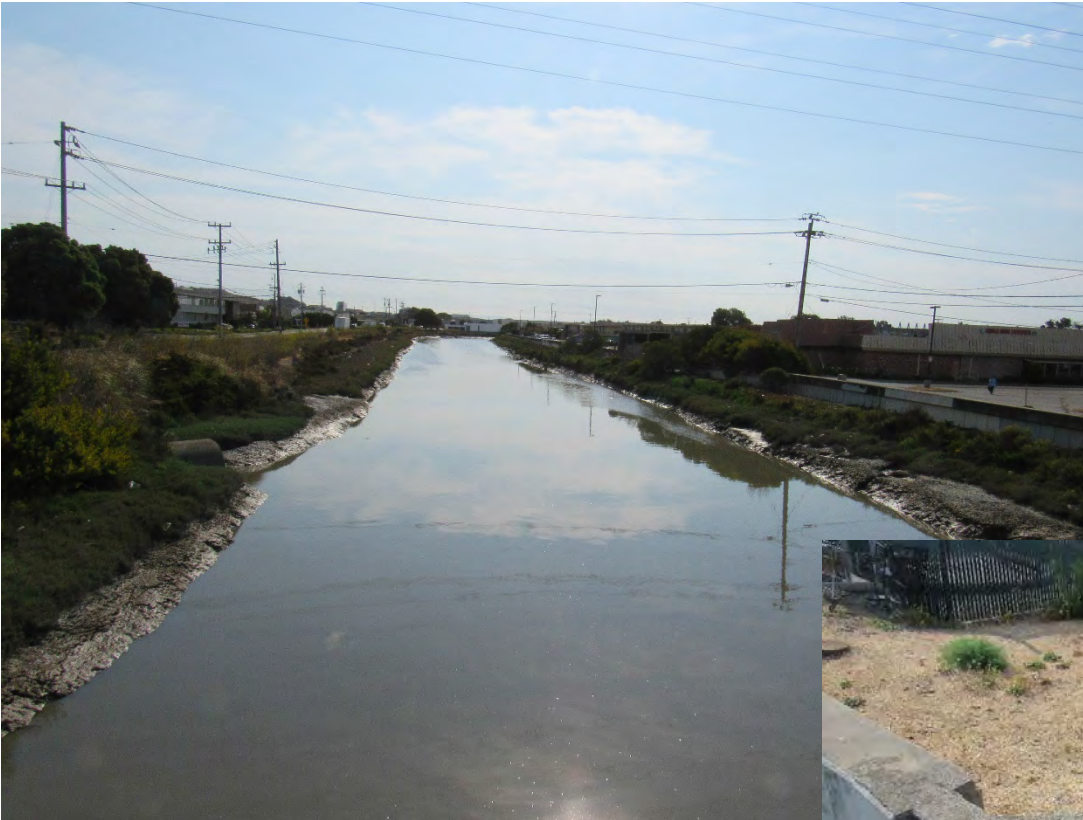
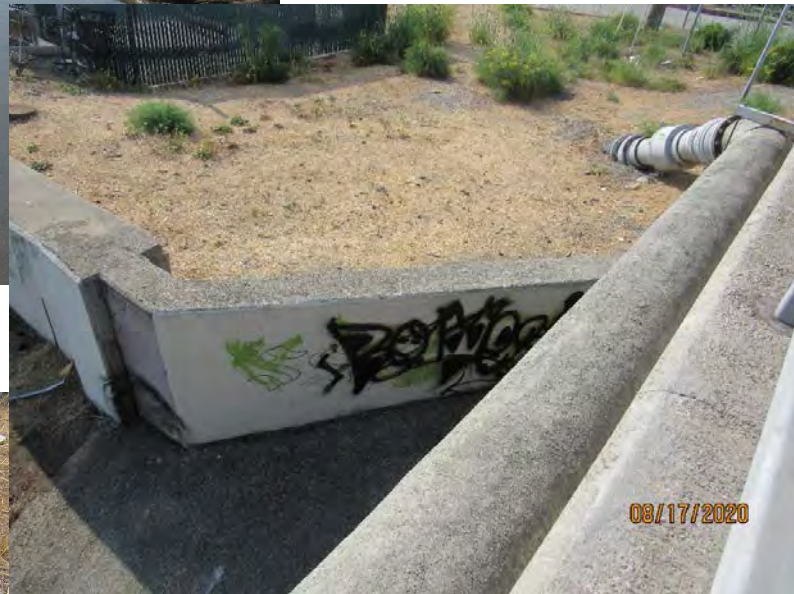
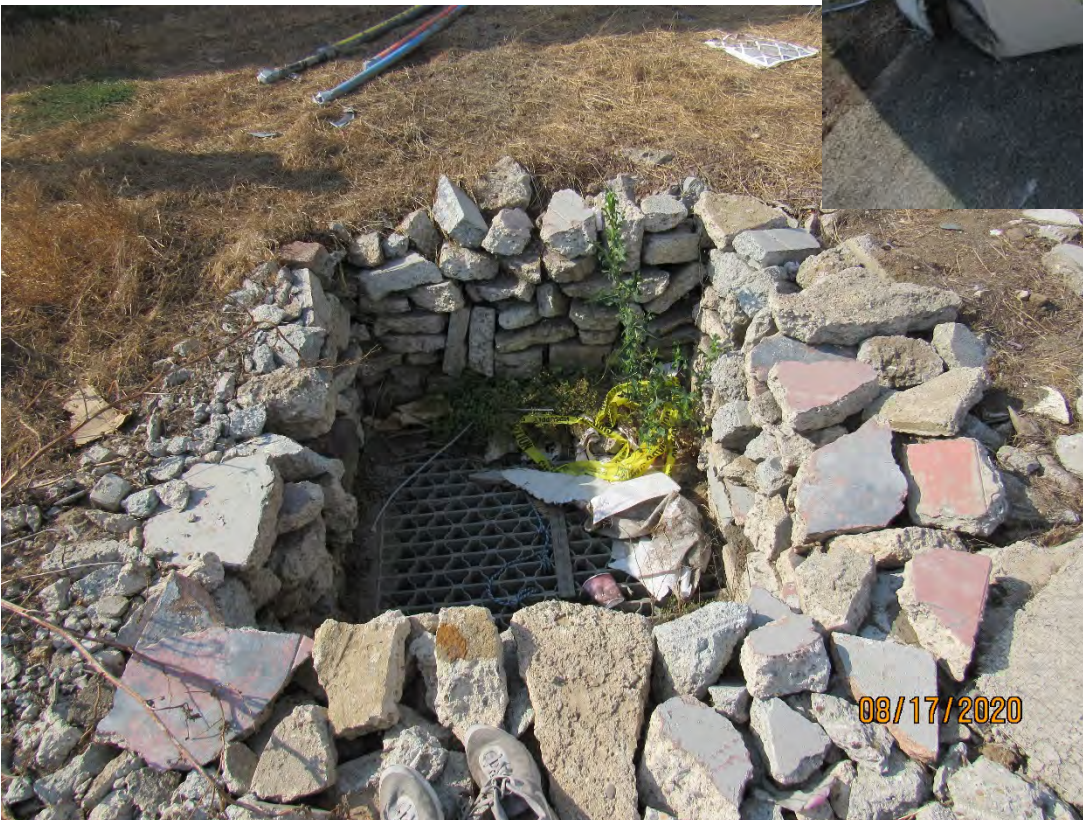
Photos 14, 15, & 16 – Top photo shows Colma Creek looking downstream from South Airport Boulevard bridge. Middle photo shows new graffiti observed at the southeast corner of the South Airport Boulevard bridge. Bottom photo shows trash accumulating at the Highway 101 storm drain inlet modified by the property owner without CalTrans or District permission or knowledge.

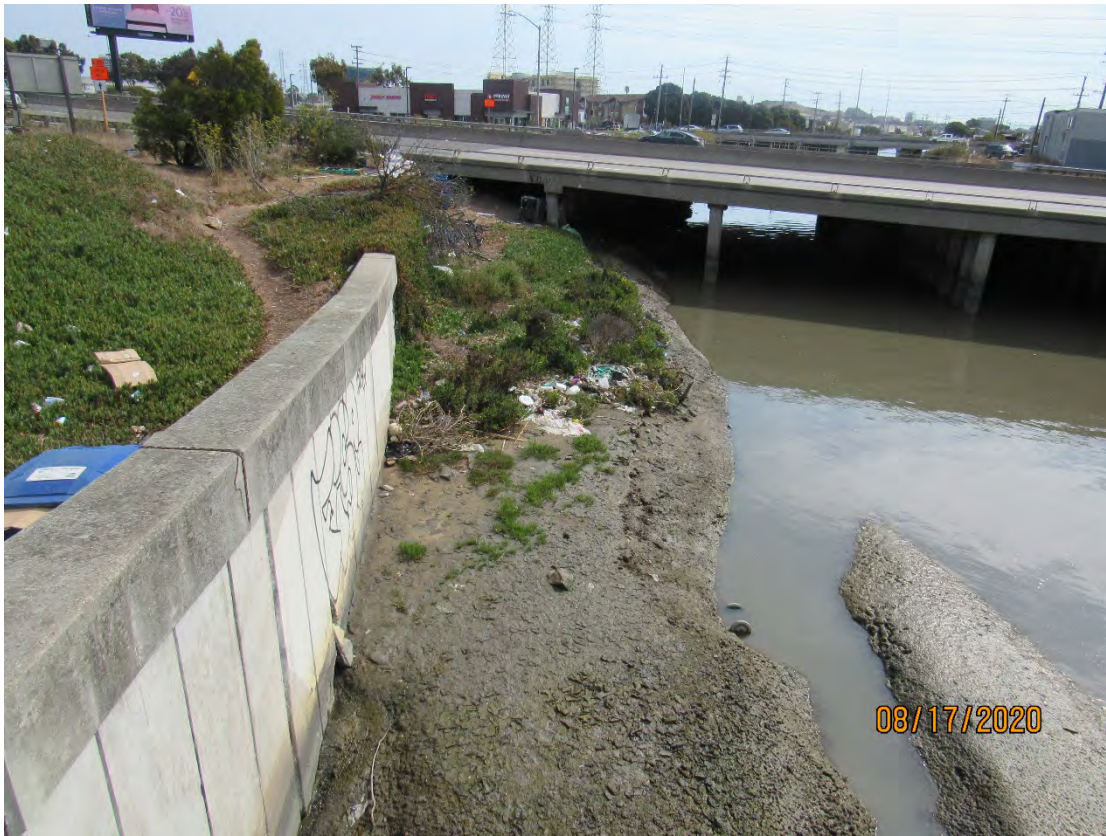
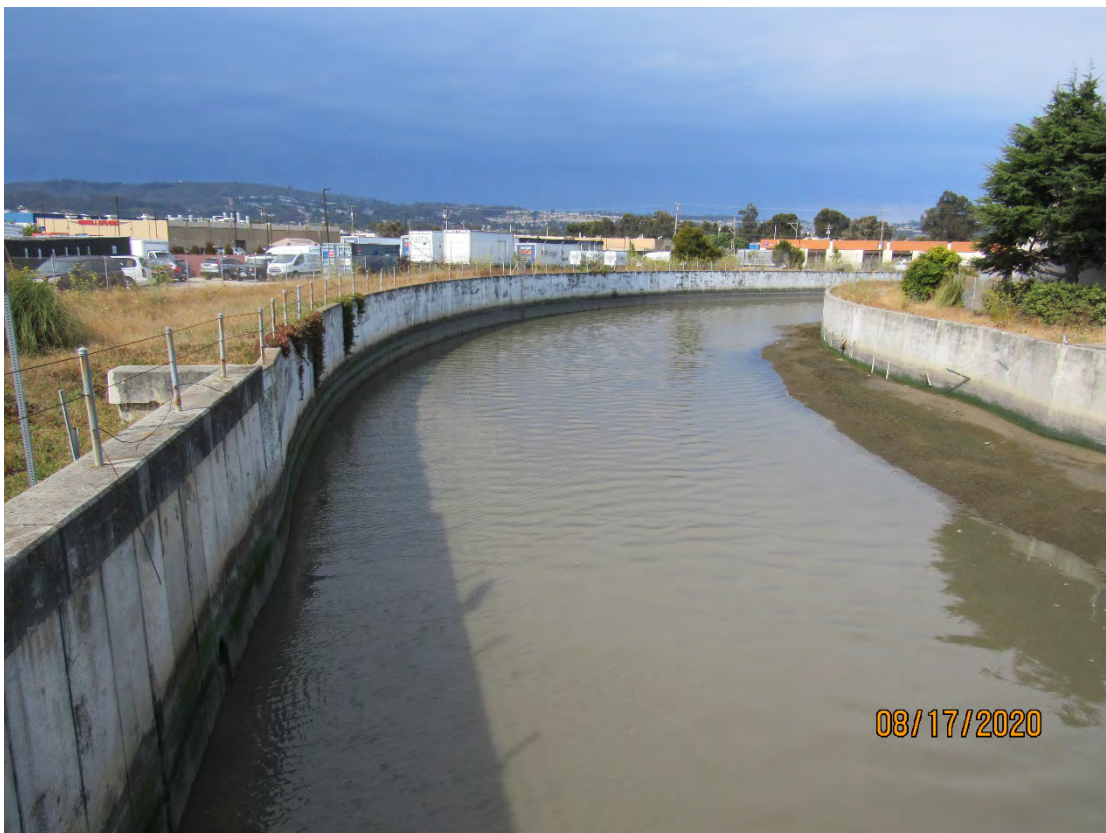
Photos 17 & 18 – Top photo shows Colma Creek looking downstream from the Produce Avenue bridge; homeless activity stemming from the Highway 101 bridge encampment observed throughout the area, as well as downstream. **CalTrans has been notified of the encampment.** Bottom photo shows Colma Creek looking upstream from the Produce Avenue bridge.

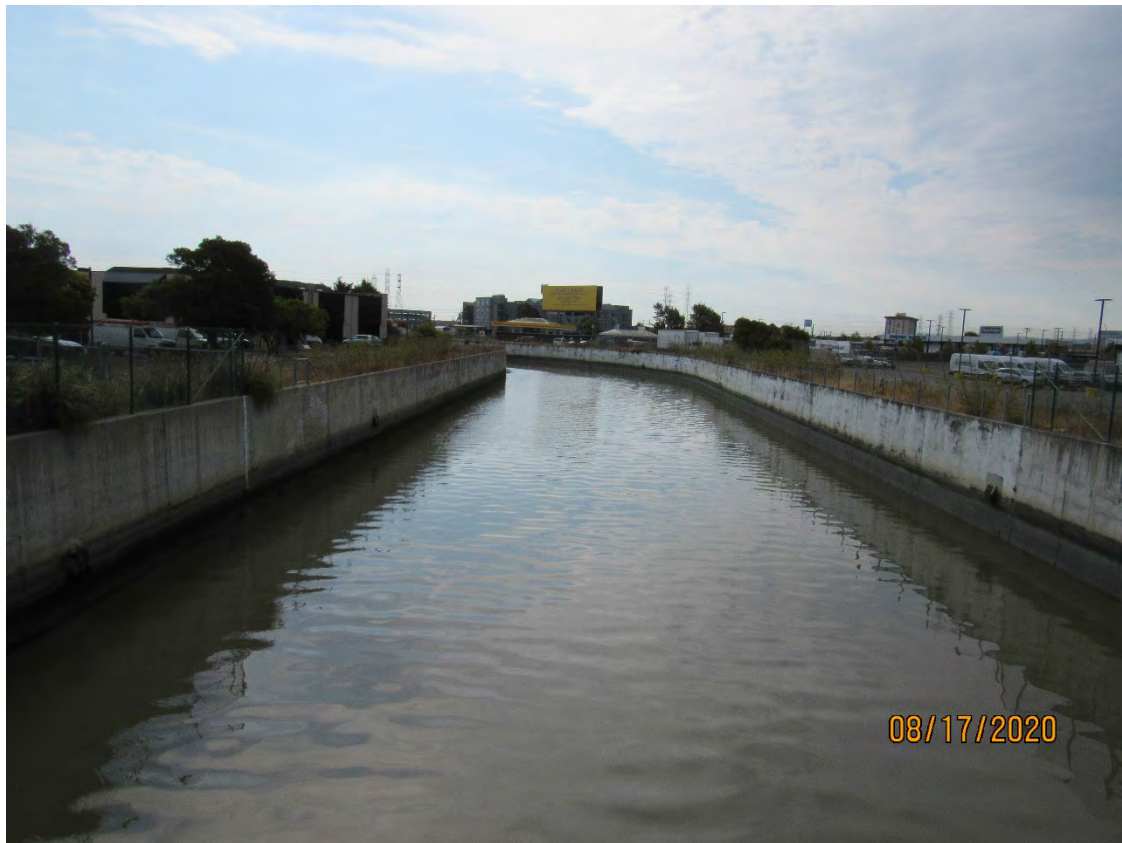
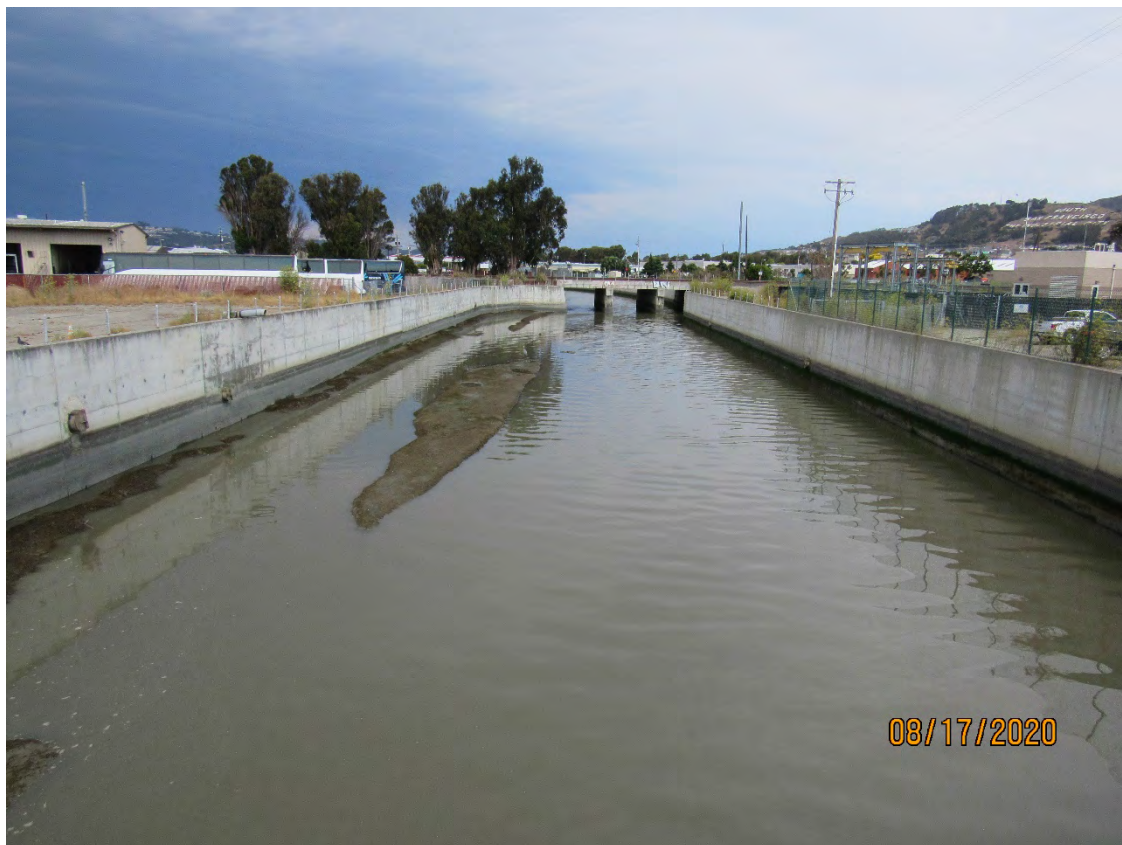
Photos 19 & 20 – Top photo shows Colma Creek looking downstream from the San Mateo Avenue bridge. Bottom photo shows section of channel dredged in 2019 looking upstream from the San Mateo Avenue bridge. The sediment bar remained from 2019 will be dredged during the 2020 maintenance season.

1. Bank vegetation management (various locations);
2. Dredging of sediment between the Caltrain mainline bridge and San Mateo Avenue bridge;
3. Culvert spalling repair downstream of the Spruce Avenue bridge;

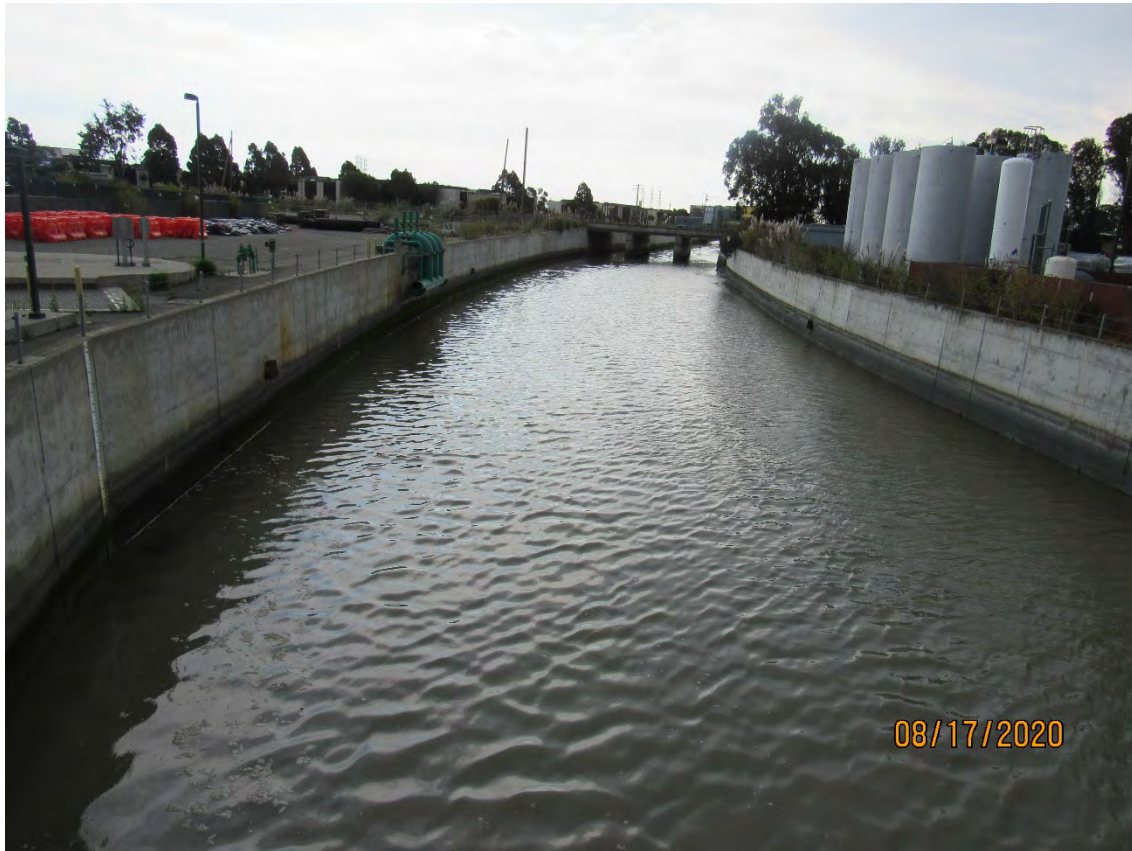
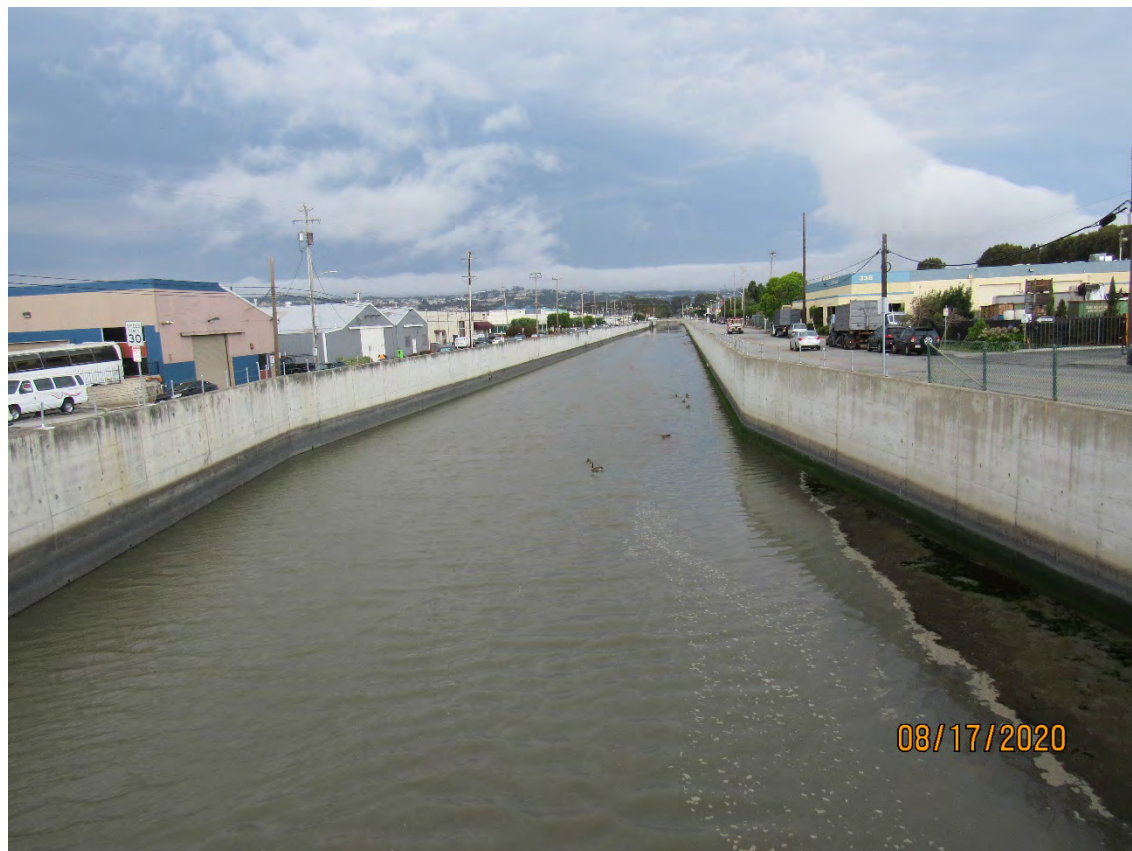
Photos 21 & 22 – Top photo shows Colma Creek looking downstream from the Linden Avenue bridge. Bottom photo shows Colma Creek looking upstream from the Linden Avenue bridge.

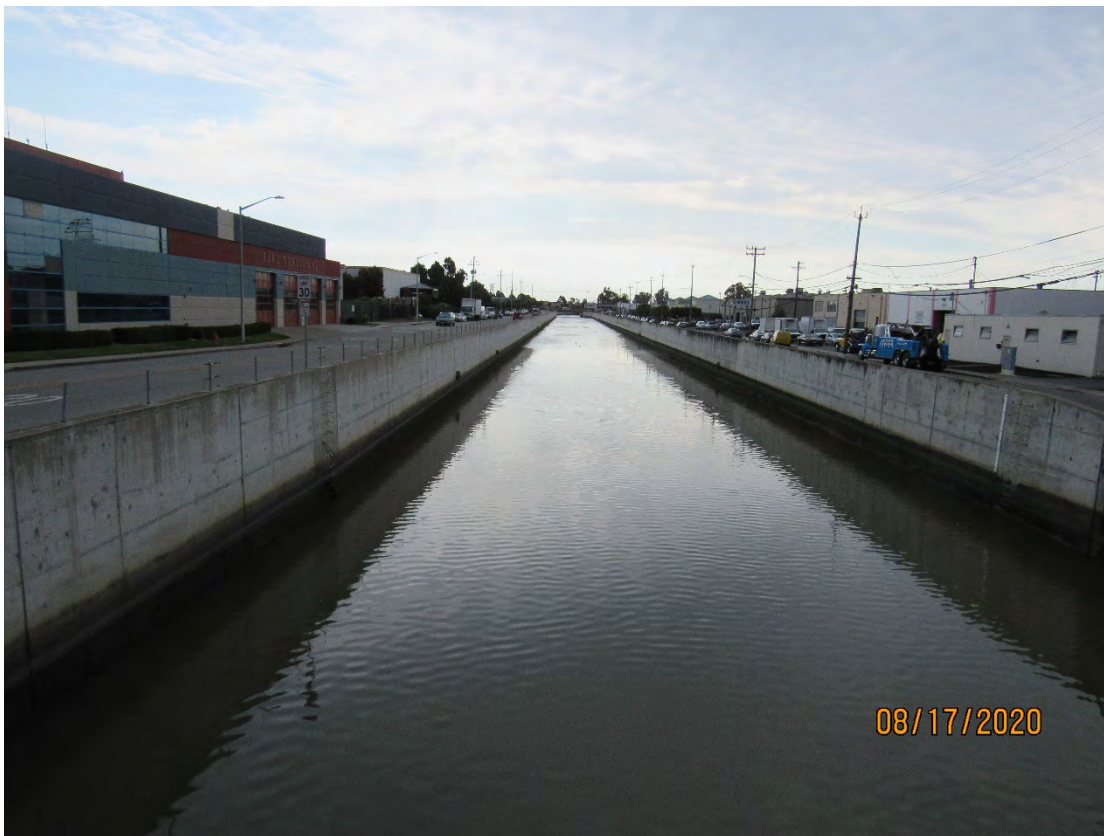
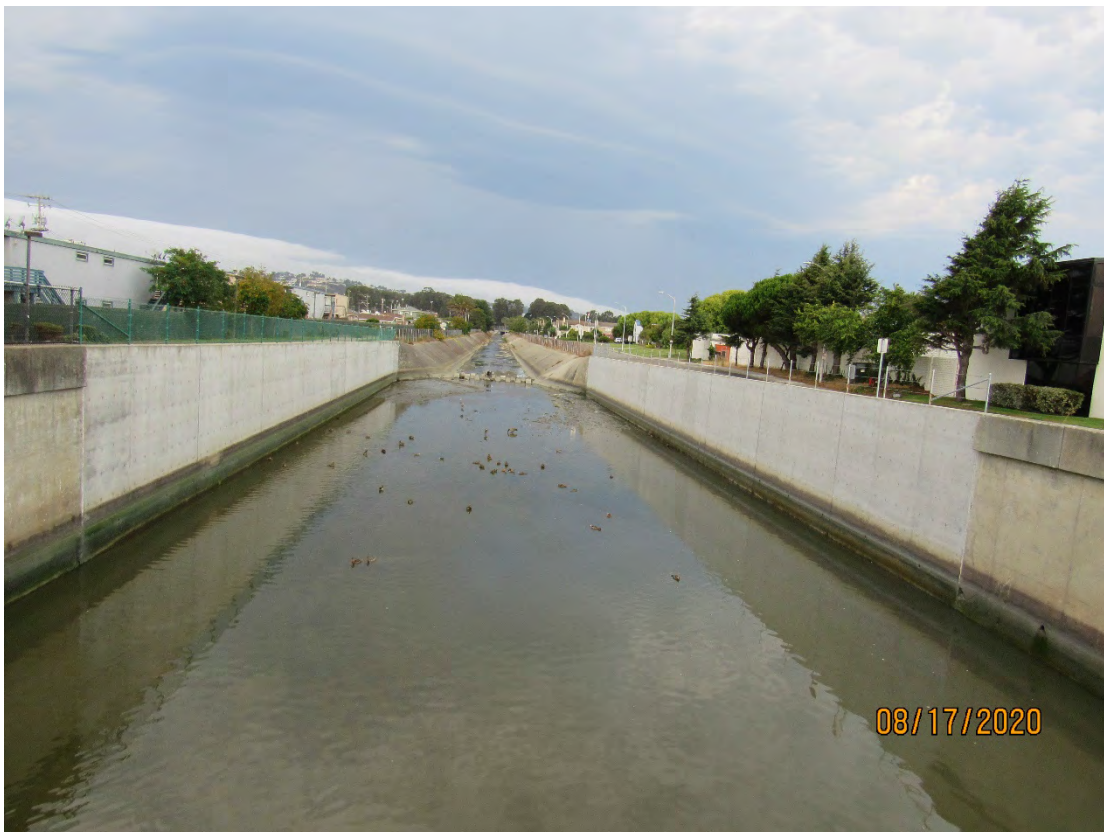
Photos 23 & 24 – Top photo shows Colma Creek looking downstream from the Spruce Avenue bridge. Bottom photo shows Colma Creek looking upstream from the Spruce Avenue bridge.
