COLMA CREEK CITIZENS ADVISORY COMMITTEE MEETING

San Mateo County Flood Control District
Colma Creek Flood Control Zone Citizens Advisory Committee

Survey Date: August 17, 2020

Colma Creek Flood Control Channel Maintenance Matrix

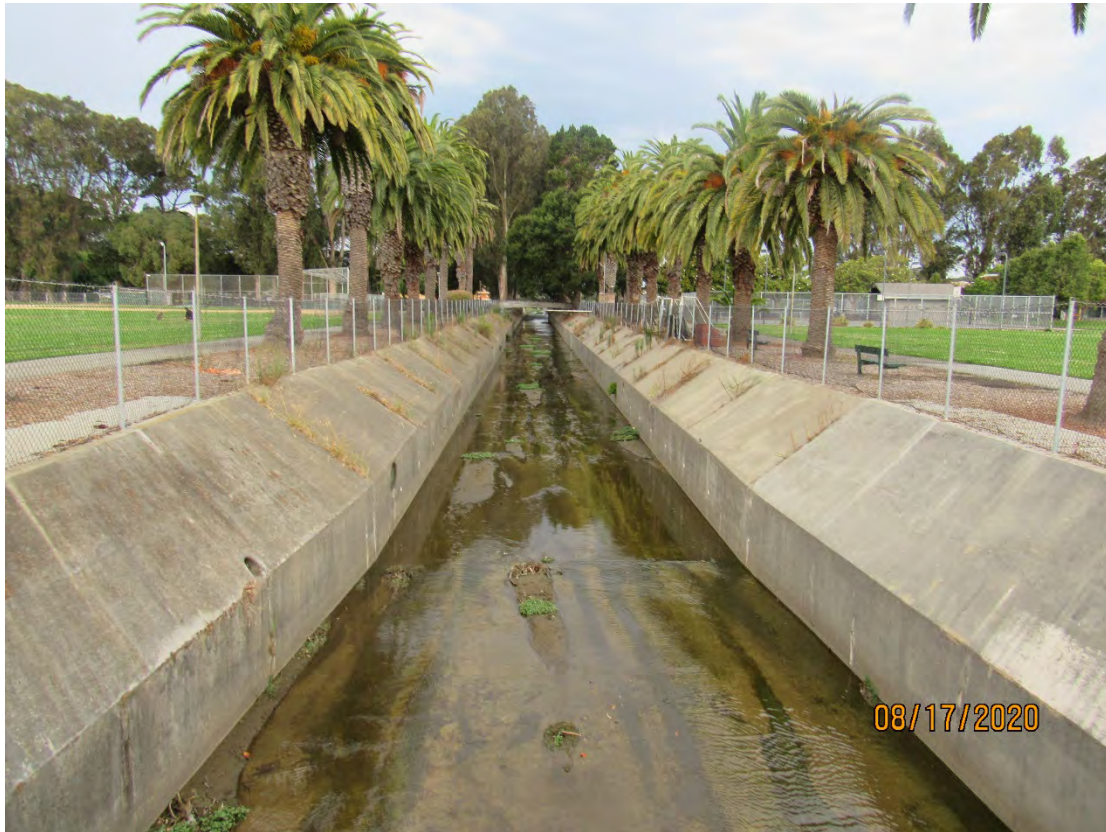
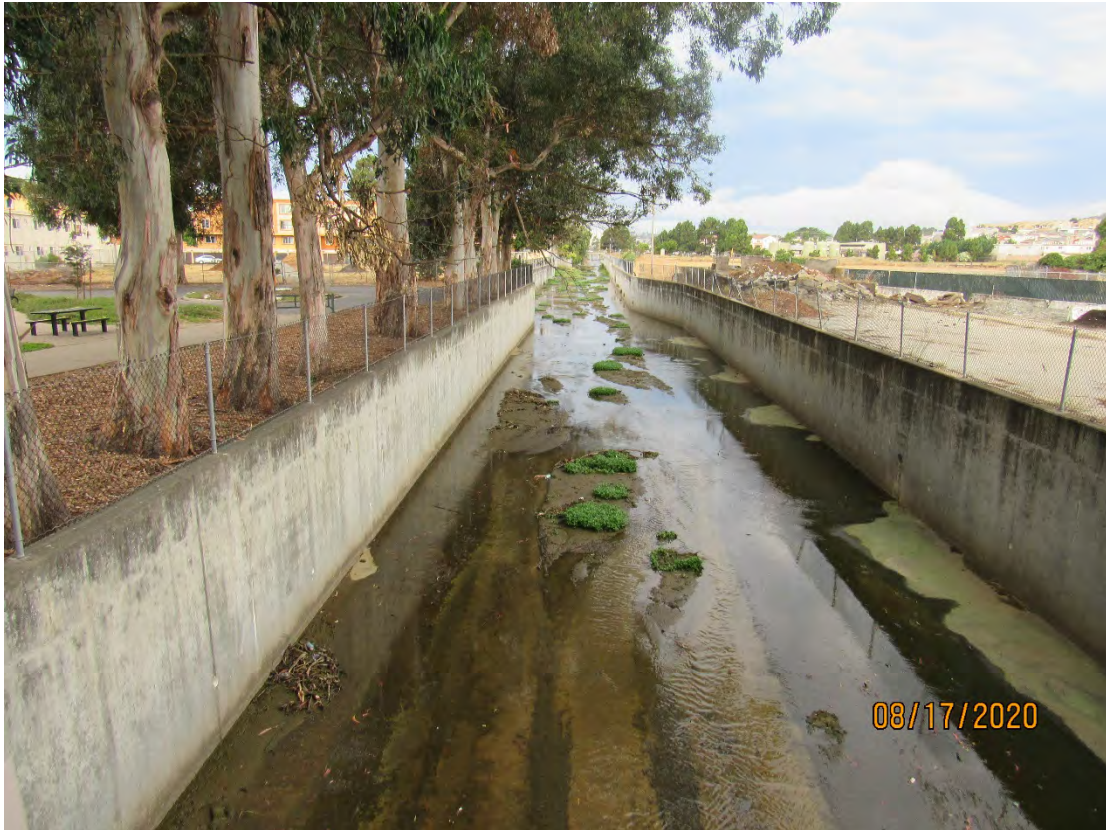
Photos 25 & 26 – Top photo shows Colma Creek looking upstream from the Orange Avenue bridge. Bottom photo shows Colma Creek looking upstream from the Orange Skate Park bridge. Sediment accumulation observed throughout the channel between the Orange Avenue and Chestnut Avenue.

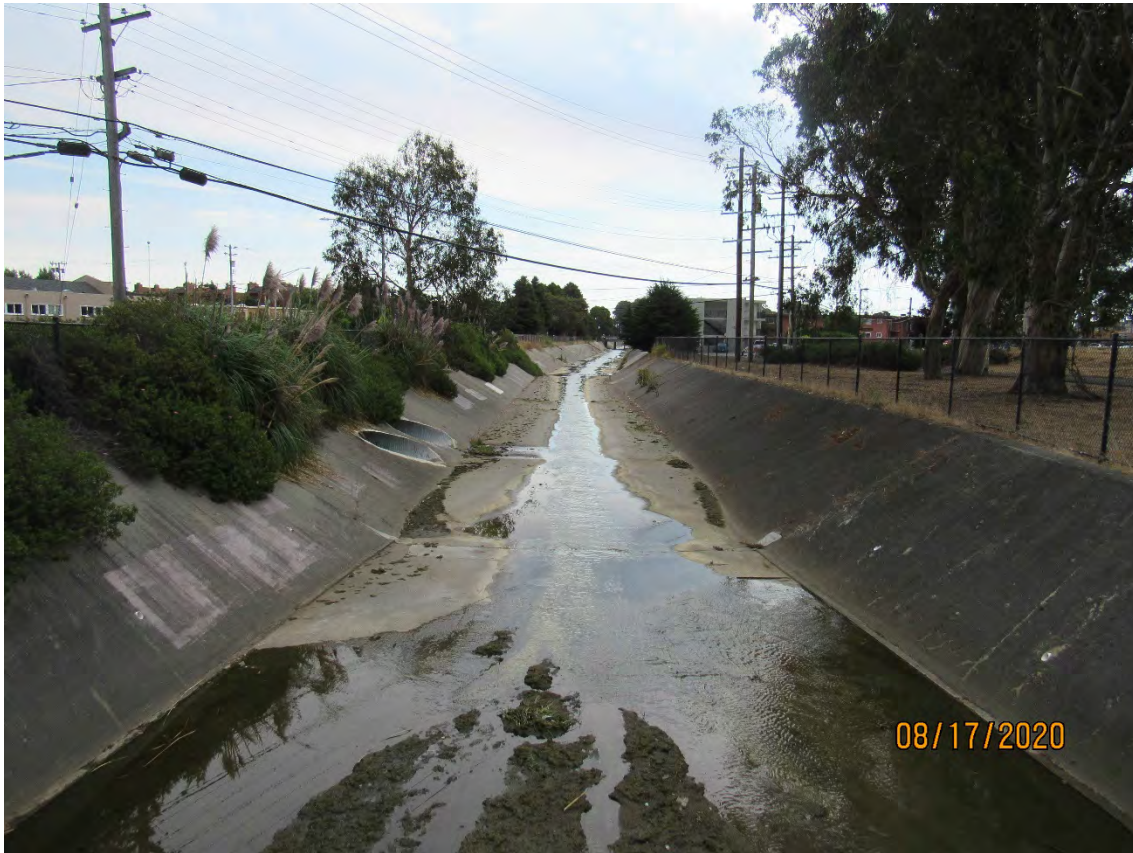
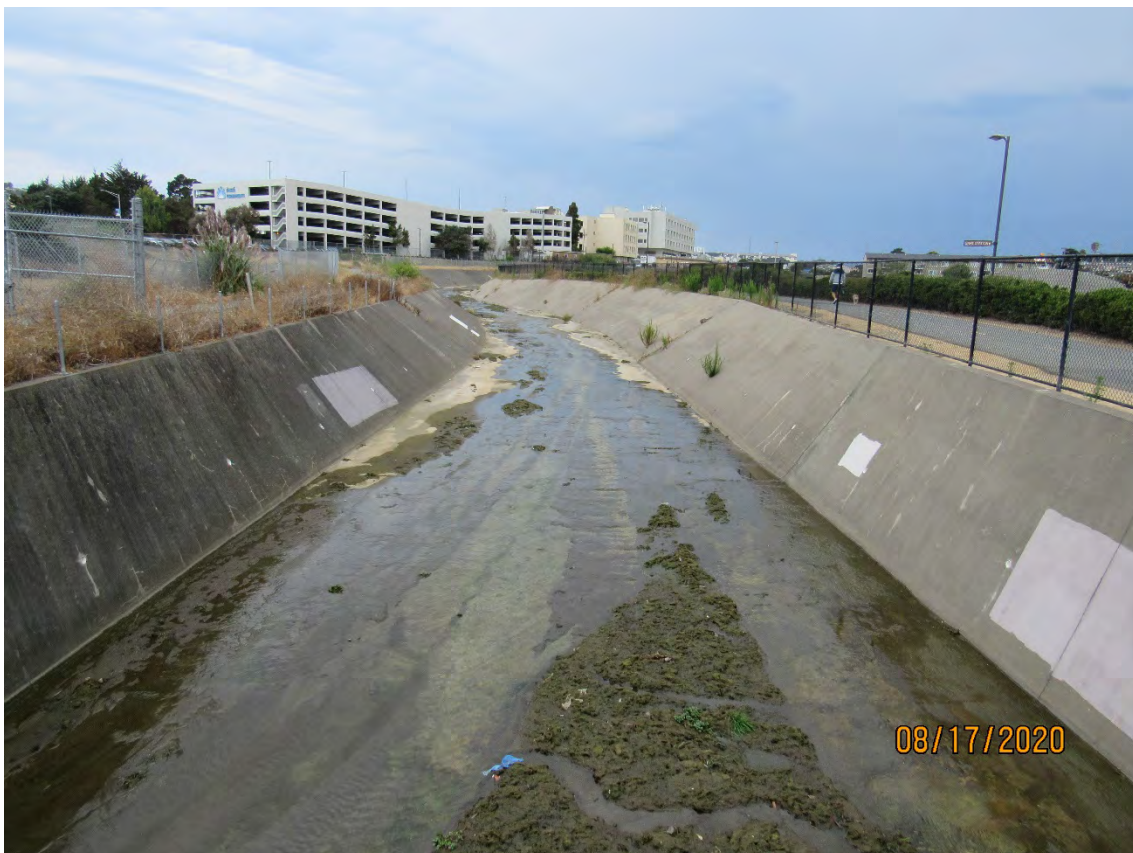
Photos 27 & 28 – Top photo shows Colma Creek looking downstream from the Centennial Way pedestrian bridge. Bottom photo shows Colma Creek looking upstream from the Centennial Way pedestrian bridge. **Offensive graffiti throughout this section of the channel were painted over by the SSF maintenance staff.**

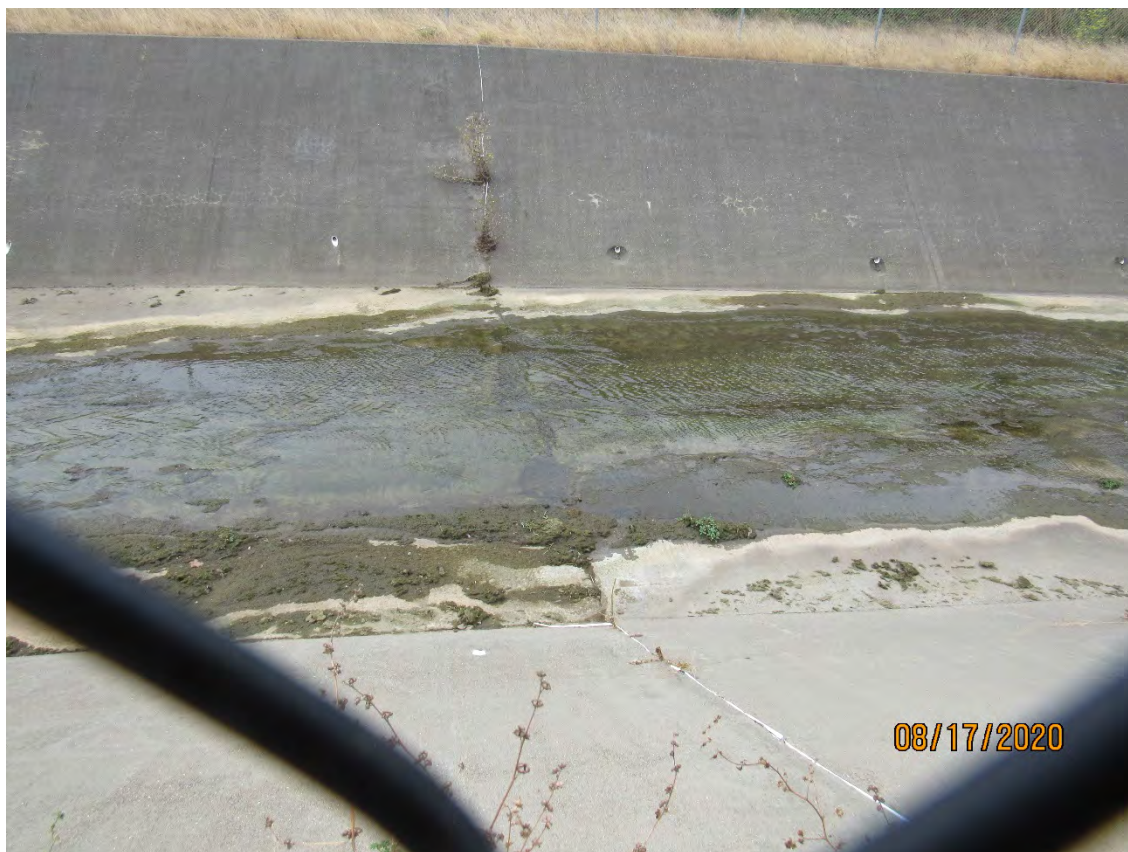
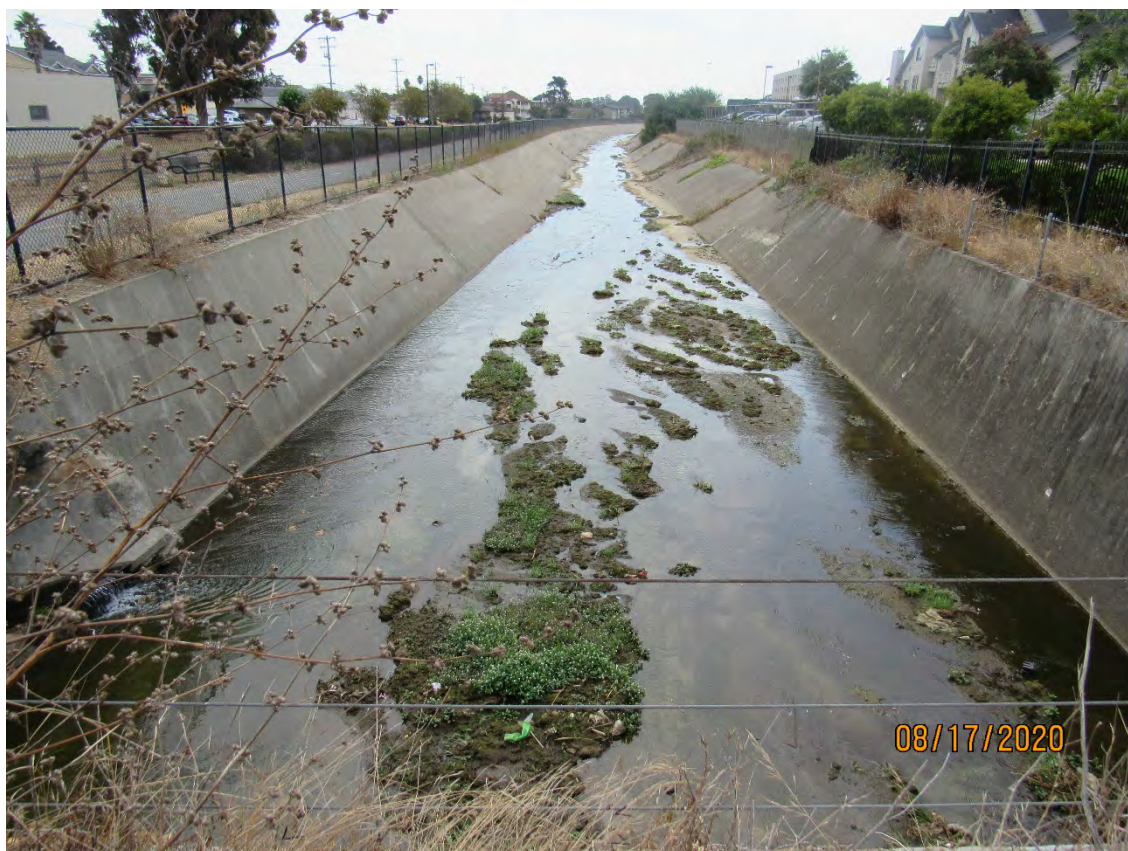
Photos 29 & 30 – Top photo shows channel bottom damage within Colma Creek. **Three areas with similar damage are to be repaired as part of the 2020 maintenance work.** Bottom photo shows Colma Creek looking downstream from the SSF BART Station box culvert.

5. Channel bottom repair at three locations between Centennial Way pedestrian bridge and the S. San Francisco BART Station box culvert outlet;
6. Culvert outlet repairs at two locations downstream of the S. San Francisco BART Station box culvert outlet;

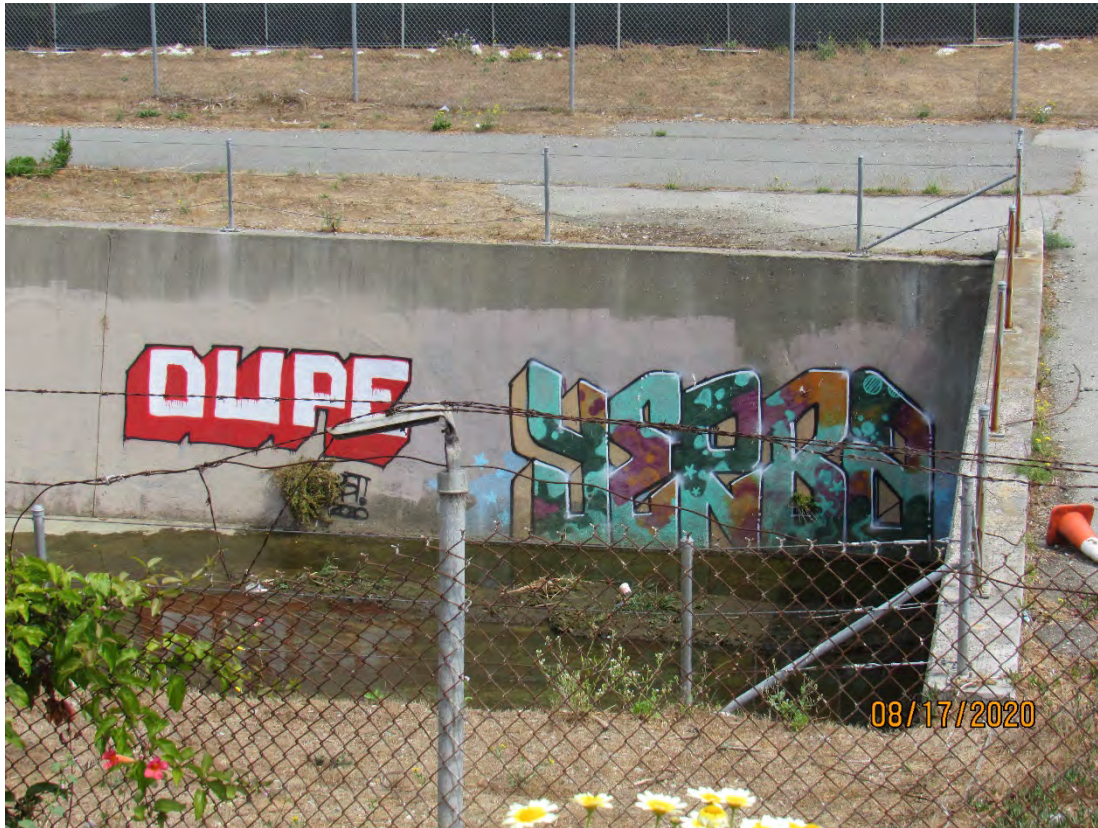
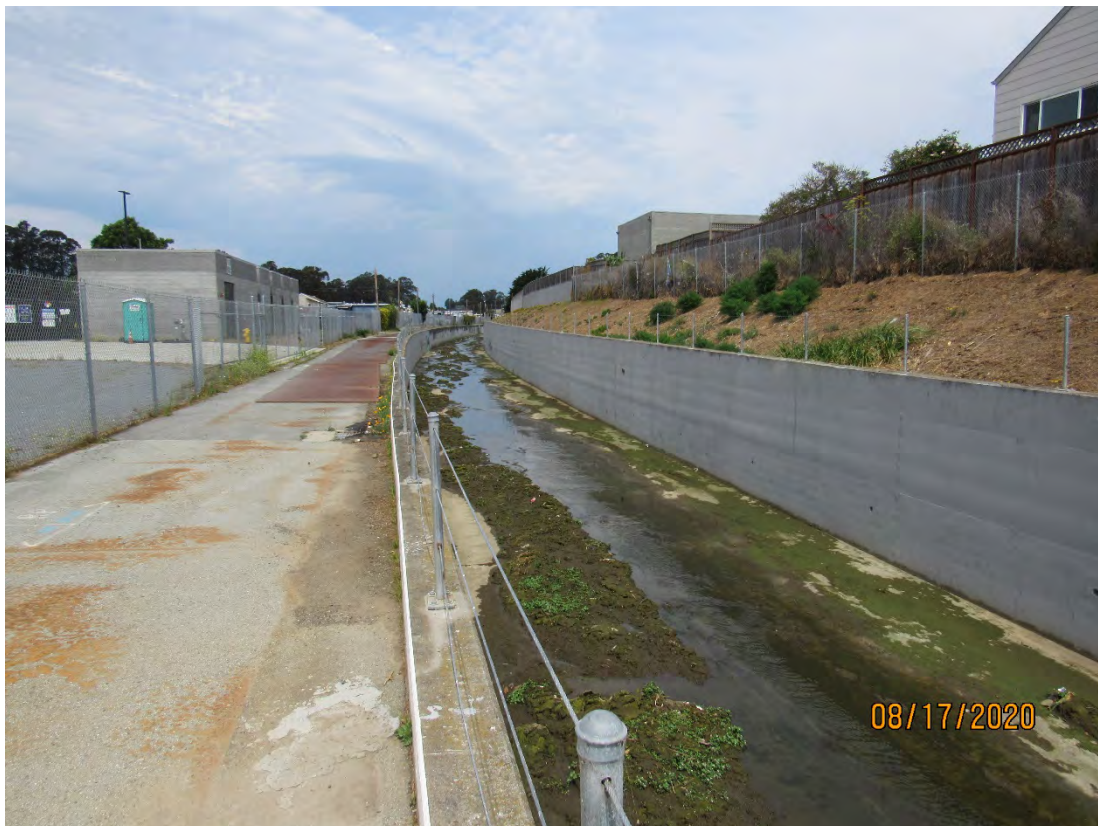
Photos 31 & 32 – Top photo shows new graffiti observed on the channel wall upstream of McLellan Drive and across from the Trader Joe's. Bottom photo shows Colma Creek looking upstream from the Costco pedestrian bridge. **Contractor retained by the Town of Colma recently cleared vegetation from the north bank and from within the channel's weep holes and joints. This work was authorized by County staff under the Memorandum of Agreement prior to its expiration.**

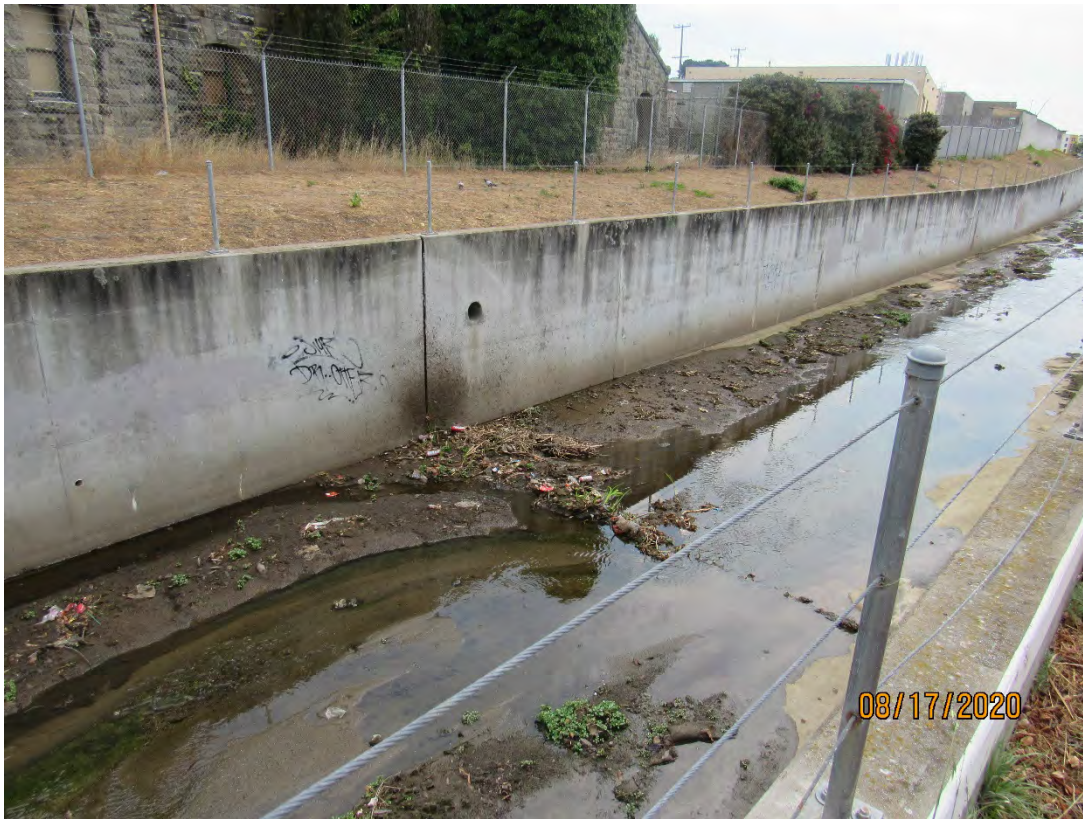
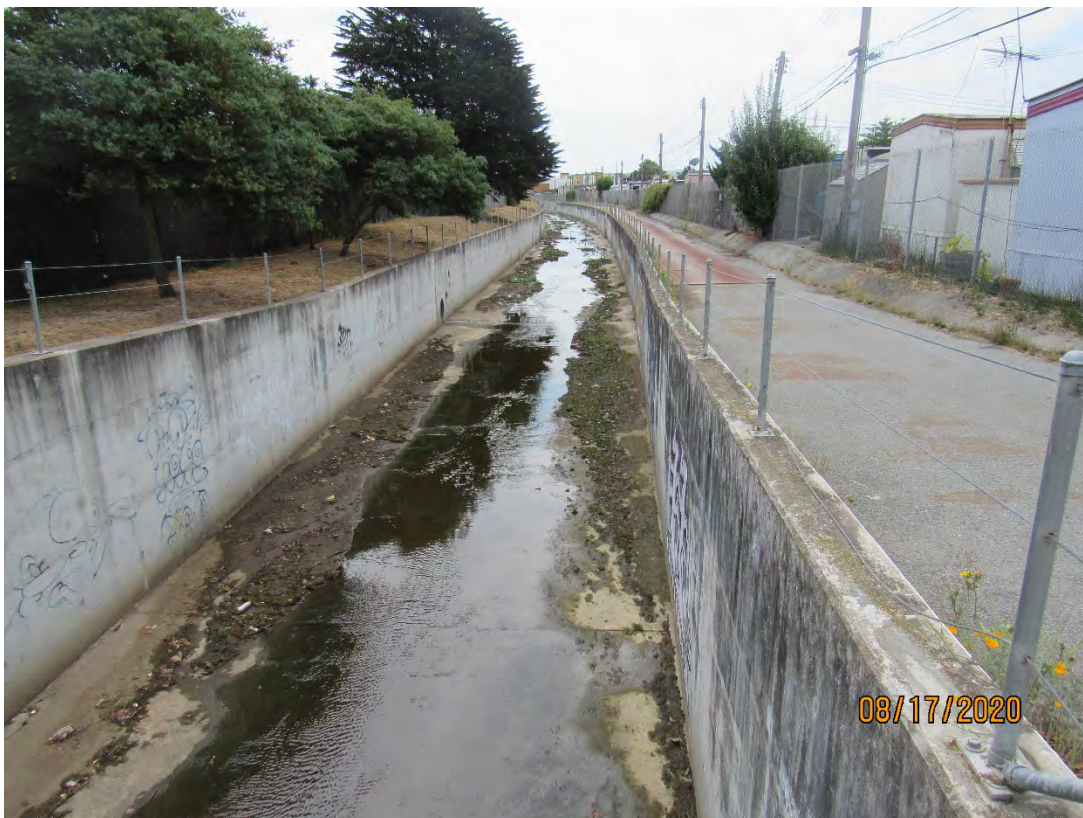
Photos 33 & 34 – Top photo shows Colma Creek following vegetation maintenance by Town of Colma's contractor. Bottom photo shows Colma Creek looking downstream from the Mission Road box culvert outlet.

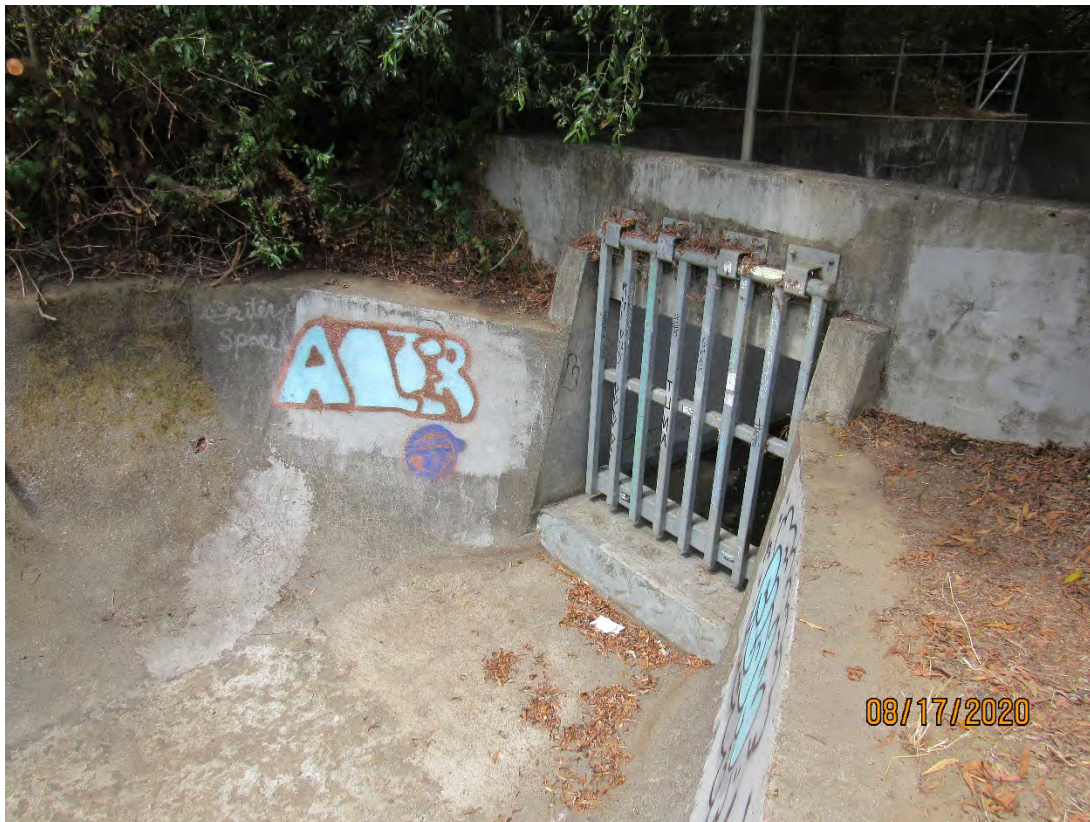
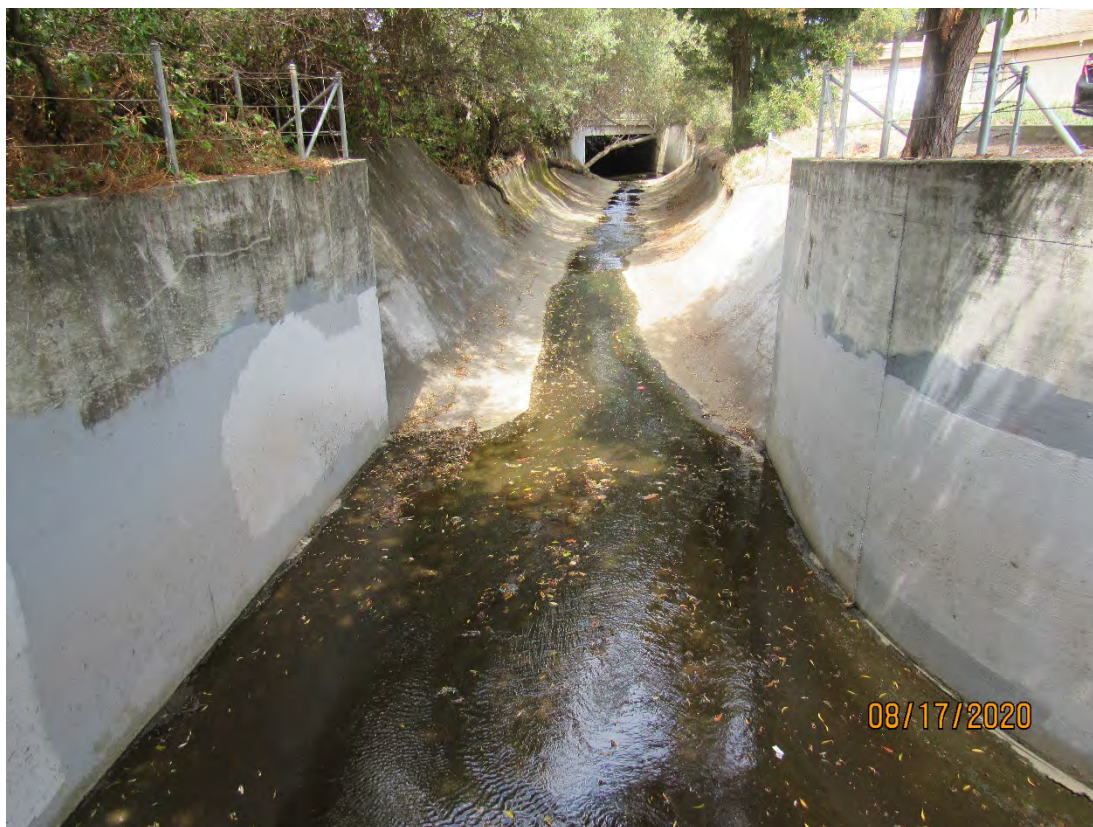
Photos 35 & 36 – Top photo shows new graffiti at the diversion structure to Old Colma Creek. Bottom photo shows Old Colma Creek channel downstream of the El Camino Real bridge at the Mission Road intersection. **Previously observed overhanging tree branches have been cleared by the Town of Colma.**
